RE: Section 5 Declaration R534/19 Lee Villa, Sundays Well, Cork

PLANNER'S REPORT Ref. R534 /19		Cork City Council Culture, Community and Placemaking
Application type	Section 5 Declaration	
Description	<i>Whether Proposed Renovation Works to Property Known as Lee Villa, Sundays Well Road in Cork City are exempted development</i>	
Location	Lee Villa, 21 Sundays Well Road, Cork	
Applicant	Jack Coughlan	
Date	30/08/2019	
Recommendation	<i>Is Development and Is Not Exempted Development</i>

Structural Condition Inspection Report

Project Number: LW27
 Project Name: Structural Condition Inspection, 21 Sundays Well, Cork City
 Client: Jack Coughlan & Associates Architects
 Document Title: LW27 – Structural Condition Inspection Report
 Document Reference: LW27R001 Current Revision: A

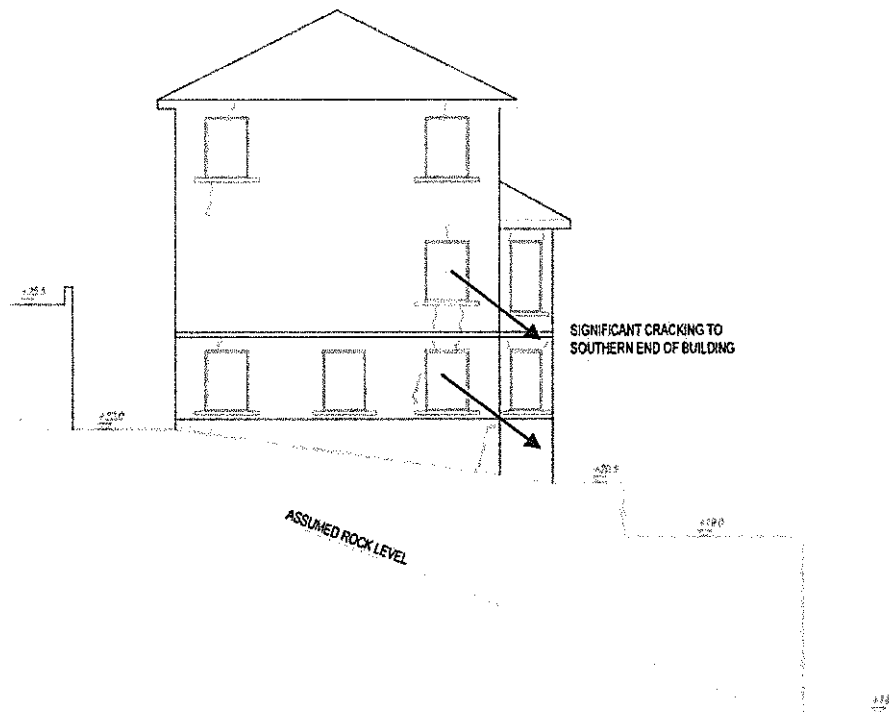
Based on the steep site and the ground conditions the northern end of the property will be founded on or near the rock level with the southern end of the house founded with in the upper clay soil/soft weather mud stone layers. The noted cracking and subsidence to the property identified in the following sections of this report are more substantial and pronounced towards the southern end of the property. See schematic section figure 02 below for information.

Figure 02 – Schematic Sketch section showing property & ground levels with rock level indicated. Crack pattern indicates settlement towards the southern end of the property

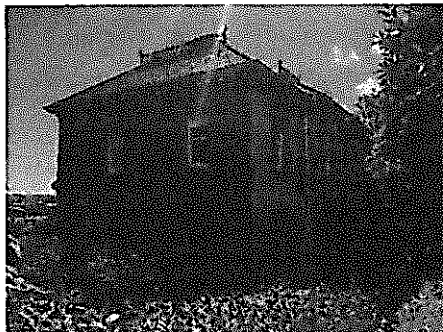
There are a number of minor cracks visible to the render particularly around window heads and cill areas. The roof is a typical A frame with hips to both the east and west with slates and two no. chimneys. A detailed inspection of the roof could not be carried out from ground.

There are timber fascia and soffit overhanging eaves on the elevations and some sections appear to be rotted in number of areas. The gutters and downpipes are painted cast iron and some deterioration has occurred at the joints however they appear to be in a relatively good condition. Evidence of staining and spot locations on the fascia indicate leaks from that joints of the gutters.

Photo -01 – Front Elevation (North East) View

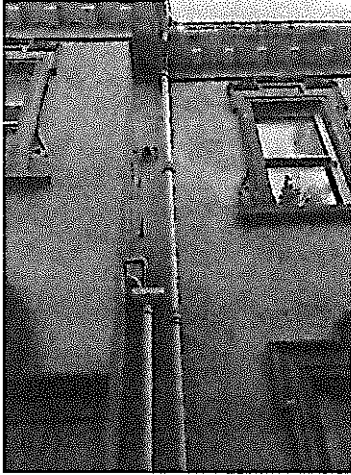
Photo -03 SVP & RWP at Front Elevation

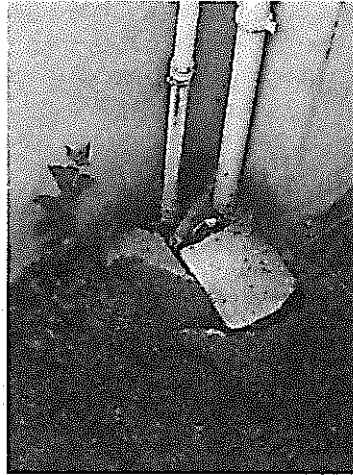
Photo -04 Gully in Well at Front Elevation

Clay Gully taking SVP & RWP in Well area discharging to 150mm Clay Drain

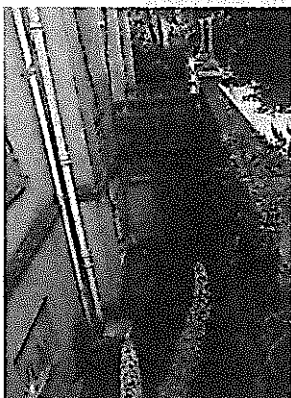
The well areas is generally surfaces with a mix of gravel and concrete paving but it is significantly over grown and where visible the concrete paving is cracked and has subsided.

Photo -05 Well area to Front Elevation looking West

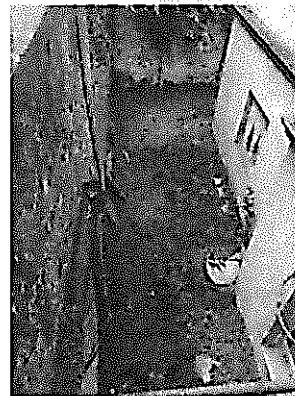
Photo -06 Well area to Front Elevation looking East

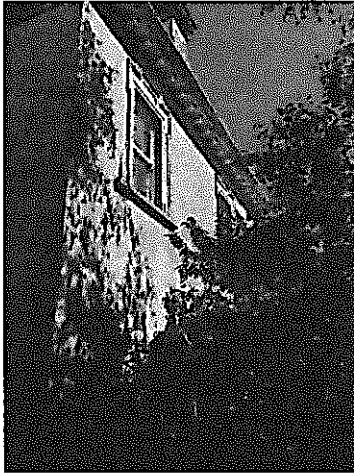
There are a number of significant structural cracks visible to the render particularly around window heads and cill areas towards the southern end of the elevation. see photos below. The direction and pattern of the structural cracking indicates subsidence movement most significantly towards the southern end of the property.

Photo -07 West Elevation High Level

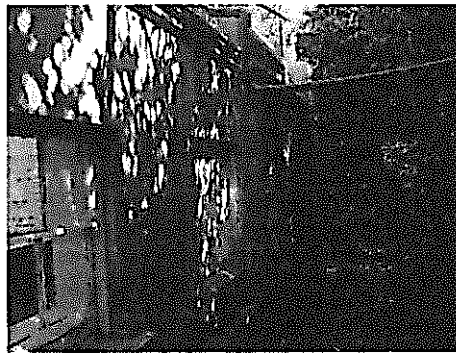
Photo -08 West Elevation low Level

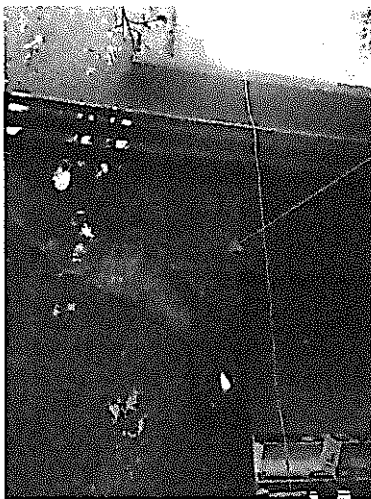
Example of significant Structural Cracking to Southern corner of east elevation.

Photo -09 Structural Cracking to West Elevation

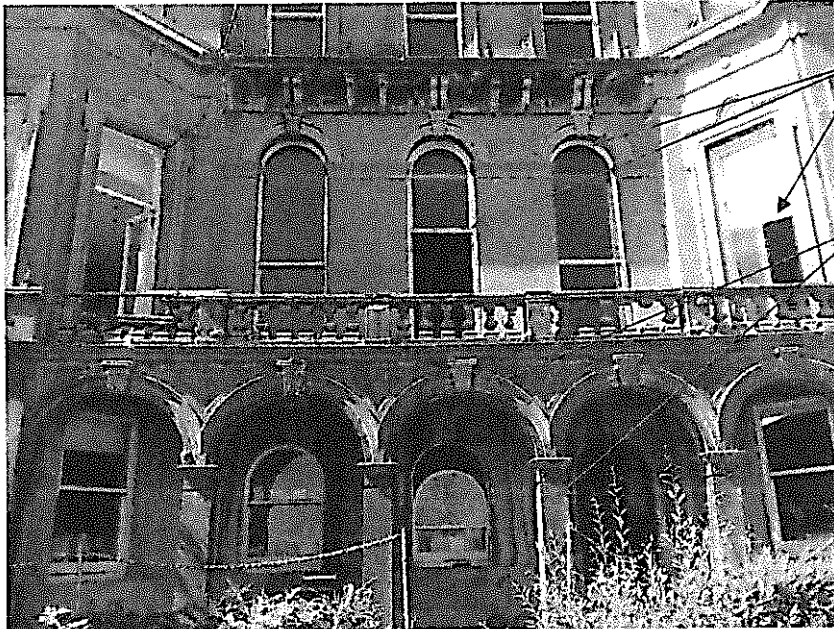
Traditional timber sliding sash

Brick Arch and Column with sand and cement

Photo 10 – South Elevation level 00 to 02.

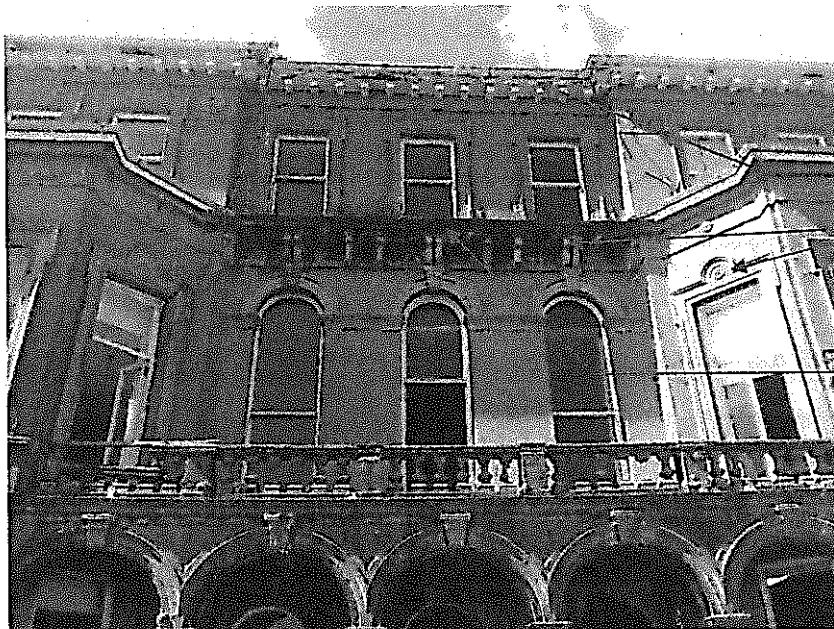
There are step outs in the building at each floor, these could act as a ledge for water to pond and ingress from.

Decorative corning and

Ledge for water to pond.

Photo 11 – South Elevation Level 01 to Roof

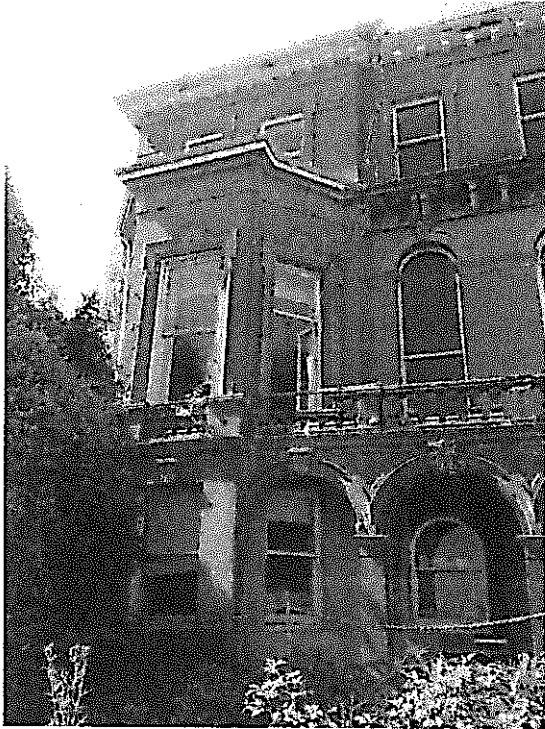
Photo 12 – South West Corner

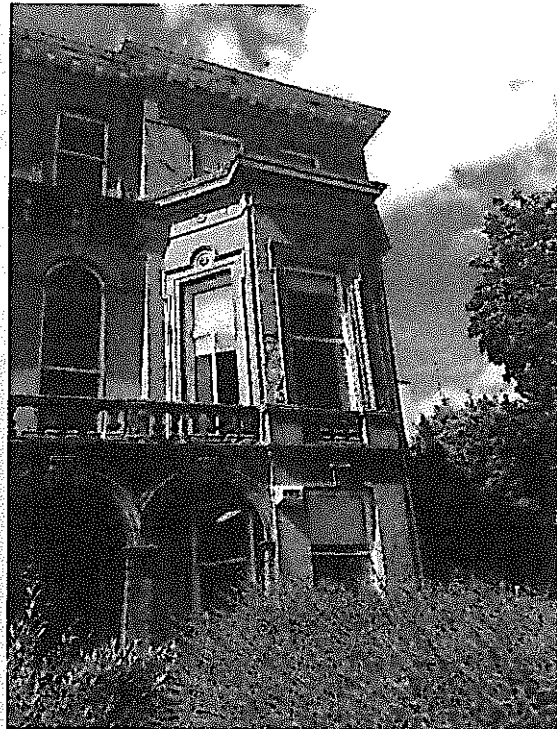
Photo 13 – South East Corner

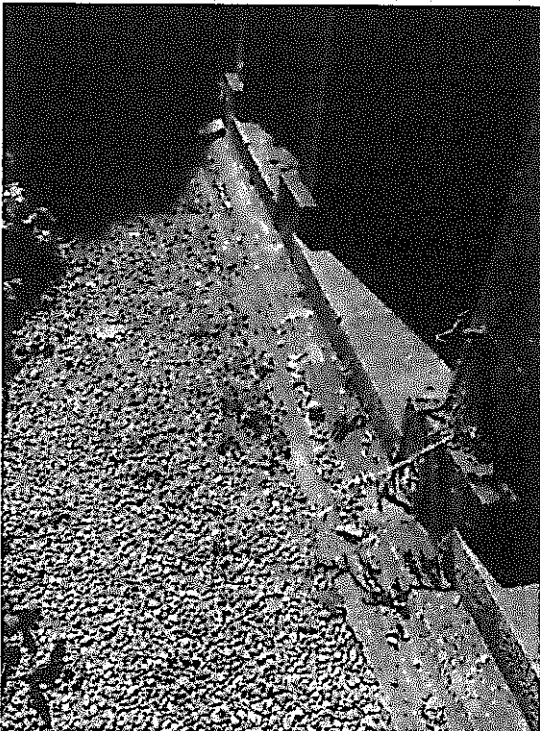
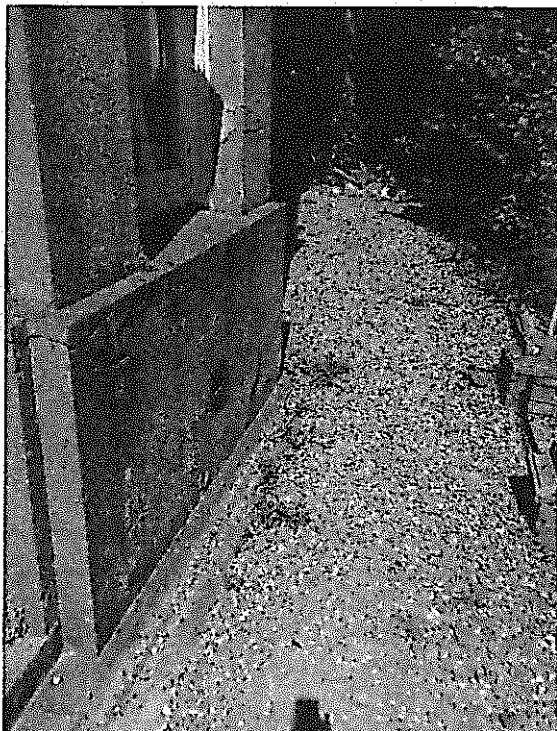
It was noted that some of the rain water down pipes were discharging either directly onto the ground in places and or over shooting the concrete channel. The gully looks to be in poor condition up and channel cracked in places.

Photo 14 – Surface Drain and Gravel Path

Photo 15 – Surface Drain and Gravel Path

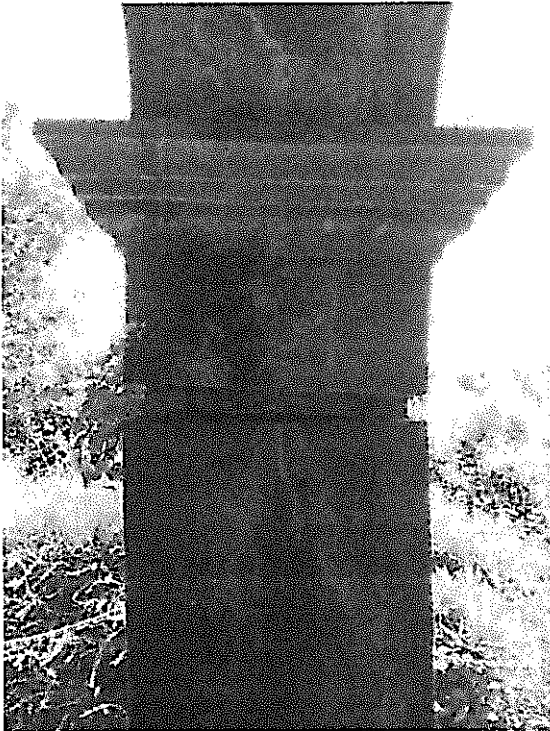
cracks visible. The columns and the arches are cracked and some show significant signs of movement. (ref to photo 16 & 17)

Photo 16 – Column Movement

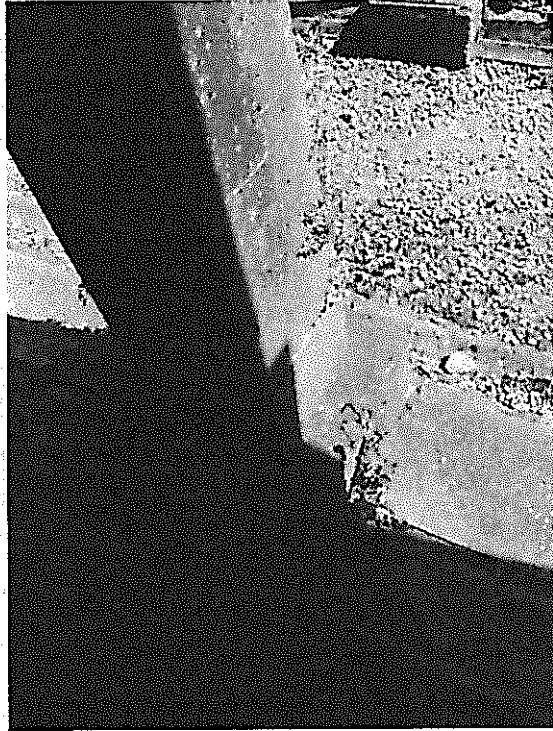
Photo 17 – Column Cracking

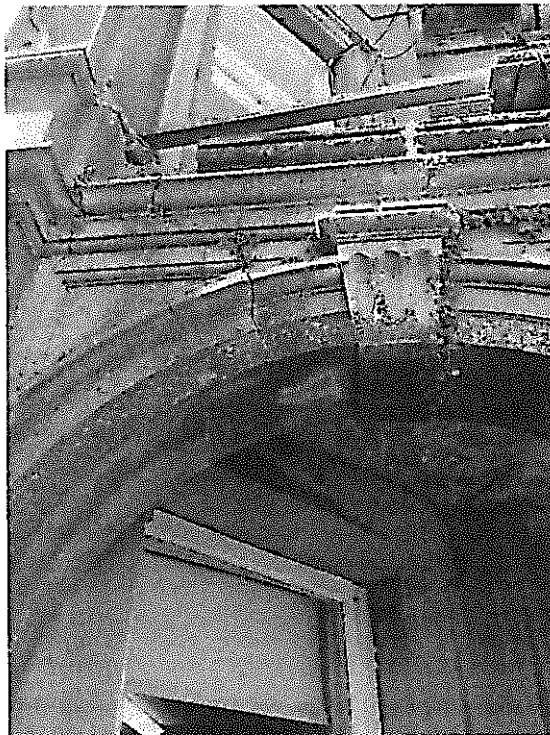
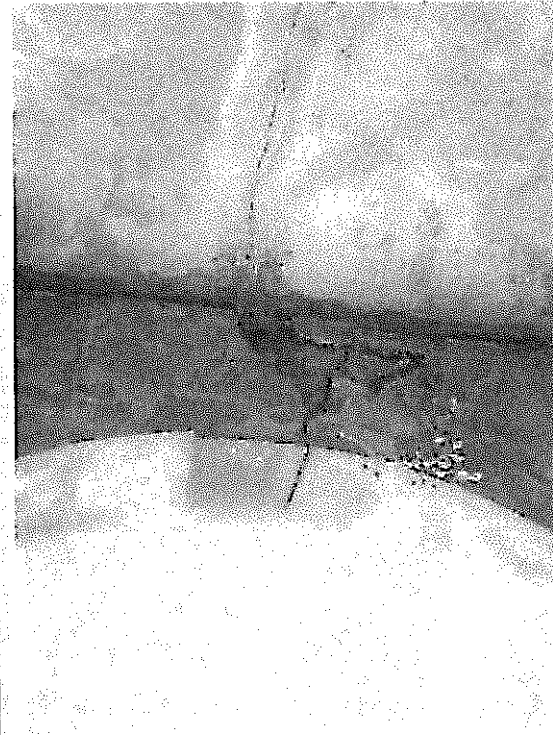
Photo 18 – Cracking in Arch

Photo 19 – Cracking in Arch

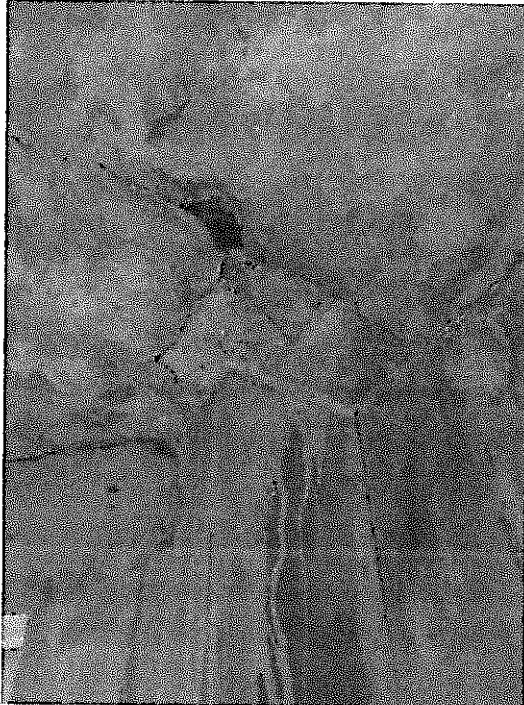
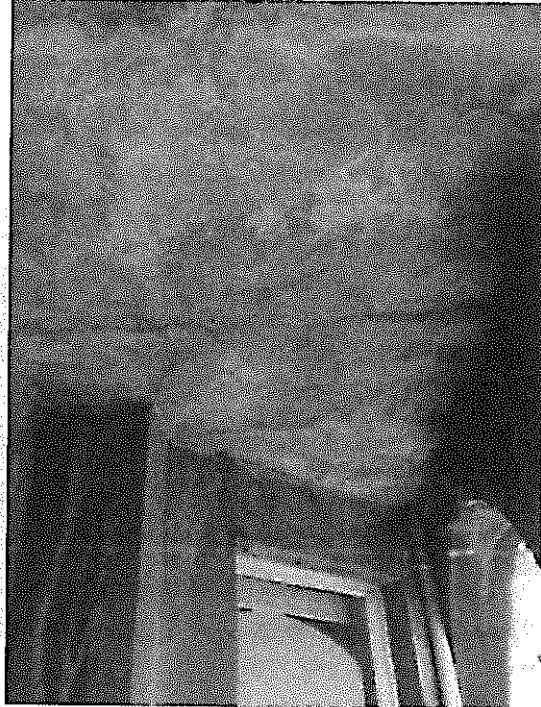
Photo 20 – Cracking to U/S of Concrete Walkway

Photo 21 – Cracking to U/S of Concrete Walkway

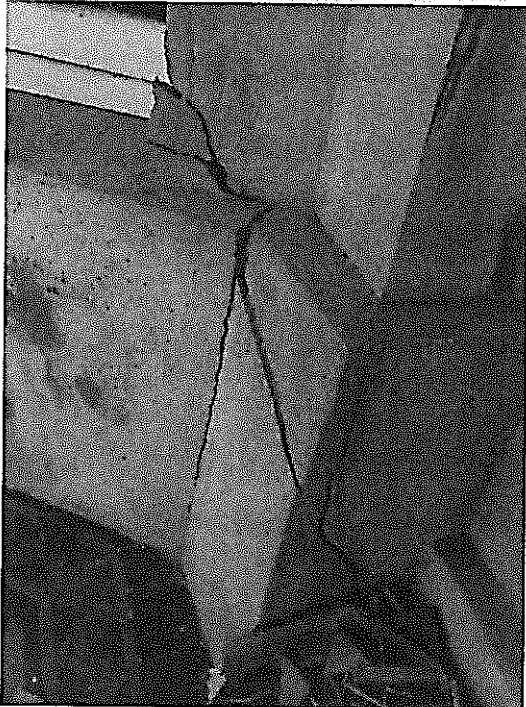
Photo 22 – Movement in South West Corner Bay

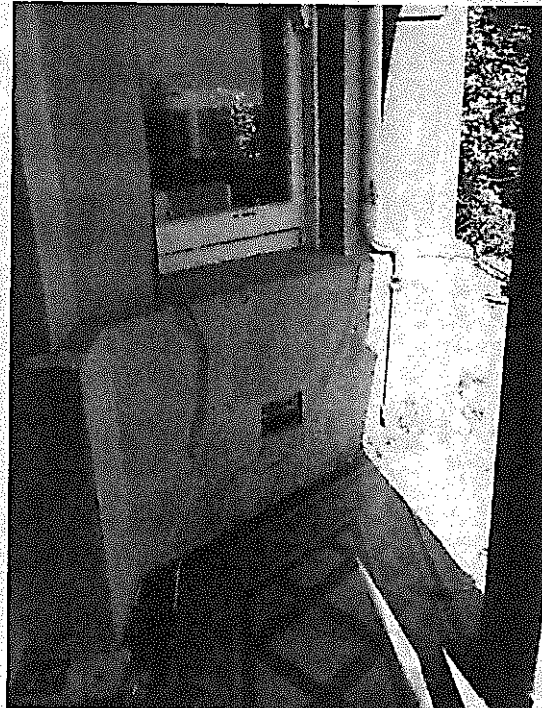
Photo 23 – Cracking in South East Corner Bay

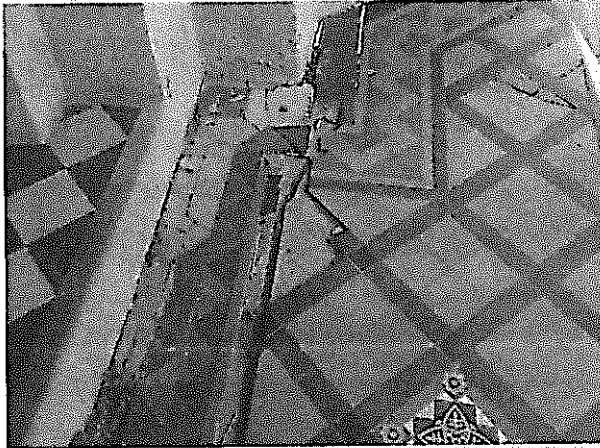
Photo 24 – Cracking in Tiles under Concrete Walkway

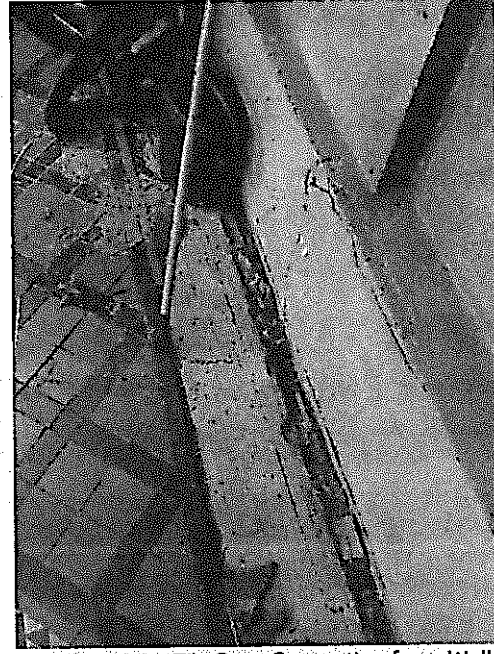
Photo 25 – Tile Base Separation from Wall

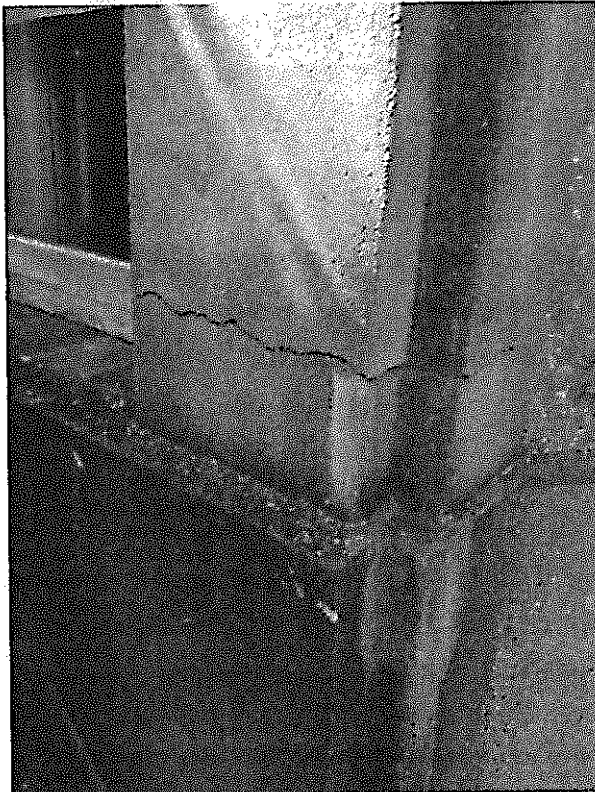
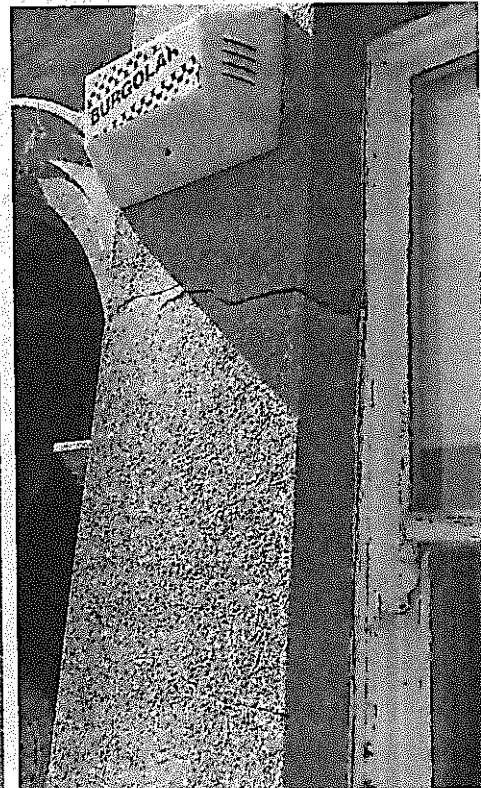
Photo 26 – Cracking in Walls

Photo 27 – Cracking in Walls

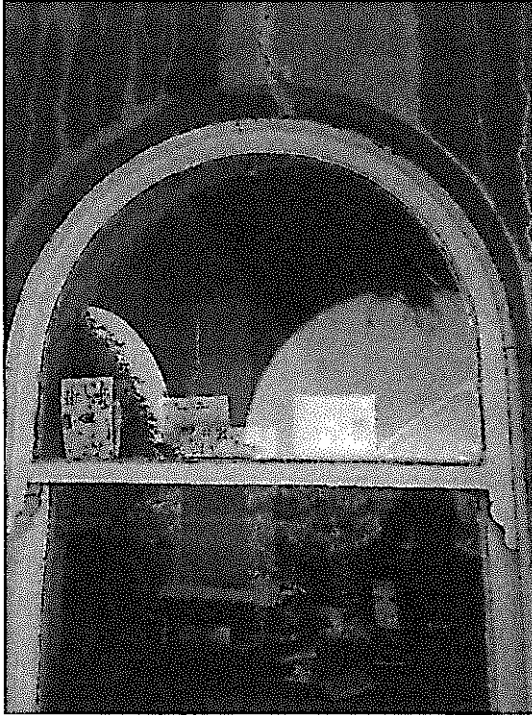
Photo 28 – Cracks around window

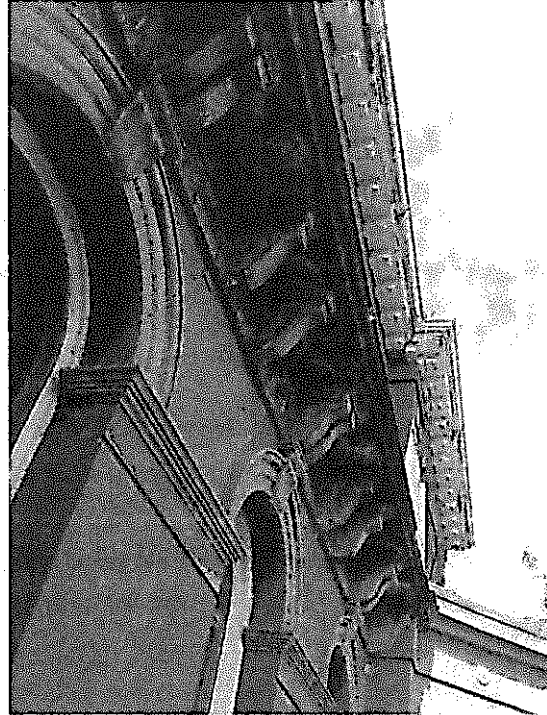
A cementations rendered covers the entire façade of this elevation, this has considerably significant structural cracking throughout. There is decorative corncicing and decorative window reveals which has deteriorated over time and many of which has now broken away completely.

Photo 29 – Deterioration of Corncing

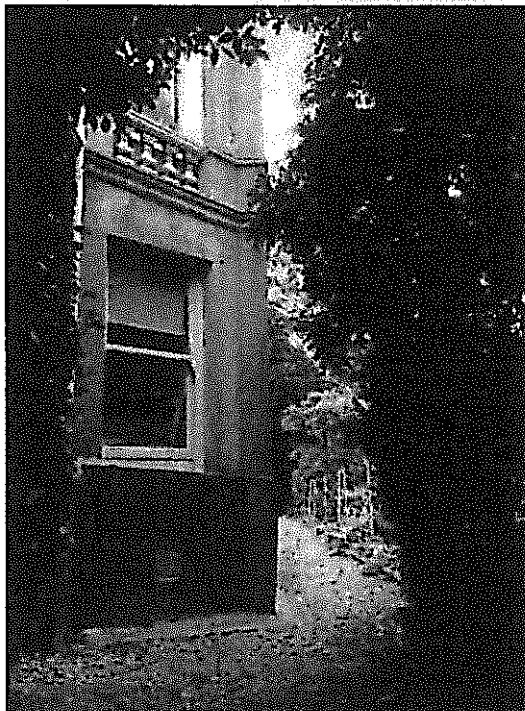
Photo 30 – South west bay window showing significant structural movment.

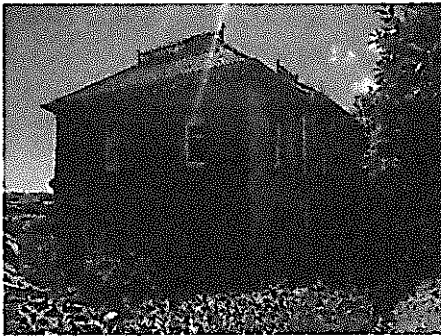
There are some structural cracks visible to the render particularly around window heads and cill as indicated in the photos below.

Photo -XX – East Elevation

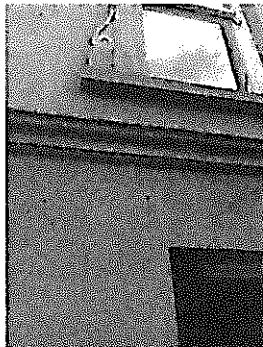
Example of Cracking to east elevation.

Photo -08 Structural Cracking to East Elevation
