# Heritage Impact Assessment

**Former National School at North Presentation Convent**

**Hillgrove Lane, Blackpool, Cork**

**Cork City Record of Protected Structures - PS1141**

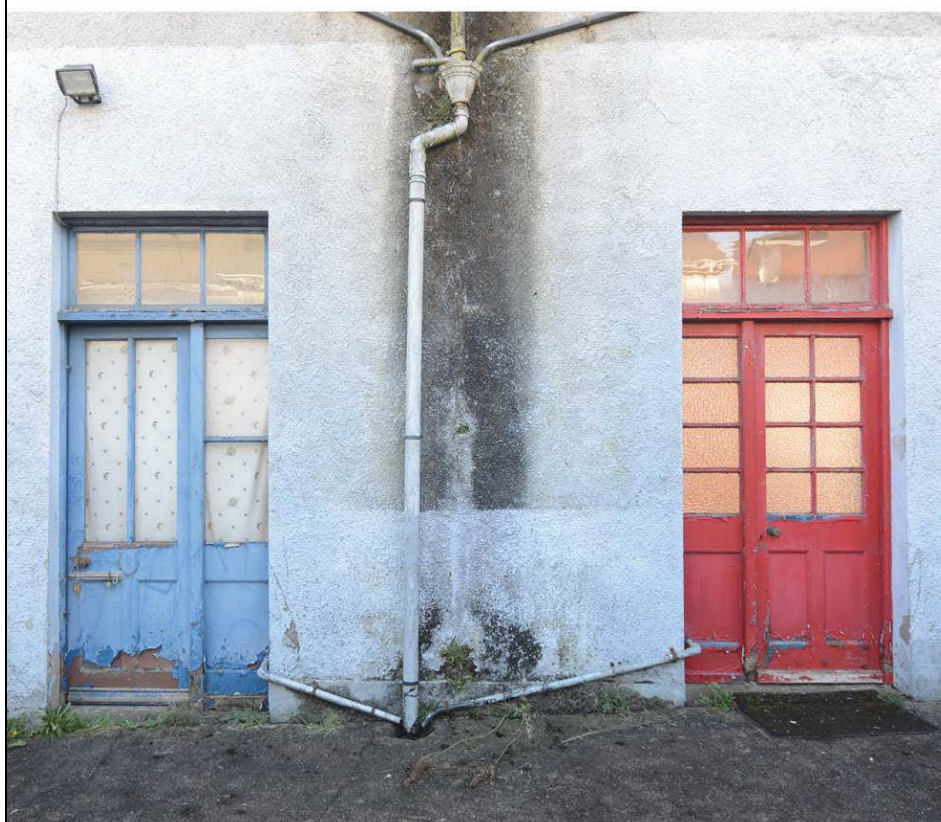
Detail of doors to rooms G04 and G05.

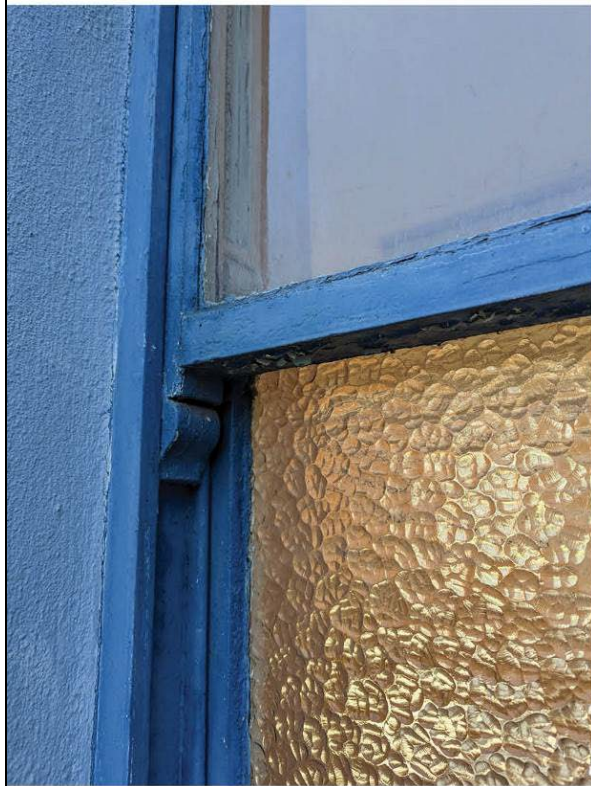
Detail of sash on window to G04.

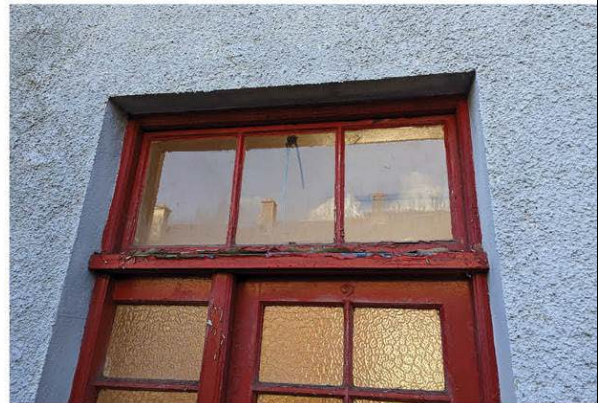
Detail of overlight to door to G04

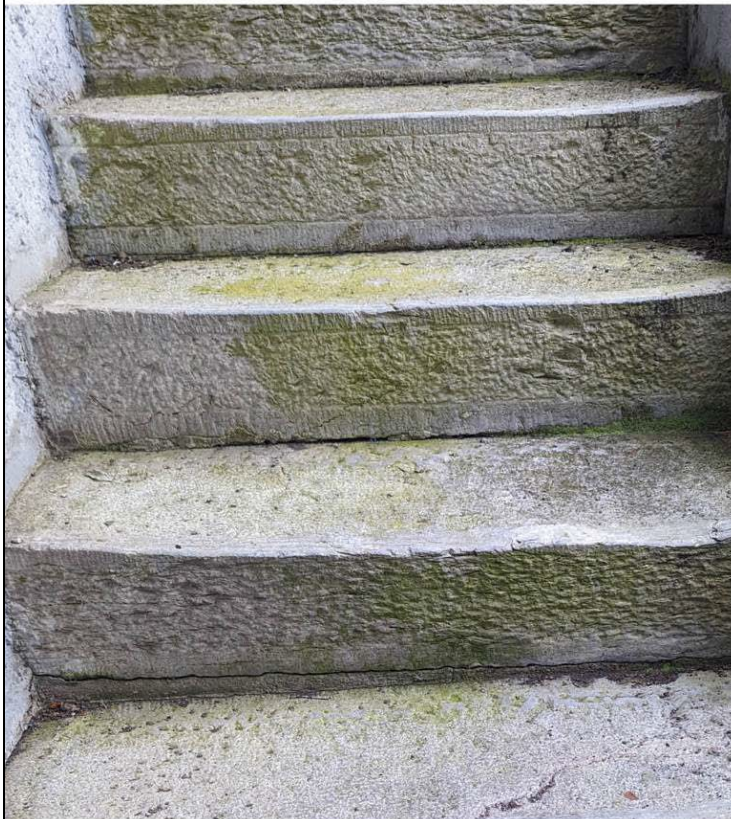
Detail of dressing and wear to eastern steps.

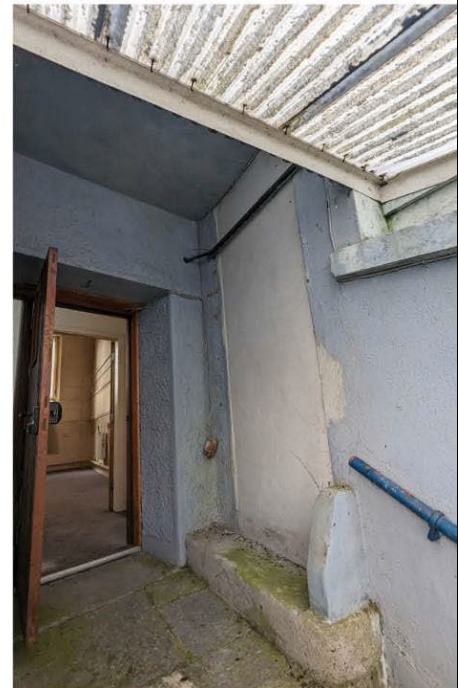
Top landing of western steps showing blocked doorway on right.

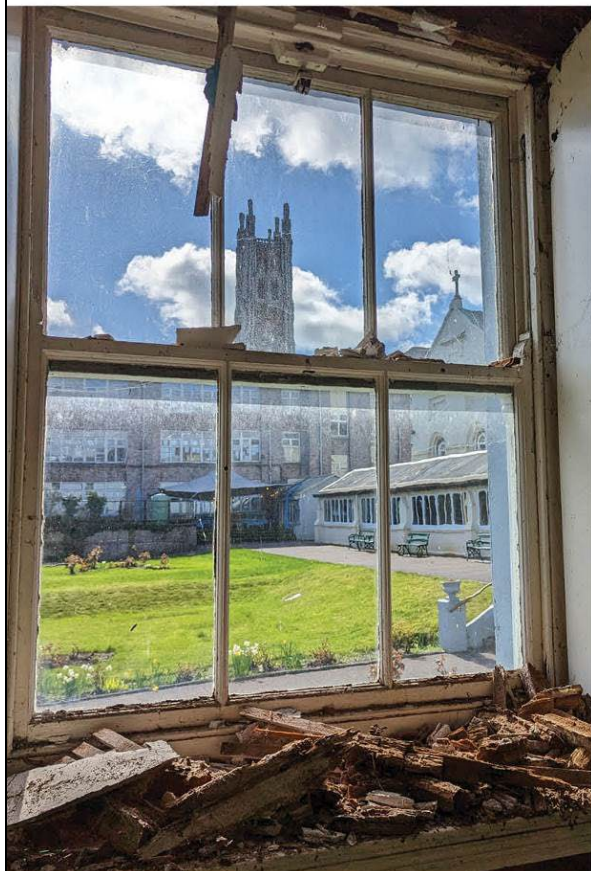
Window to south wall G05 showing detritus from collapsed lintel and view of garden beyond.

Mitigation: Care should be taken to protect the walls and internal features around the works area. Demolition should be confined absolute minimum to achieve the required action. Repairs should utilise conservation materials. The work should be scheduled under the guidance and supervision of a supervising architect and attending conservation specialists; with appropriate records created and maintained.

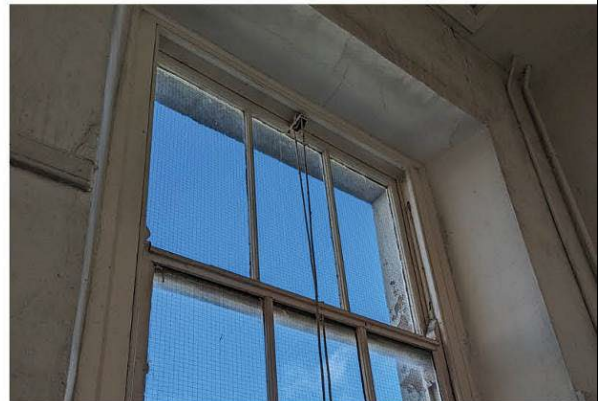
Detail of window in F01 showing replacement wired glass.

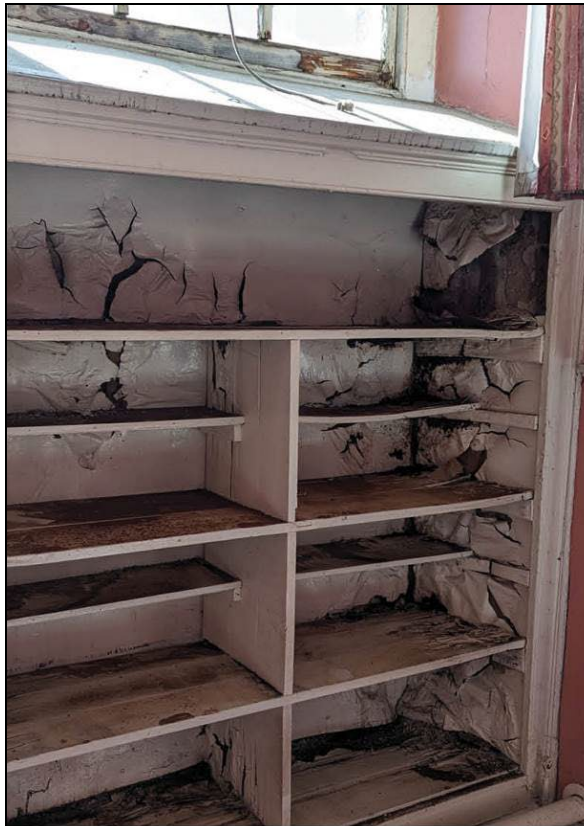
Detail of window and cupboard to south of Room F08 showing damage.

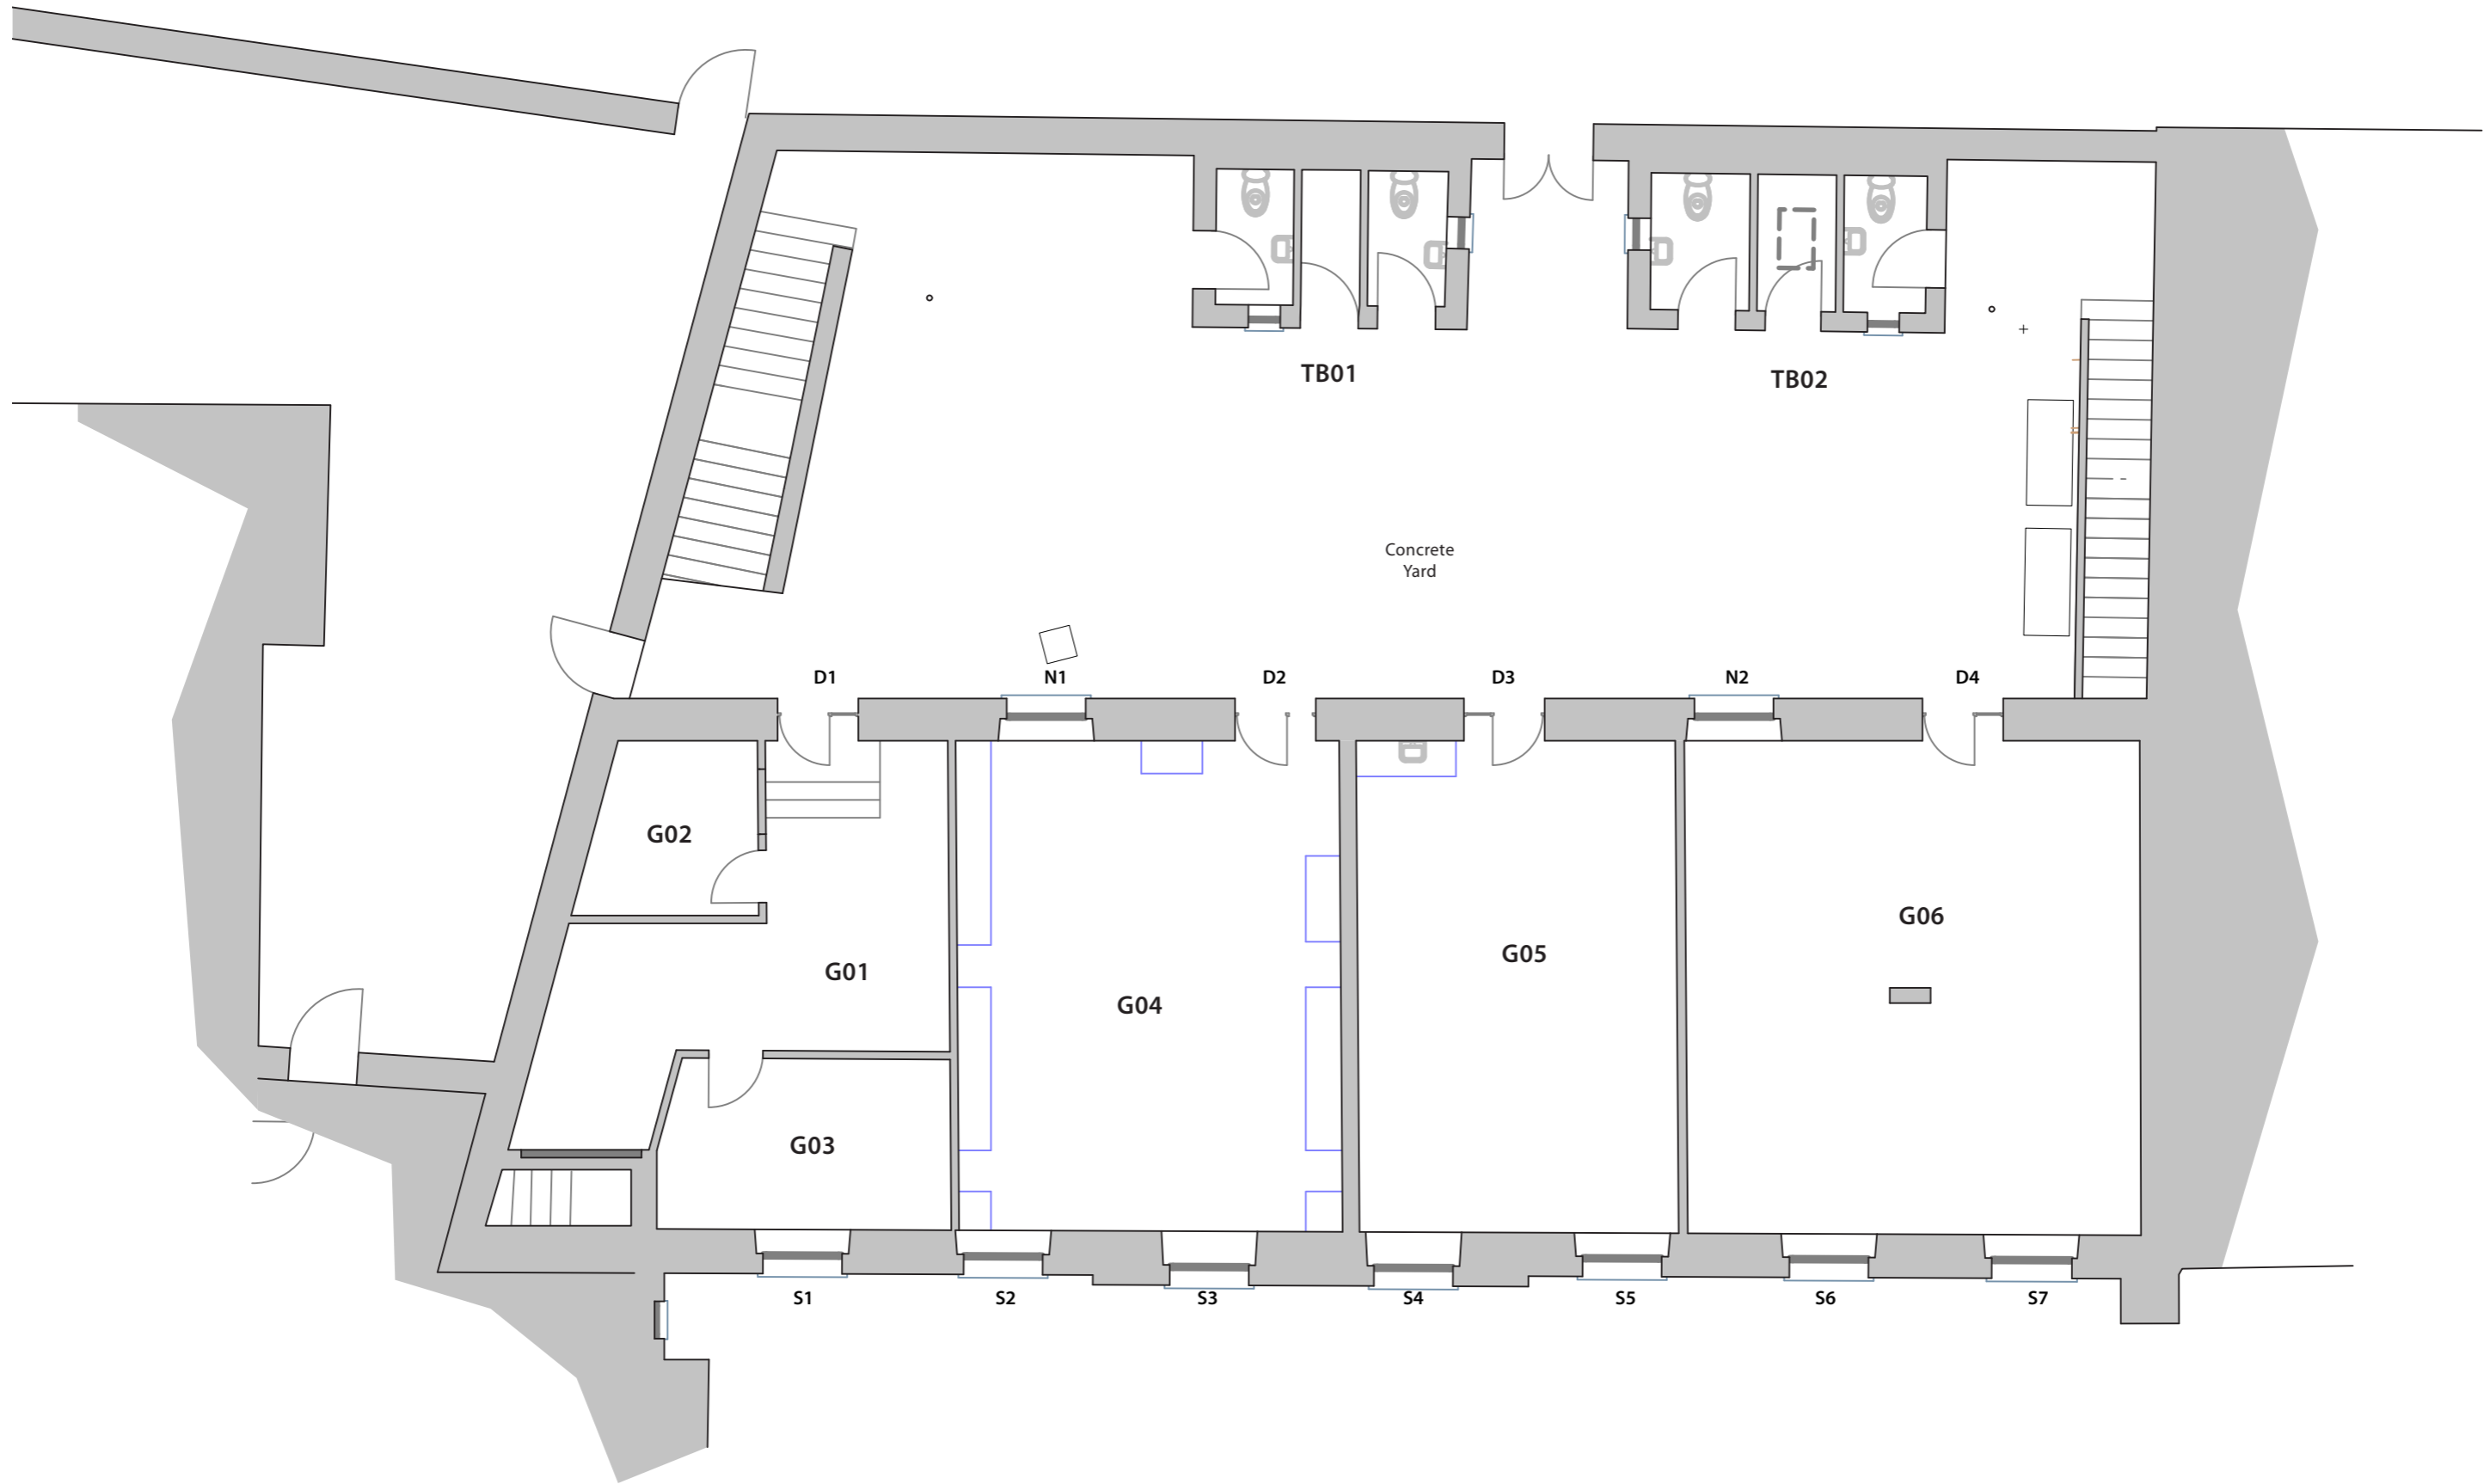
DRAWING  
**04 Ground Floor Plan**

<b>WINDOW</b>	<b>TYPE</b>	<b>CONDITION</b>	<b>GLASS</b>
<b>N1</b>	3 over 3 sliding sash	Both sashes in reasonable condition	2 panes cylinder glass at top, 3 panes obscure glass at bottom
<b>N2</b>	3 over 3 sliding sash	Both sashes in reasonable condition	3 panes cylinder glass at top, 2 panes obscure and 1 pane modern replacement at bottom
<b>N3</b>	3 over 3 sliding sash	Replacement sashes	6 panes wired modern glass
<b>N4</b>	3 over 3 sliding sash	Original sashes in reasonable condition	5 panes cylinder glass
<b>N5</b>	3 over 3 sliding sash	Original sashes in reasonable condition	5 panes cylinder glass
<b>N6</b>	3 over 3 sliding sash	Both sashes in reasonable condition	3 panes cylinder glass at bottom
<b>N7</b>	3 over 3 sliding sash	Both sashes in poor condition	inaccessible
<b>N8</b>	3 over 3 sliding sash	Both sashes are replacements	6 panes wired modern glass
<b>S1</b>	3 over 3 sliding sash	Both sashes in reasonable condition	3 panes cylinder glass at top, 3 panes obscure at bottom

<b>S2</b>	3 over 3 sliding sash	Both sashes in reasonable condition	3 panes cylinder glass at top, 3 panes fluted at bottom
<b>S3</b>	3 over 3 sliding sash	Both sashes in reasonable condition Rot and buckling in upper part of frame	3 panes cylinder glass at top, 3 panes fluted at bottom

<b>S4</b>	3 over 3 sliding sash	Both sashes in reasonable condition, lintel is failing, rot in upper part of frame	5 panes cylinder glass, 1pane modern replacement
<b>S5</b>	3 over 3 sliding sash	Both sashes in reasonable condition, severe rot in lintel, some rot in frame	all 6 panes cylinder glass
<b>S6</b>	3 over 3 sliding sash	Both sashes in slightly poor condition,	all 6 panes cylinder glass
<b>S7</b>	3 over 3 sliding sash	Both sashes in slightly poor condition,	all 6 panes cylinder glass
<b>S8</b>	3 over 3 sliding sash	Lower sash is a replacement,	3 panes cylinder glass at top
<b>S9</b>	3 over 3 sliding sash	Lower sash is a replacement, some rot in frame	1 pane cylinder glass at top
<b>S10</b>	3 over 3 sliding sash	Lower sash is a replacement and in poor condition	1 pane cylinder glass at top
<b>S11</b>	3 over 3 sliding sash	Lower sash is a replacement	2 panes cylinder glass at top
<b>S12</b>	3 over 3 sliding sash	Lower sash is a replacement and in poor condition, some damage to upper sash	3 panes cylinder glass at top

<b>S13</b>	3 over 3 sliding sash	Lower sash is a replacement, frame in v poor condition	3 panes cylinder glass at top
<b>S14</b>	3 over 3 sliding sash	Lower sash is a replacement in poor condition, top sash in poor condition, some rot to frame	3 panes cylinder glass at top
<b>S15</b>	3 over 3 sliding sash	Lower sash is a replacement in poor condition, some rot to frame	3 panes cylinder glass at top

<b>E1</b>	2 over 2 casement with 4 pane fanlight	Reasonable condition	4 panes of fanlight cylinder glass
<b>D1</b>	Part glazed timber panelled door with glazed side light on panelled riser, and glazed square headed overlight.	Reasonable condition some rot at base of frame	6 panes cylinder glass in fanlight
<b>D2</b>	Part glazed timber panelled door with glazed side light on panelled riser, and glazed square headed overlight.	Reasonable condition some rot at base of frame	3 panes cylinder glass in fanlight
<b>D3</b>	Part glazed timber panelled door with glazed side light on panelled riser, and glazed square headed overlight.	Reasonable condition some rot at base of frame	2 panes of cylinder glass in fanlight
<b>D4</b>	Part glazed timber panelled door with glazed side light on panelled riser, and glazed square headed overlight.	Reasonable condition some rot at base of frame	5 panes cylinder glass in fanlight

<b>D5</b>	Part glazed modern timber batten door with wired glass side light	Good condition	Wired modern glass
<b>D6</b>	Part glazed modern timber batten door	Good condition	Wired modern glass

Mitigation: Work should be carried out by tradespeople specialising in the restoration and repair of historic windows. Care should be taken to preserve and retain the cylinder blown glass extant in many of the windows. The opportunity should be taken to upgrade staff and parting beads of sliding sash windows with brushes to improve draught proofing. In cases where sash, frame, window or door is deemed irreparable it should be replaced like for like with matching details. The work should be scheduled under the guidance and supervision the attending conservation specialists; with appropriate records created and maintained.
