RE: Section 5 Declaration R883/24 3 Daunt Square, Cork

Question/Declaration Details: Is repair works to the external shop front at 3 Daunt Square exempted development? Works consist of The 'like for like' replacement of decayed/damaged timber shop front.

SECTION 5 APPLICATION FOR REPAIR WORKS AT 3 DAUNT SQUARE, CORK TO THE EXISTING TIMBER SHOPFRONT AND WINDOW SURROUNDS AT GROUND FLOOR ONLY

APPENDIX 1: SCHEDULE OF PHOTOGRAPHS

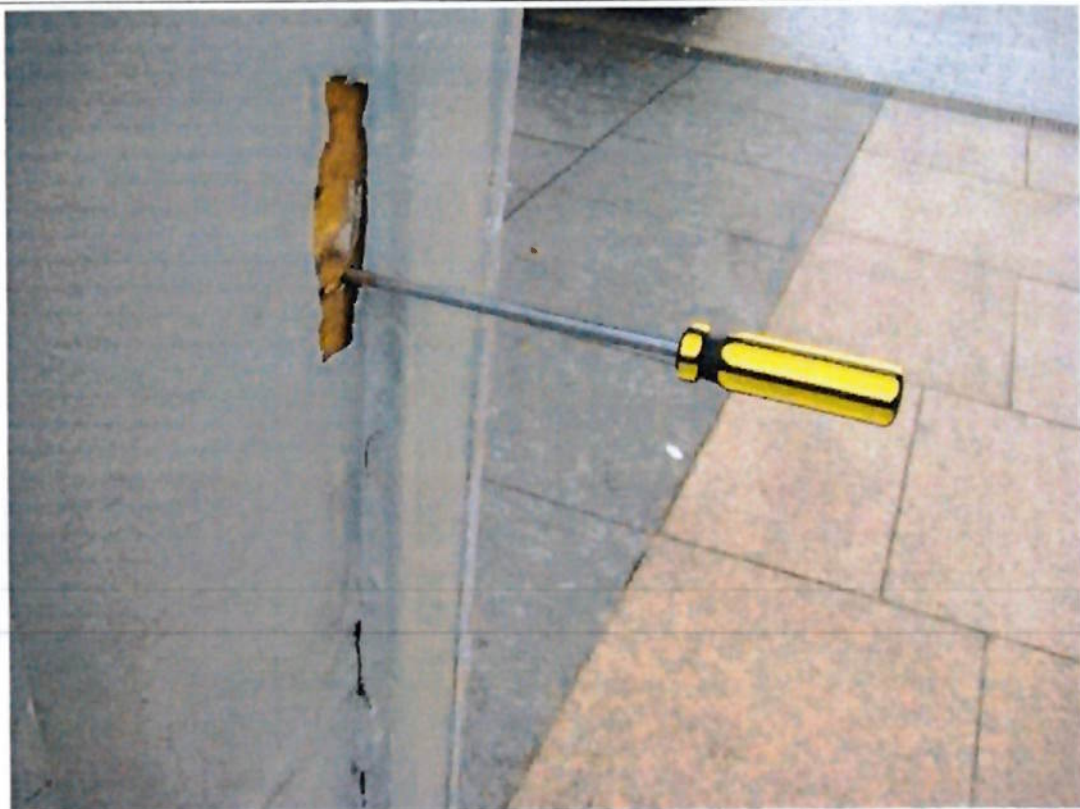
Photograph 22 View of timber decay and chipped paint to Column 2.

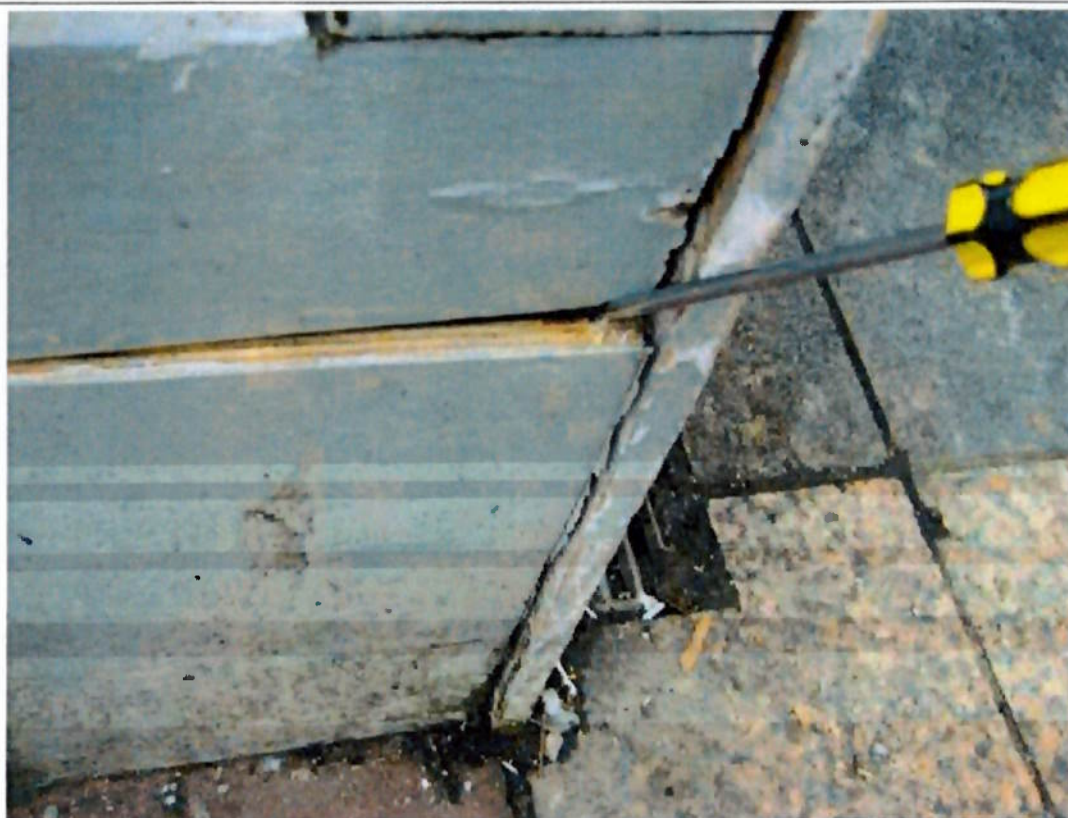
Photograph 23 View of screwdriver placed within a gap to the timber panels.

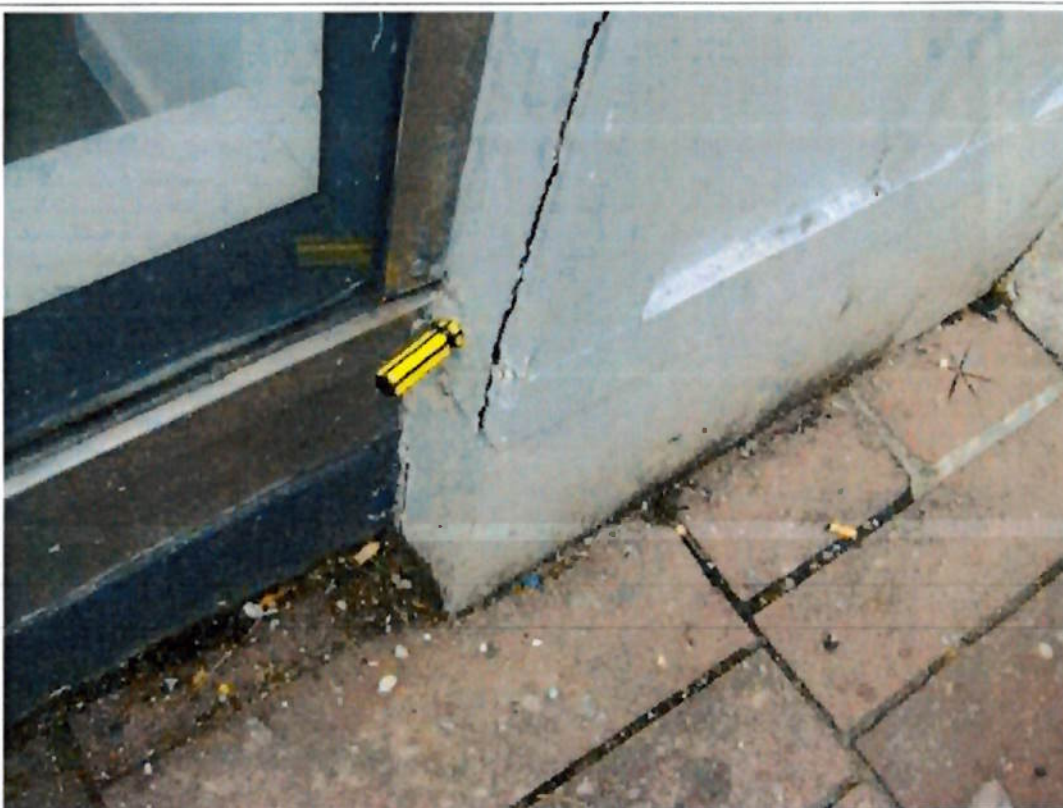
Photograph 24 View of screwdriver puncturing through decayed timber.

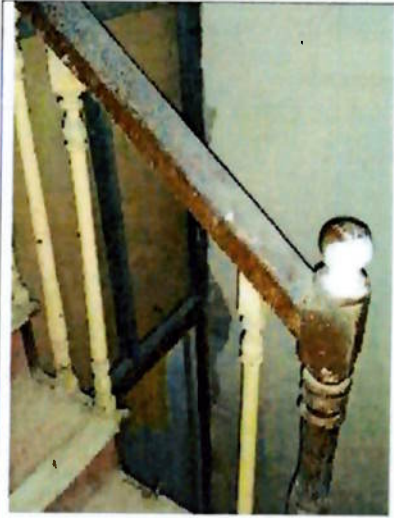
Missing balusters on staircase between first and second floors

The staircase is to be redecorated throughout. Missing balusters/ spindles to be provided to match the existing. Damaged elements to be conserved and repaired where possible or replaced if necessary by a joiner experienced in working with historic buildings. It is proposed to redecorate and service the doors with new ironmongery to be installed as required. Missing or defective elements are to be replaced on a like for like basis by a joiner experienced in working with historic buildings. The skirting boards, architraves, dado rails and picture rails are to be redecorated throughout. Damaged elements are to be repaired if possible or replaced if necessary on a like for like basis. All timber trims, jamb panels, window boards, plinth panels and sash boxes are to be inspected by a joiner experienced in working with historic windows and damaged or missing elements are to be repaired or replaced on a like for like basis if necessary. Internal window elements are also to be redecorated throughout the first, second and third floors.

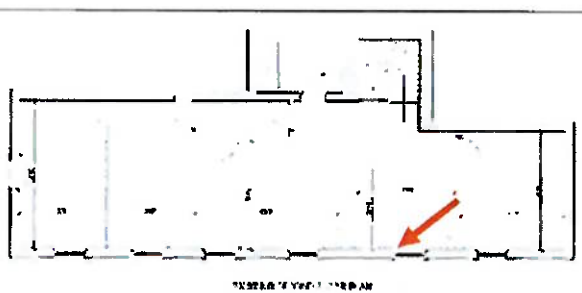
Sash boxes have been damaged in order to remove chords and pulleys on almost all windows

All sliding sash timber windows to be removed assessed by a joiner experienced in the conservation of historic sash windows. Windows to be conserved/ repaired where necessary and removed from site for same if deemed necessary by joiner. Sash chords and pulleys to be reinstated.

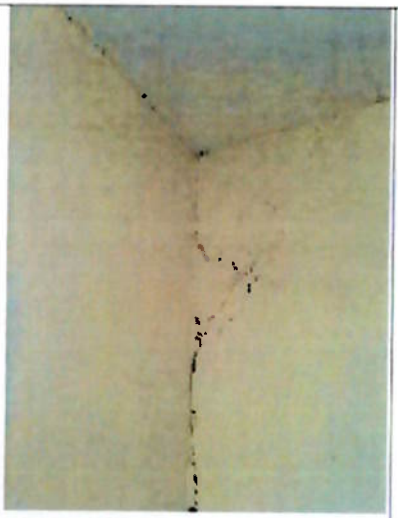
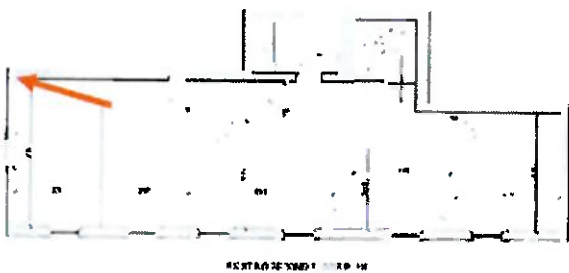
and Appendix 1). There is quite a serious crack at the junction of the northern and western elevations on the second floor. The floorboards are not tied into the wall here and as a result the western elevation is bowing outwards. This should be addressed at the earliest opportunity under the supervision of a structural engineer.

Serious cracking at the junction of the northern and western elevations of the second floor which needs to be addressed as a matter of urgency

A number of cracks are visible in the existing structural walls and arches, which were inspected by Chris Southgate, FIEI. Cracks on the front elevation are historic and due to the gradual settlement of the building over time. The crack on the junction between the western and northern elevation is serious and should be tied in accordance with 'Type B' detail (Appendix 1) as a matter of urgency. Cracks in the northern side of the arches on the second and third floor landings should be tied with 6mm Helibars @ 450 centres. The northern sides of the arches on the second and third floors should be stitched in accordance with the specifications in Appendix 1.

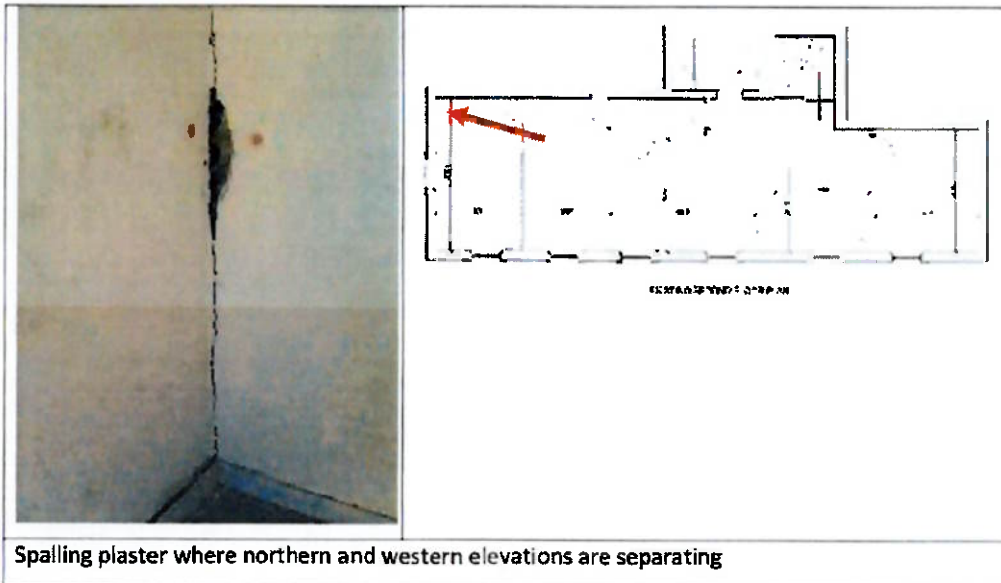
Spalling plaster where northern and western elevations are separating

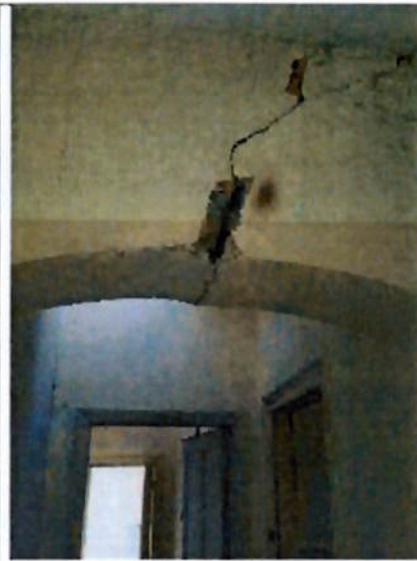
The northern side of the arch on the third floor also needs to be stitched

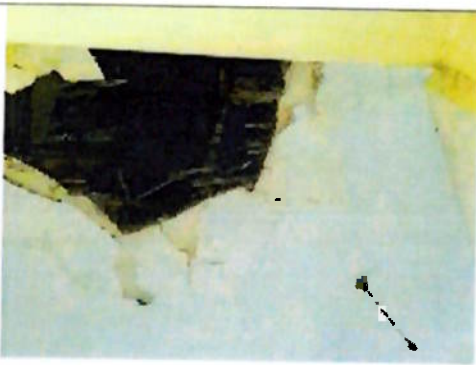
Hole in lath and plaster ceiling, where leaking water tank caused localised collapse

Internal works will be carried out on the second and third floor only, including the staircase from the first to the second floor. Minor repairs are required to the plaster ceilings in localised areas and decoration is necessary throughout. Where significant damage is identified, areas of lath and plaster ceilings to be removed and new lath and plaster to be reinstated.
