RE: **Section 5 Declaration R883/24 3 Daunt Square, Cork**

**Question/Declaration Details:** Is repair works to the external shop front at 3 Daunt Square exempted development? Works consist of The 'like for like' replacement of decayed/damaged timber shop front.

| <b>PLANNER'S REPORT</b><br><b>Ref. R883/24</b> | | <b>Cork City Council</b><br><b>Development</b><br><b>Management</b><br><b>Strategic Planning and</b><br><b>Economic Development</b> |

**SECTION 5 APPLICATION FOR REPAIR WORKS AT 3 DAUNT SQUARE, CORK TO THE EXISTING TIMBER SHOPFRONT AND WINDOW SURROUNDS AT GROUND FLOOR ONLY**

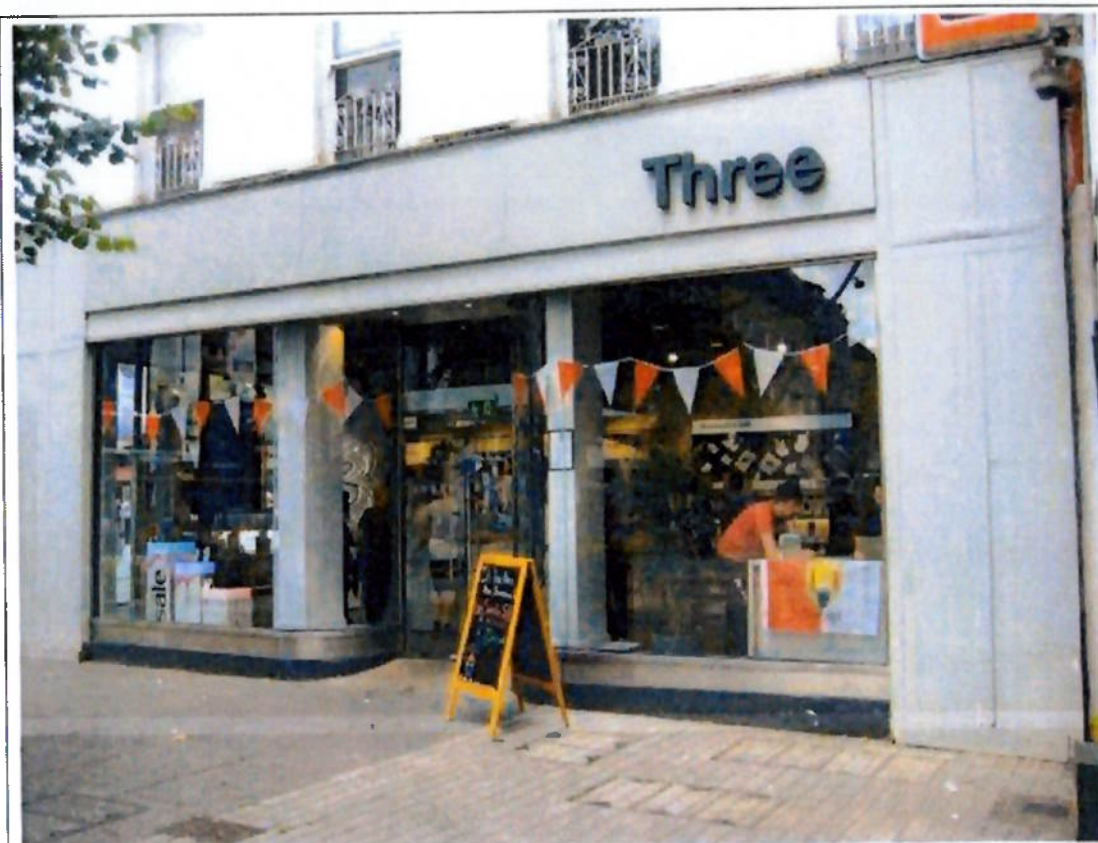
**Photograph 1** General view of Front Elevation.

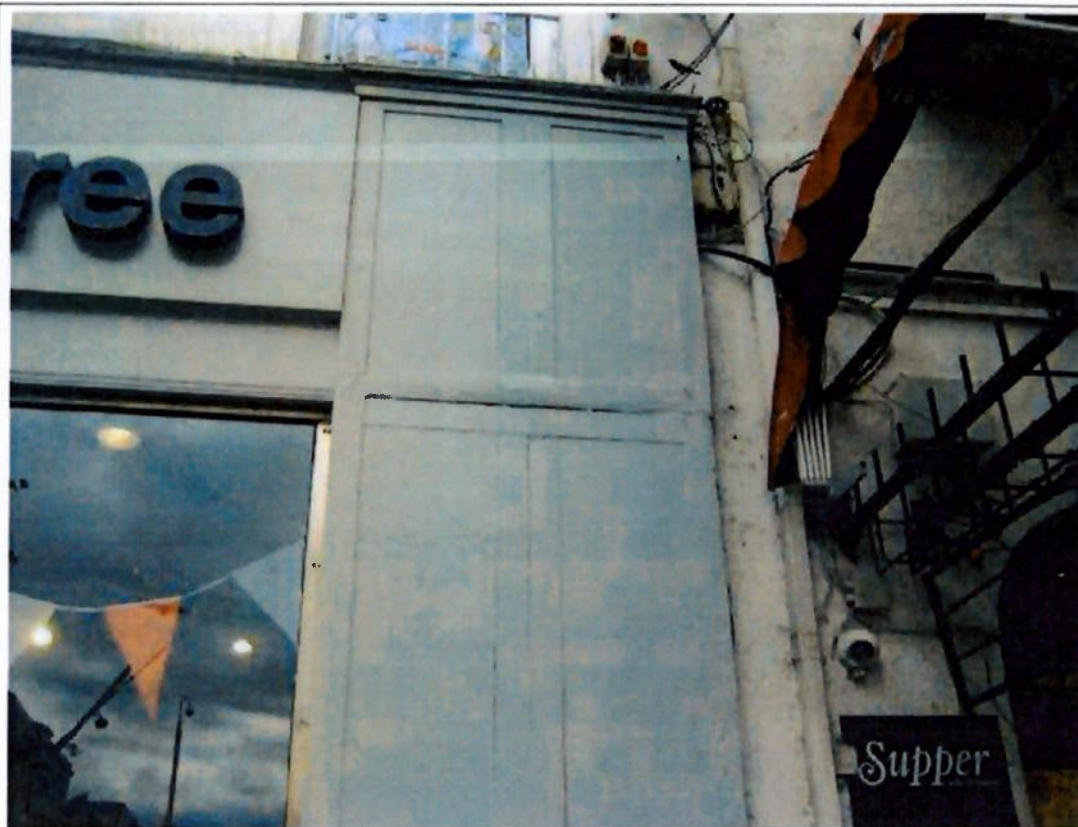
**Photograph 3** View of timber decay and flaking paint to Column 4.

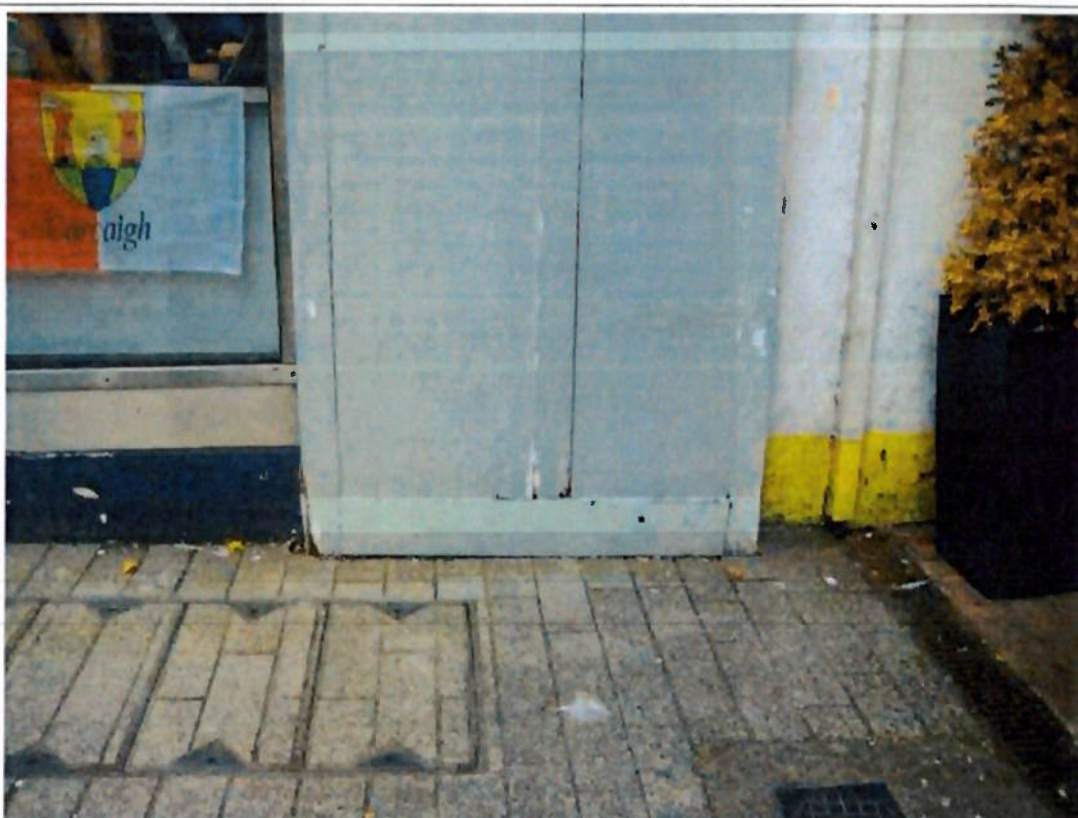
**Photograph 4** View of timber decay and chipped sections to Column 4.

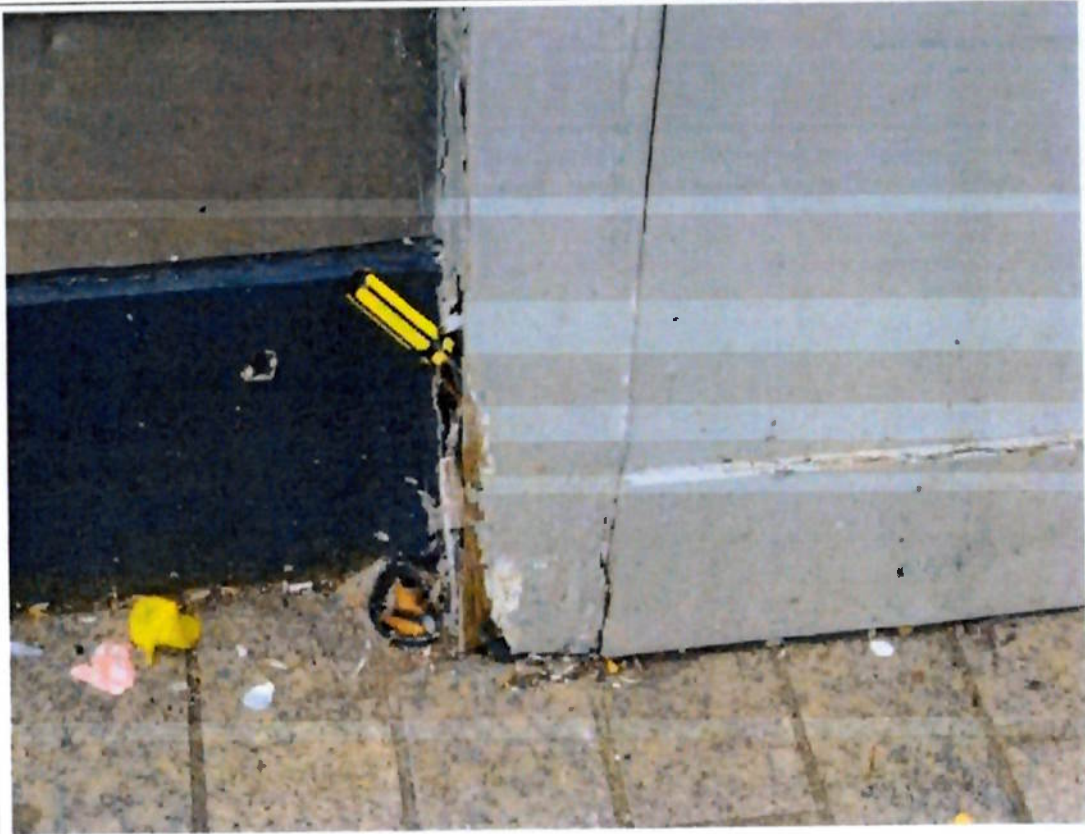
**Photograph 5** View of chipped section to Column 4.

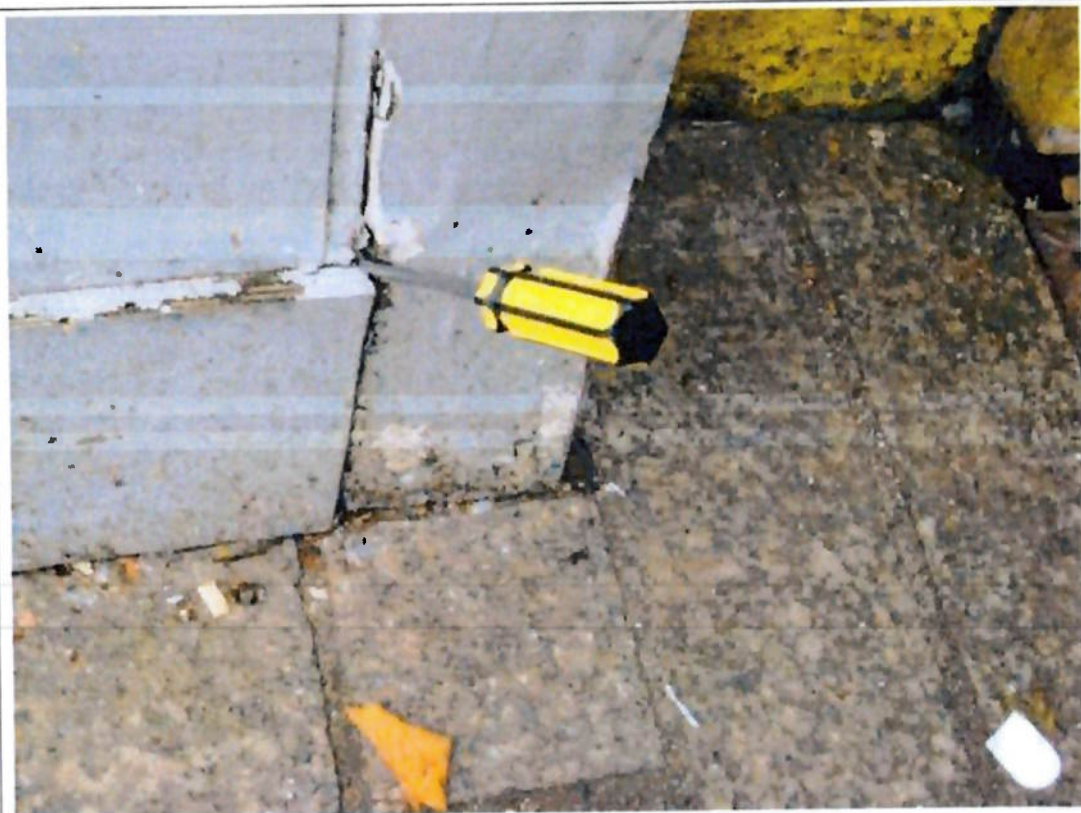
**Photograph 6** View of screwdriver puncturing through decayed timber.

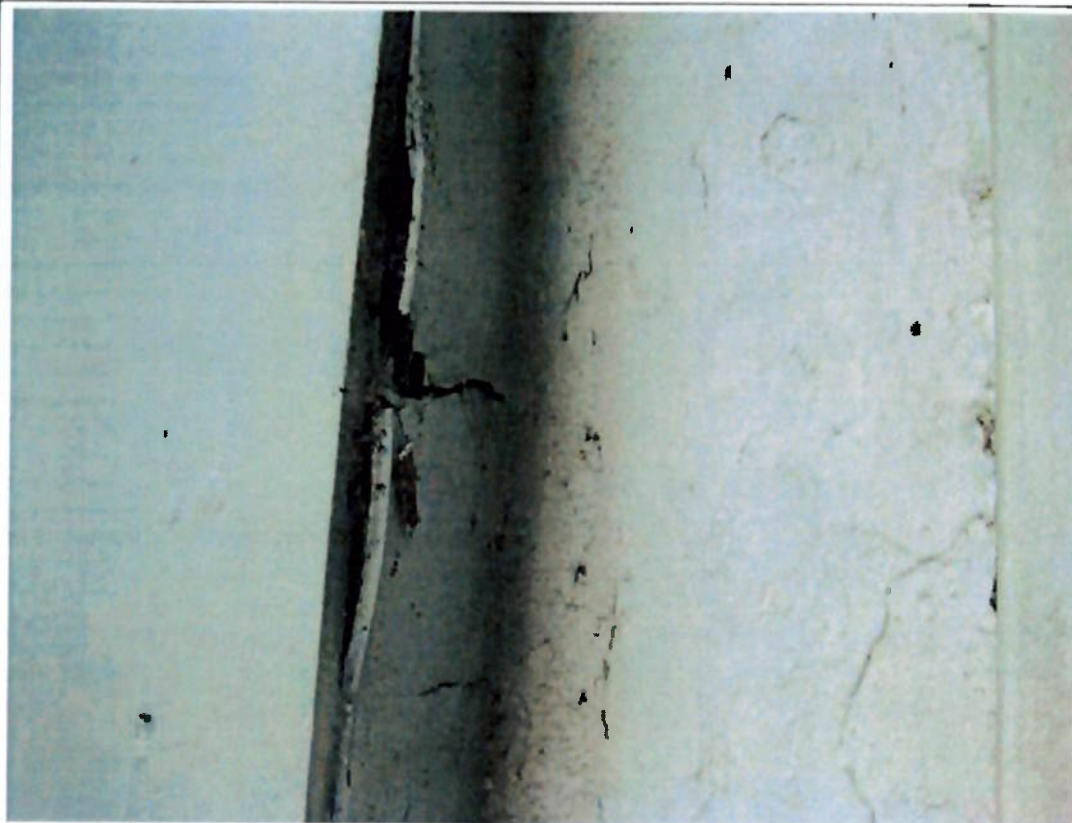
**Photograph 7** View of chipped timber panel to Column 4.

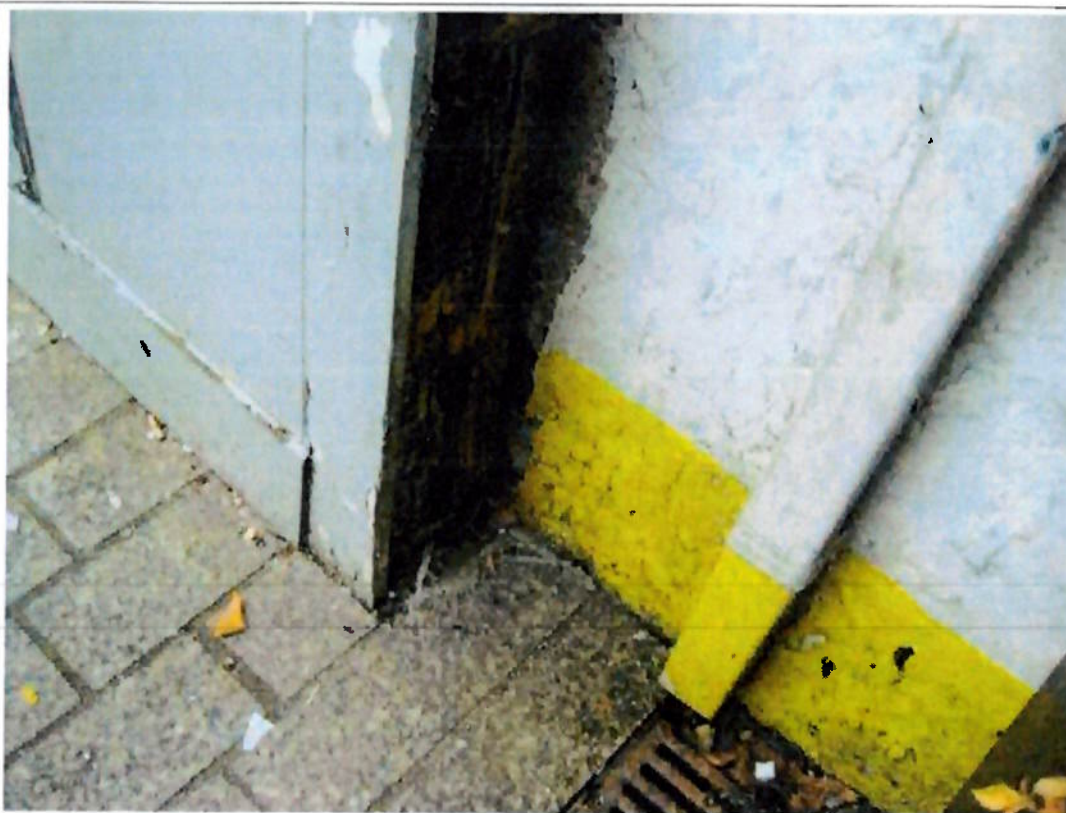
**Photograph 8** View of missing timber panel to Column 4.

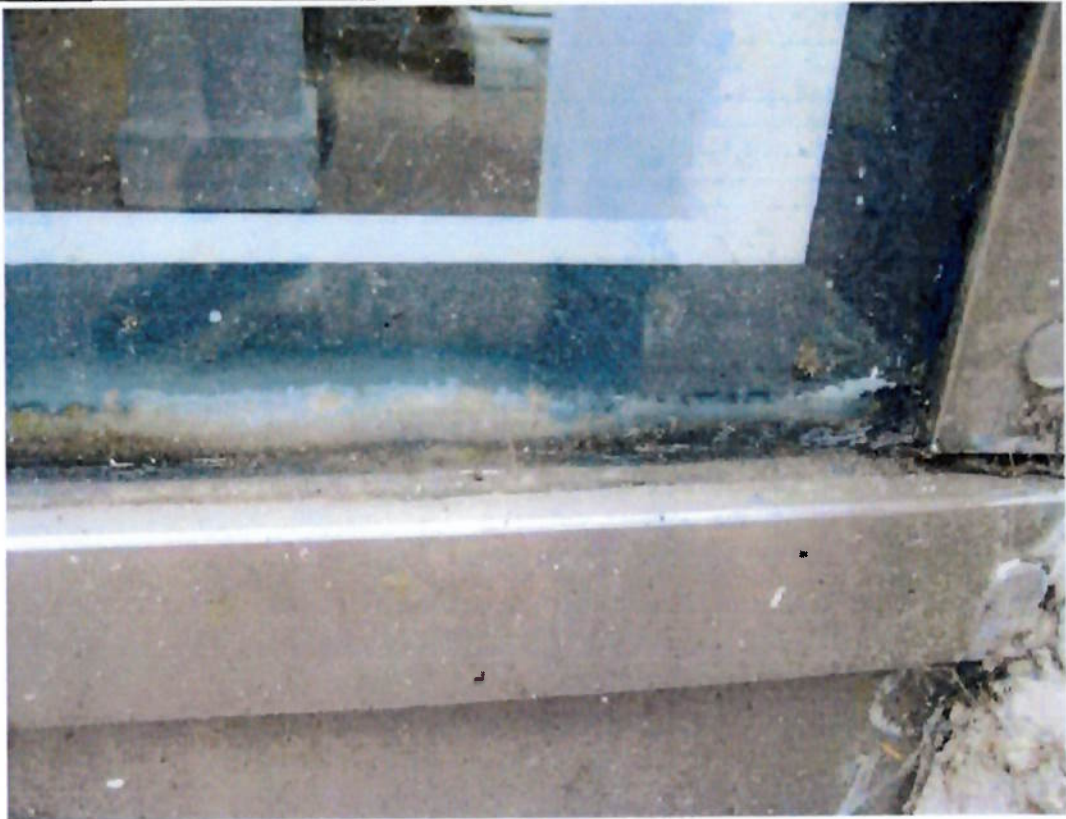
**Photograph 9** View of perished mastic seal to the Front Elevation.

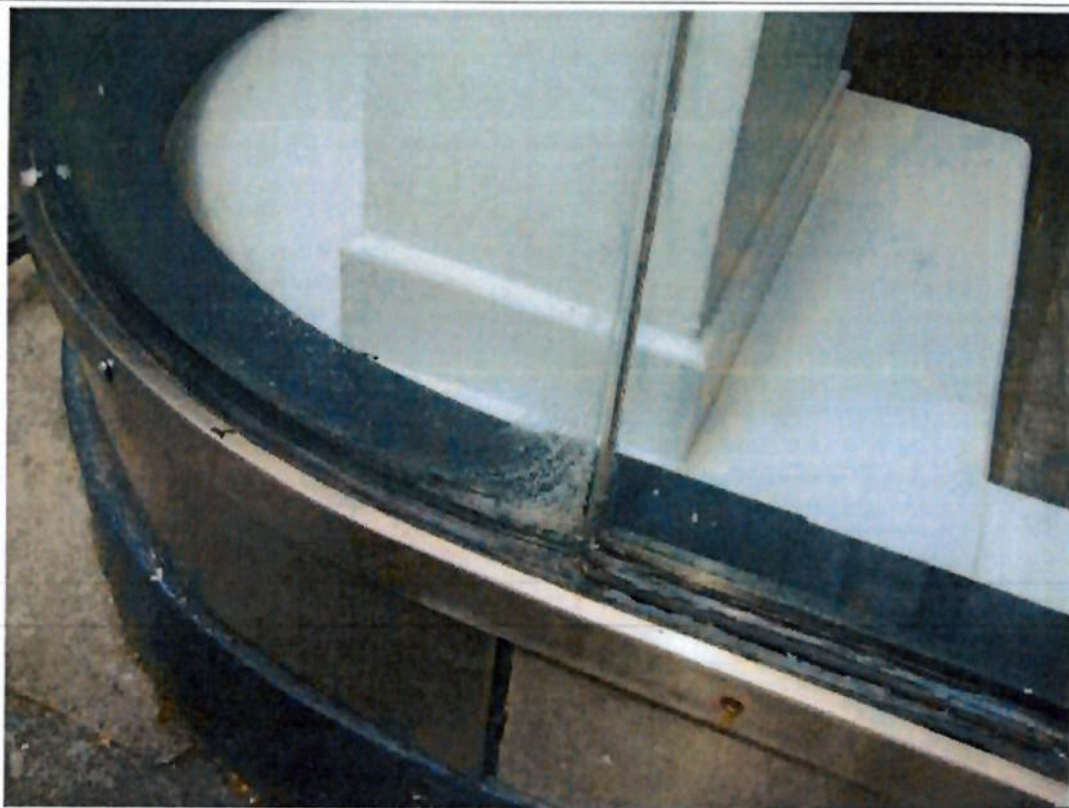
**Photograph 12** View of moisture ingress at the perished seals.

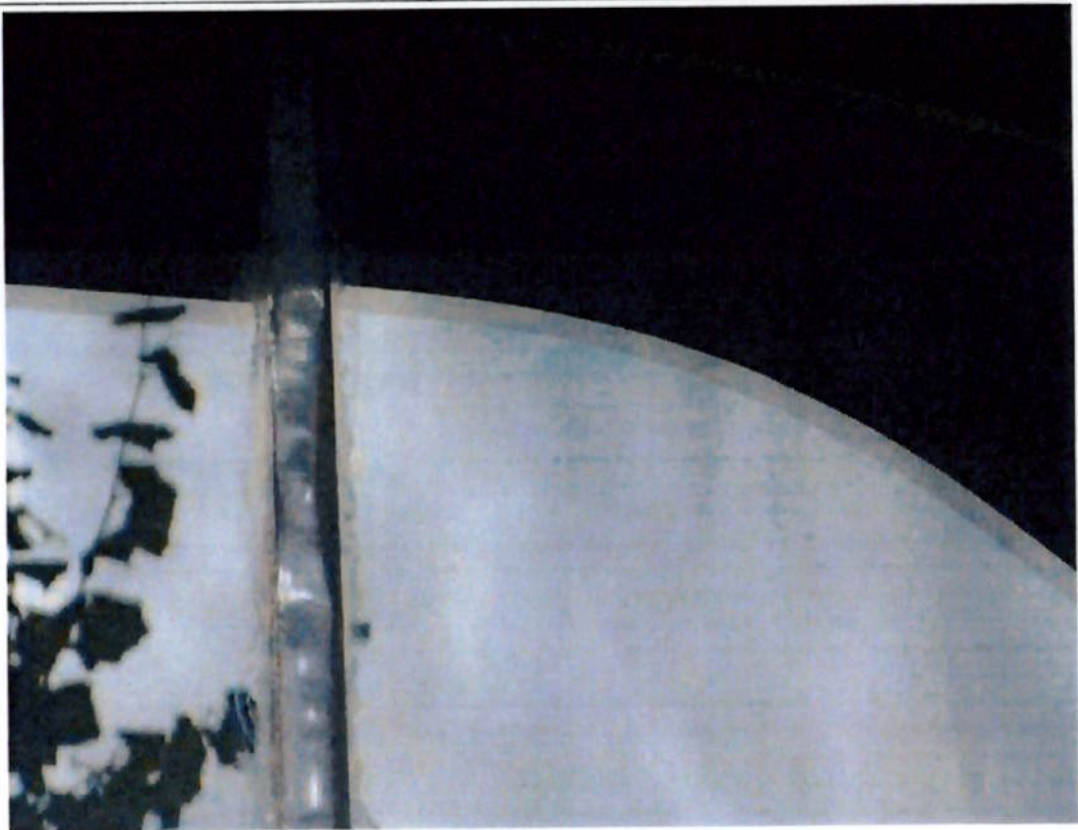
**Photograph 13** View of wear to the mastic seal.

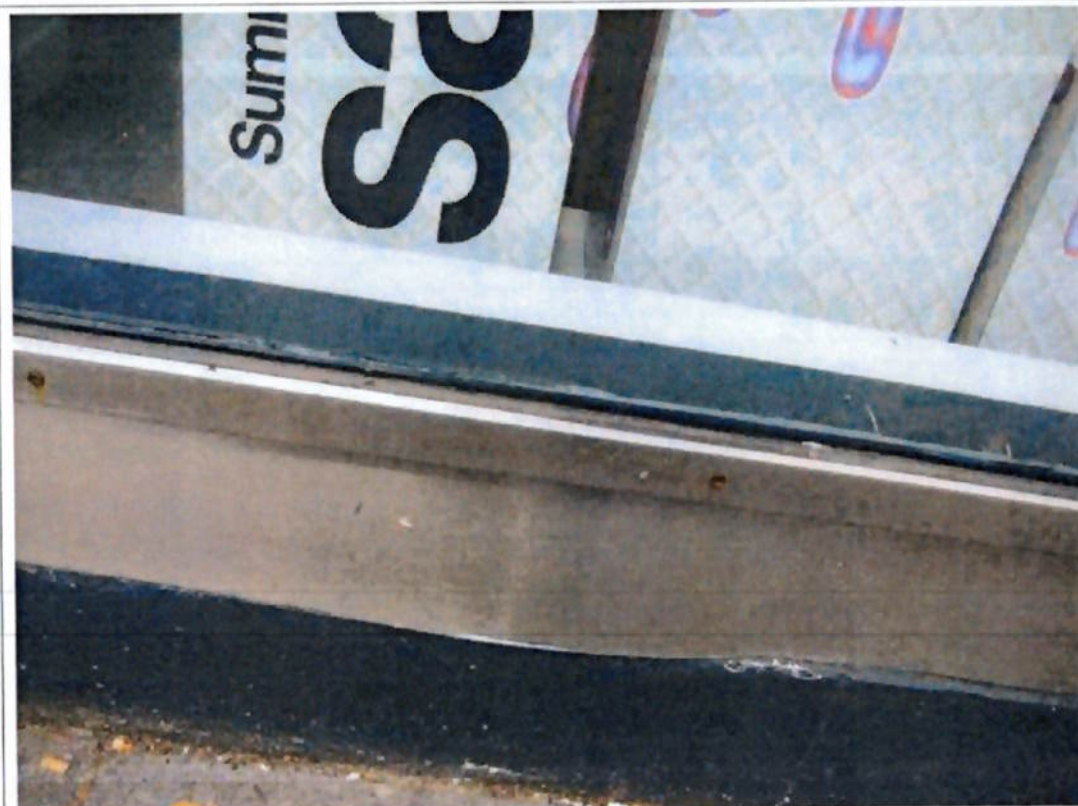
**Photograph 14** View of deflected stainless steel plinth.

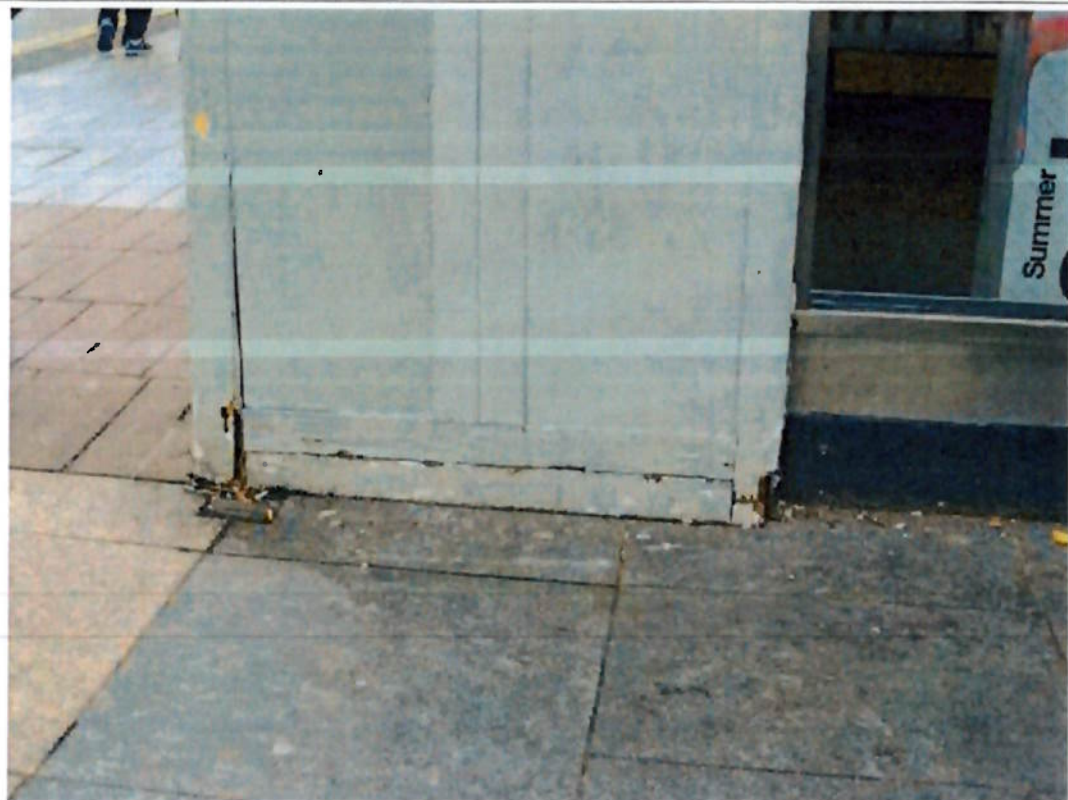
**Photograph 16**      **View of timber decay and chipped sections to Column 3.**

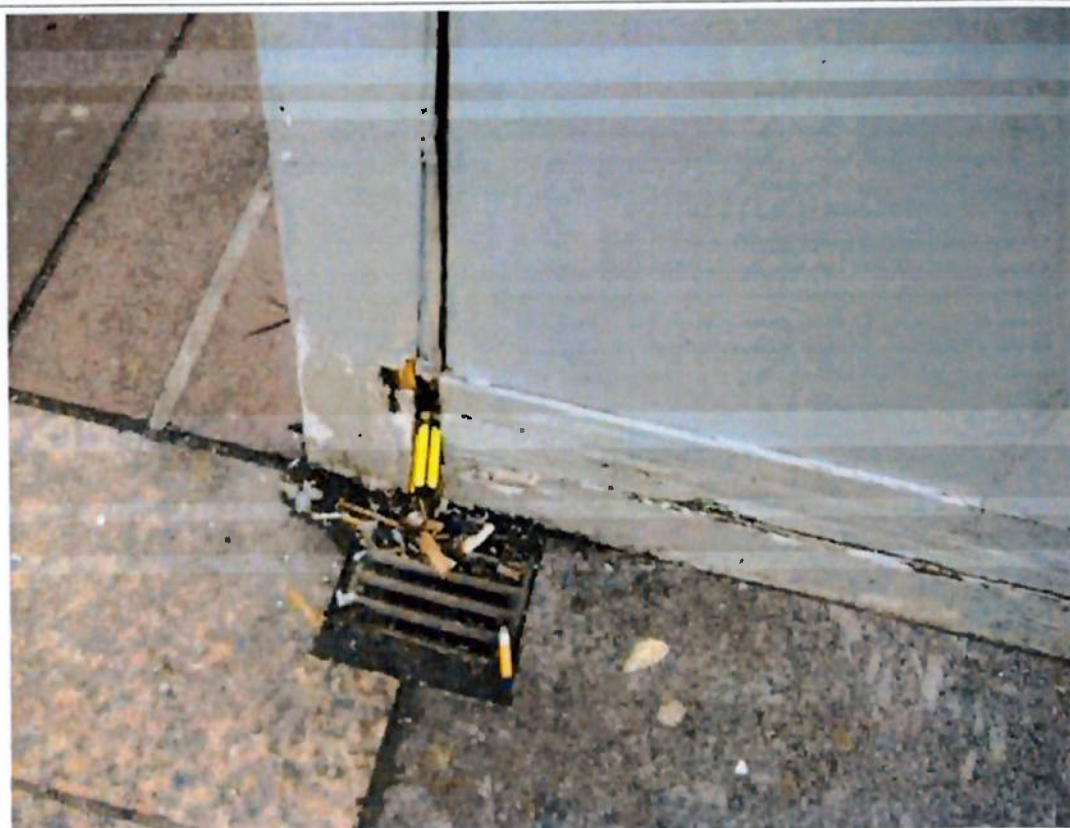
**Photograph 17** View of screwdriver placed within a large gap to the timber panels.

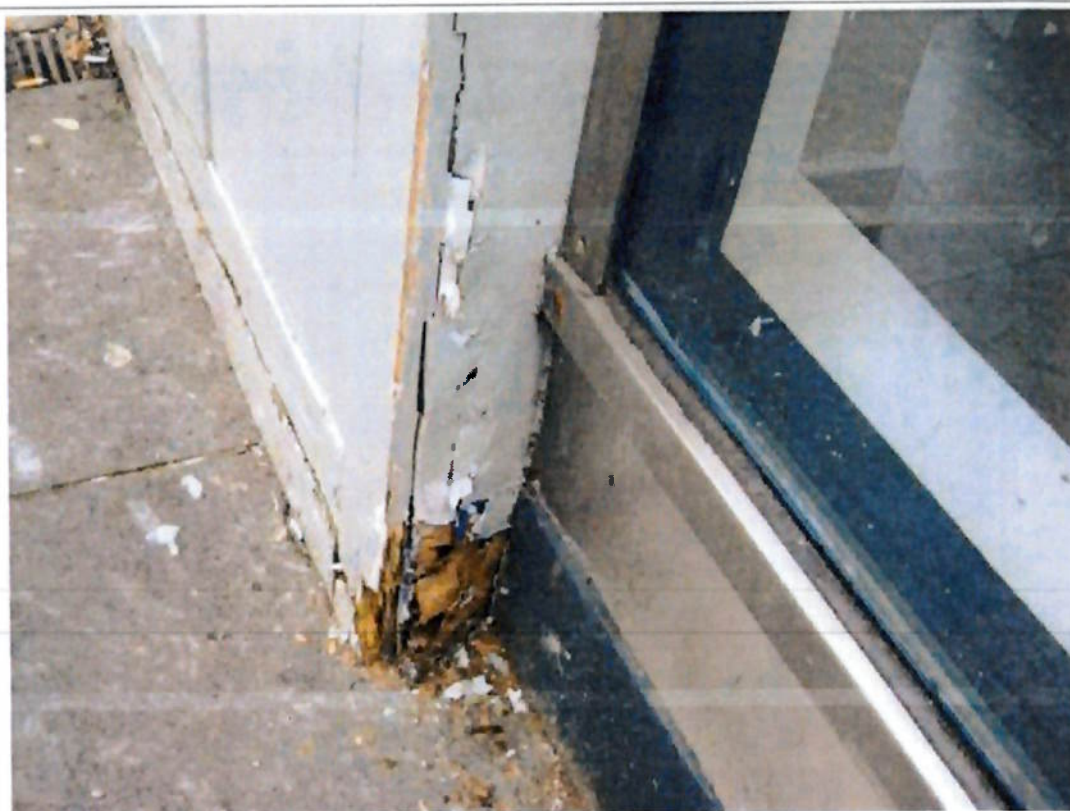
**Photograph 18** View of significant decay and chipped sections to Column 3.

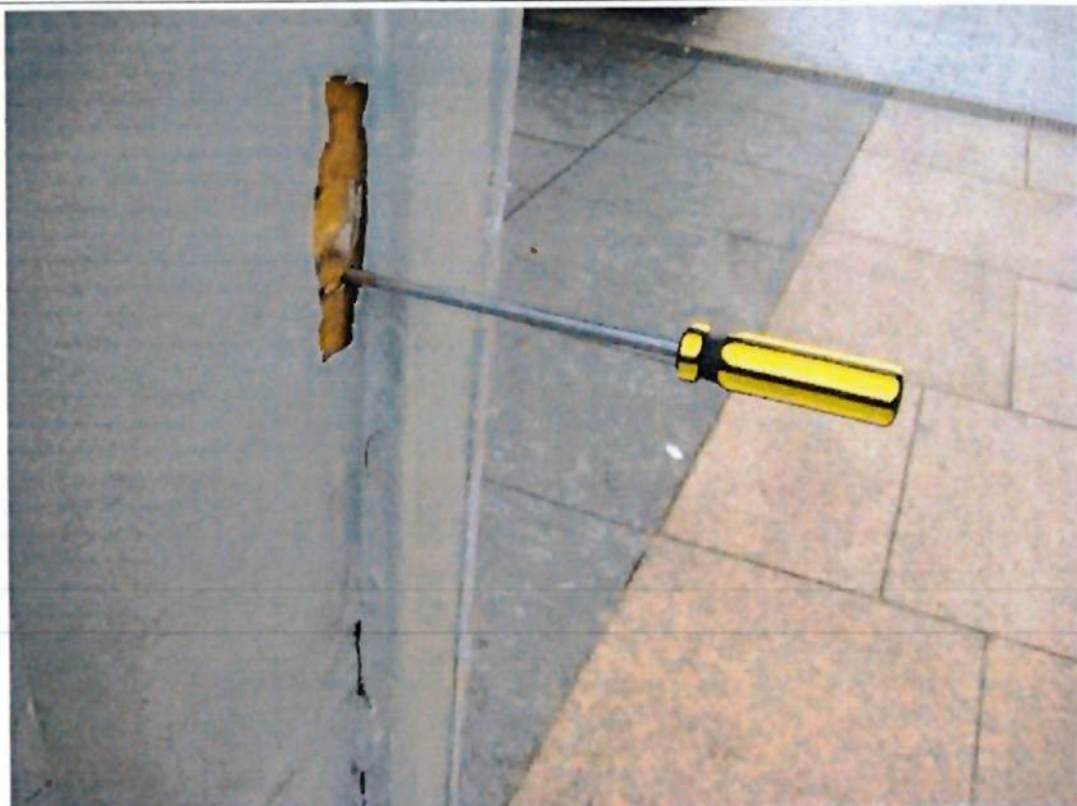
**Photograph 22**      **View of timber decay and chipped paint to Column 2.**

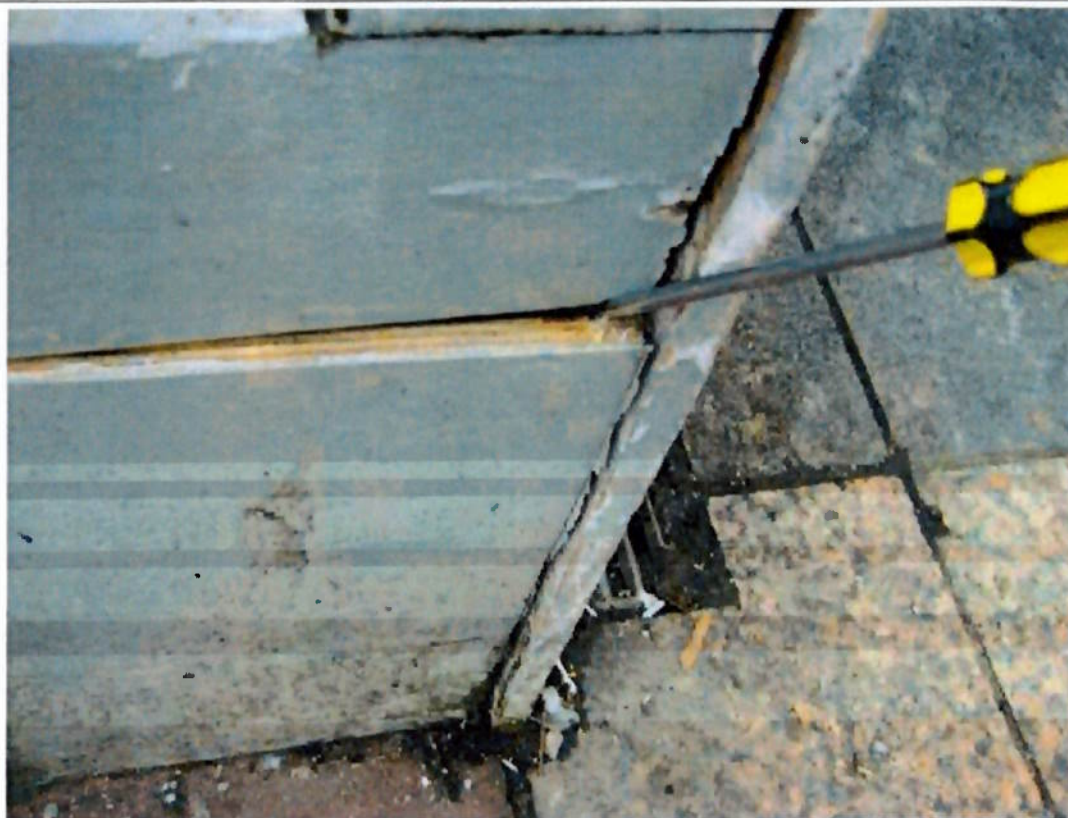
**Photograph 23** View of screwdriver placed within a gap to the timber panels.

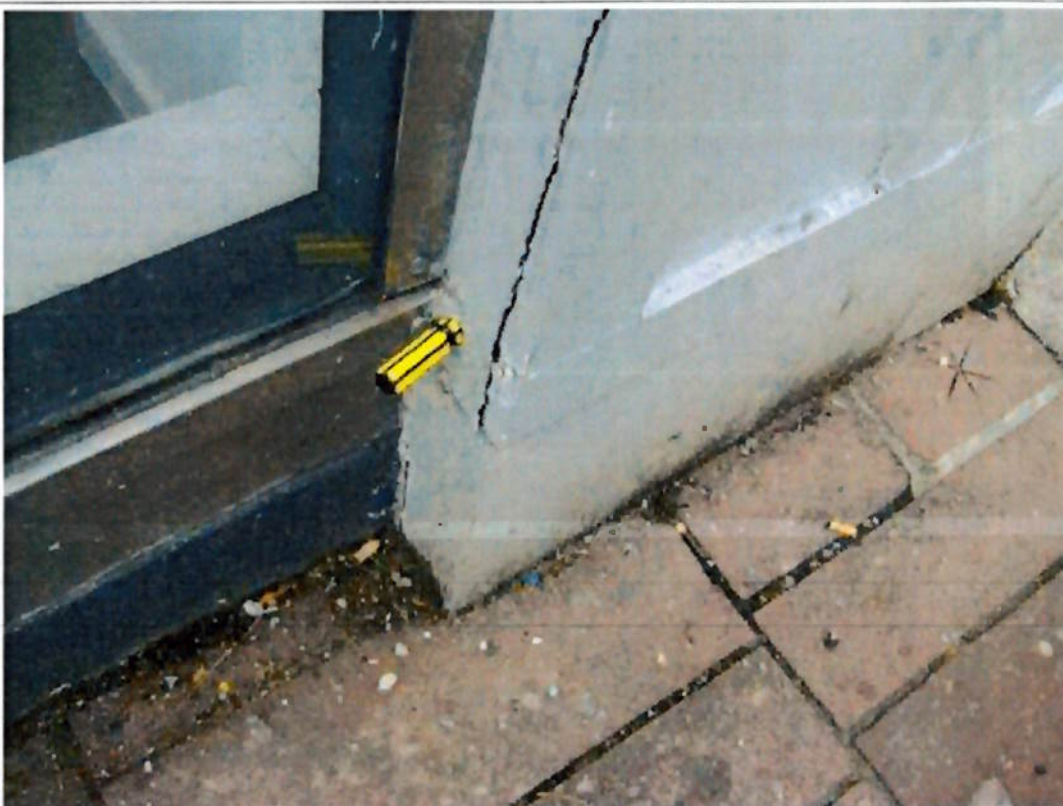
**Photograph 24** View of screwdriver puncturing through decayed timber.

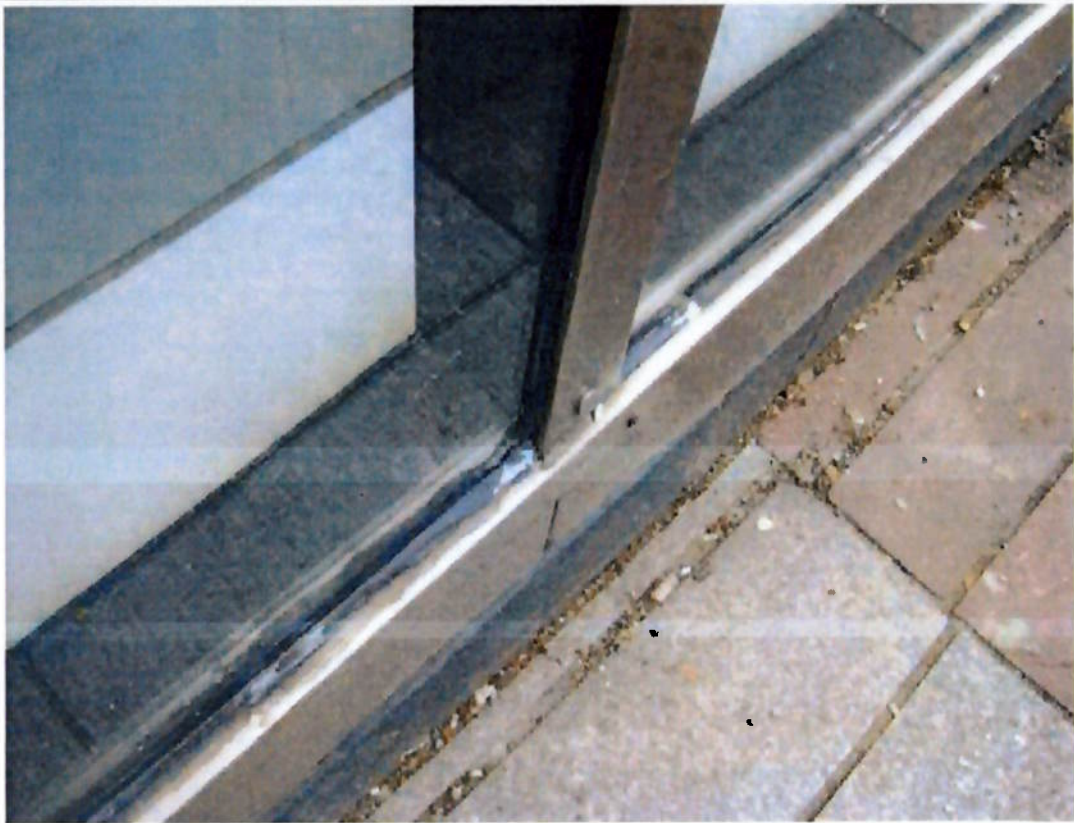
**Photograph 25** View of perished mastic seal to the Side Elevation.

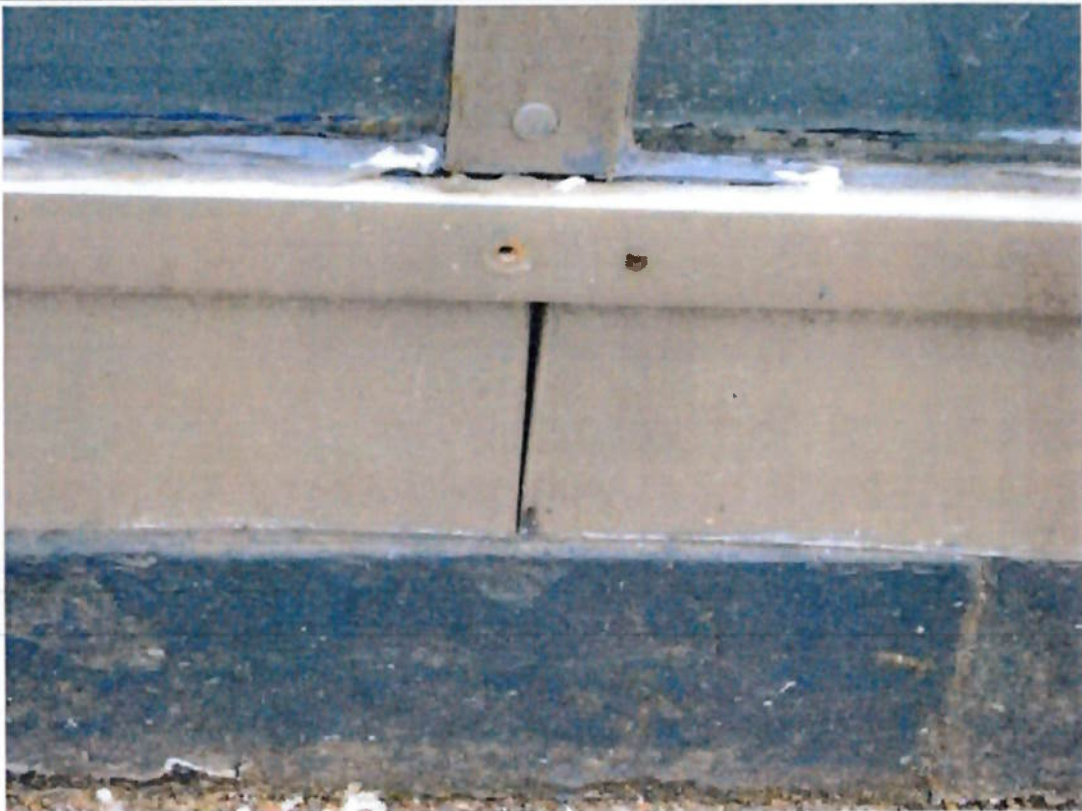
**Photograph 26** View of missing screws and gap to the stainless steel plinth.

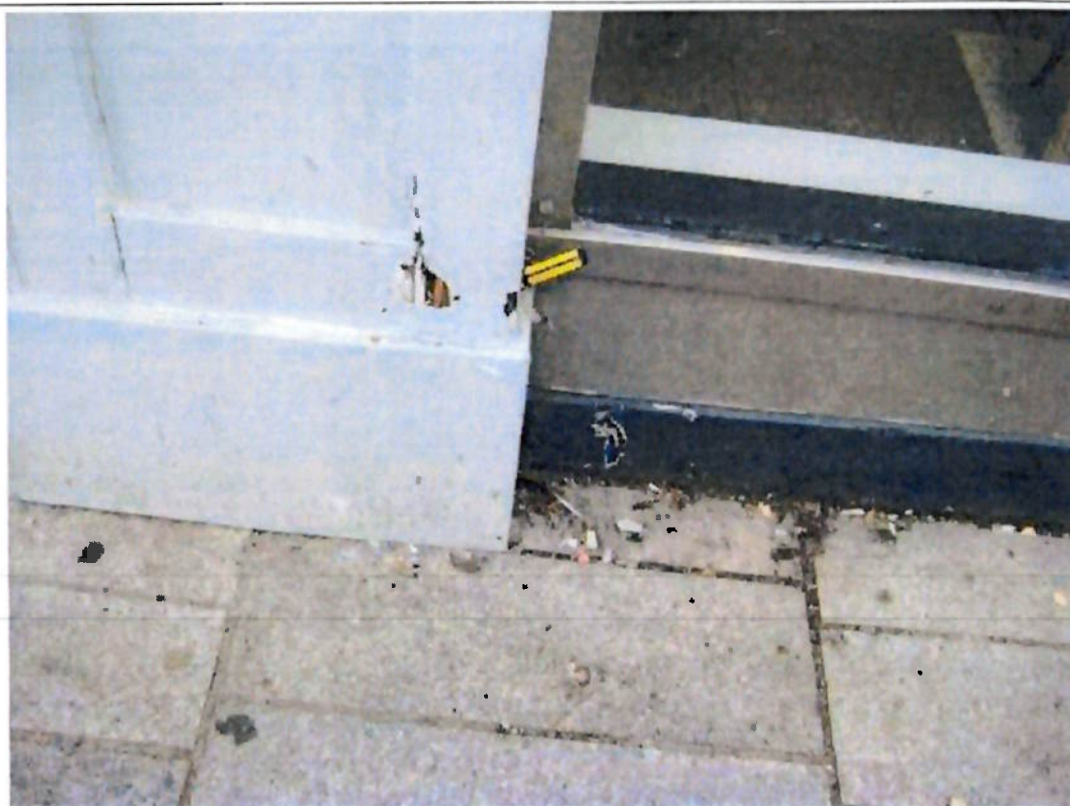
**Photograph 30** View of screwdriver puncturing through decayed timber.

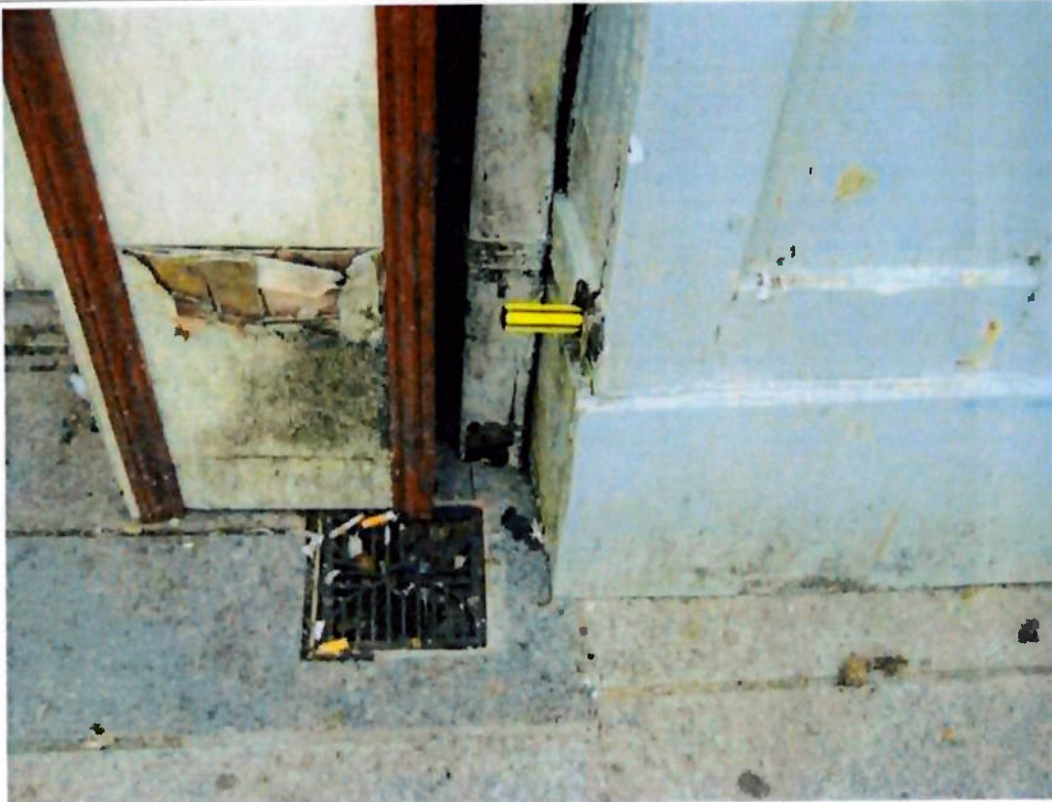
**Photograph 31**      **View of screwdriver puncturing through decayed timber.**

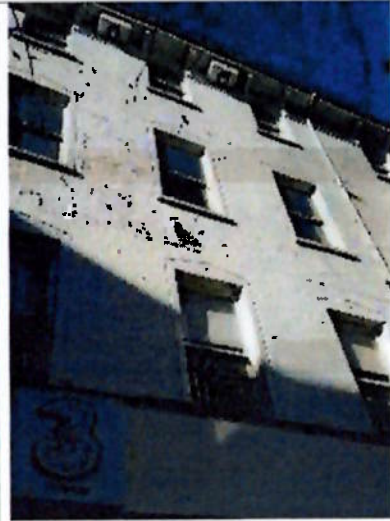
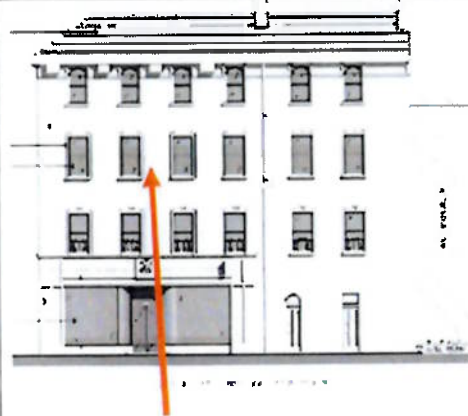
Southern elevation, showing cracked and peeling paint

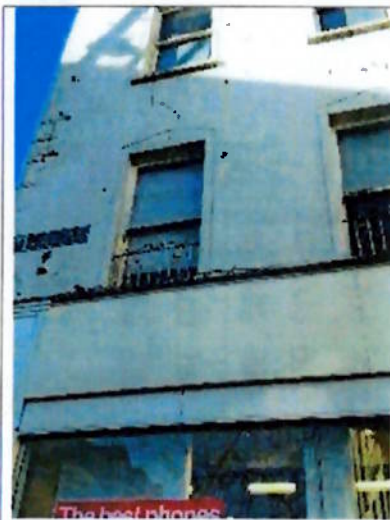
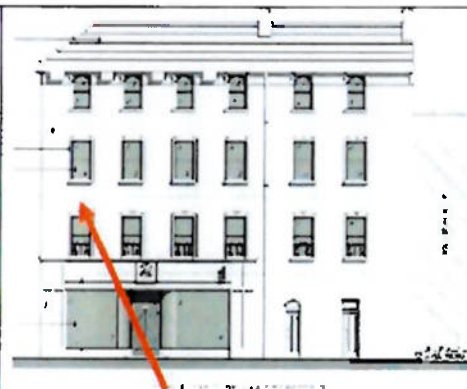
Western end of southern elevation, showing one of the cracks that needs to be stitched

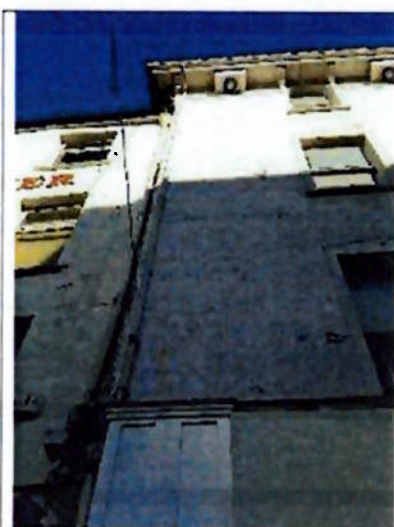
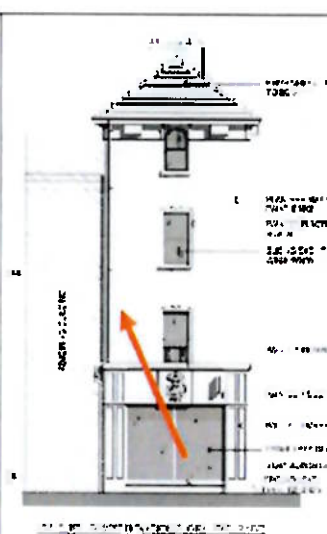
Western elevation showing horizontal cracks at first floor level where the elevation is bowing outwards

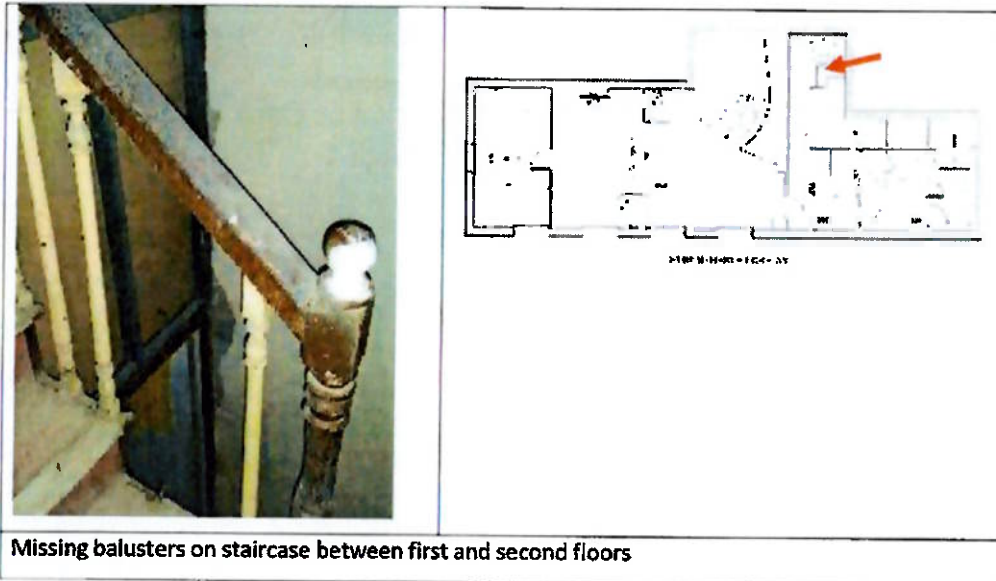
Missing balusters on staircase between first and second floors

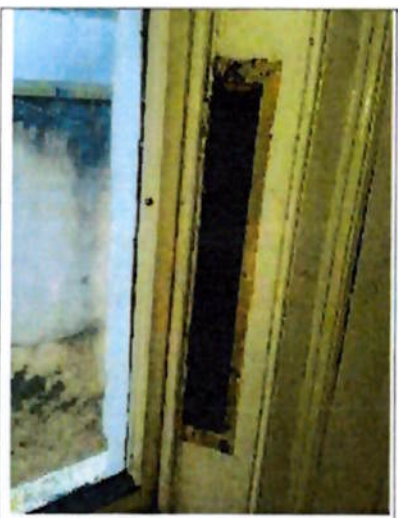
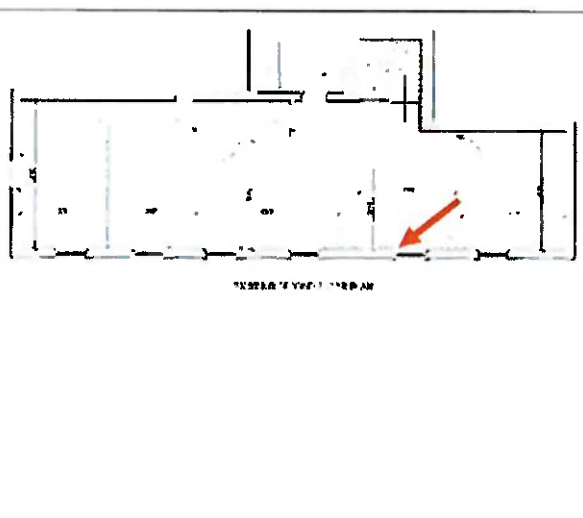
Sash boxes have been damaged in order to remove chords and pulleys on almost all windows

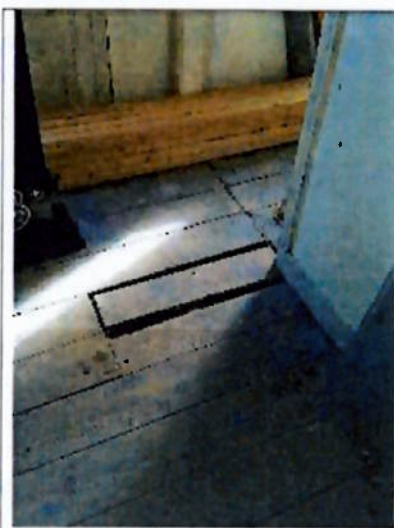
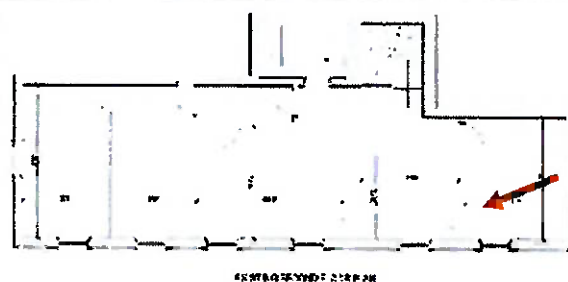
Some floor boards are loose with sections missing, but they are generally in good condition

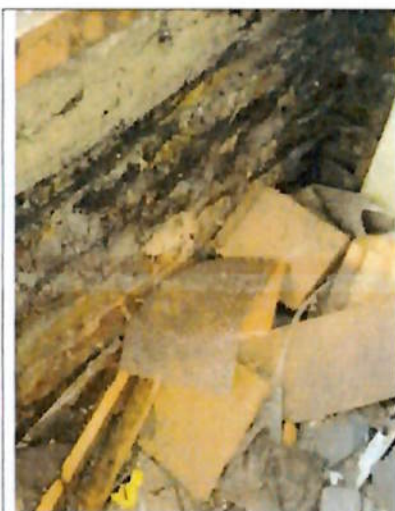
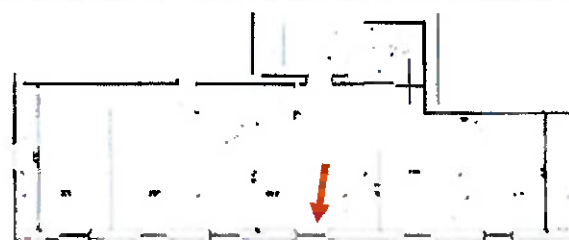
FIGURE 2: FRIABLE BRICKWORK

Yellow slob brick with lime mortar, which has become loose and friable. The fruiting body of wet or dry rot is also visible and should be further investigated

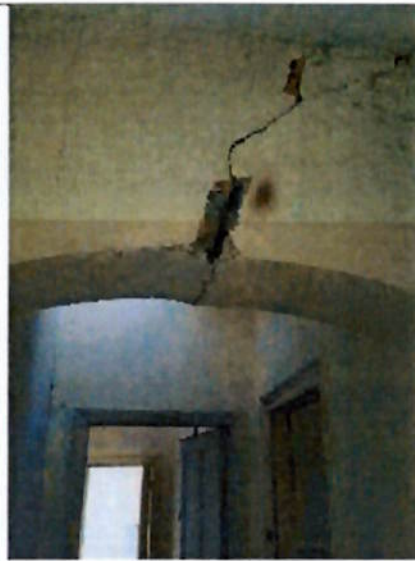
The northern side of the arch on the third floor also needs to be stitched

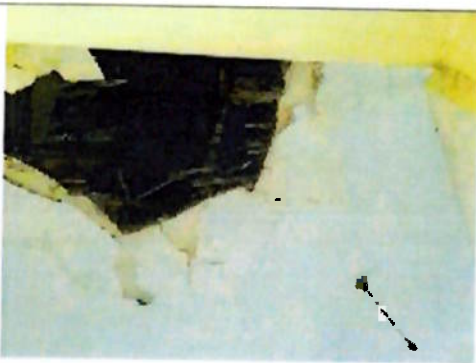
Hole in lath and plaster ceiling, where leaking water tank caused localised collapse
