# Heritage Impact Assessment

**Former National School at North Presentation Convent**

**Hillgrove Lane, Blackpool, Cork**

**Cork City Record of Protected Structures - PS1141**

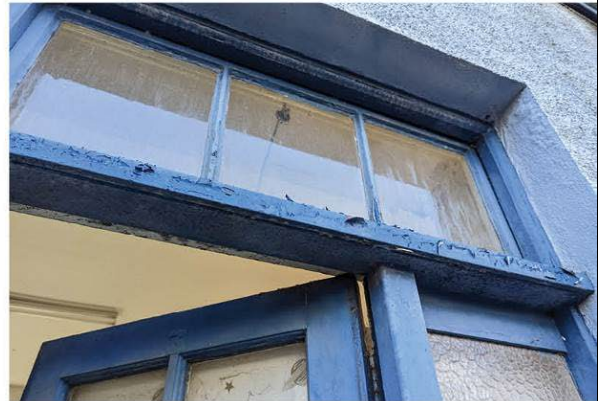
Square classroom, accessed from yard via door in the north wall, timber lintel over door showing some decay. Lit by pair of windows in south wall. Lino over carpet to floors, painted lime plaster and gypsum plaster to walls, with significant damp evident to south wall. plaster ceiling. Timber batten wainscoting below dado level to walls at south and west. Window openings in south having enclosed shelf space under and simple folding shutters. Early 20<sup>th</sup> century iron radiator to south. Blackboard with painted lines mounted to wainscoting at west.

Detail of door to room G05.

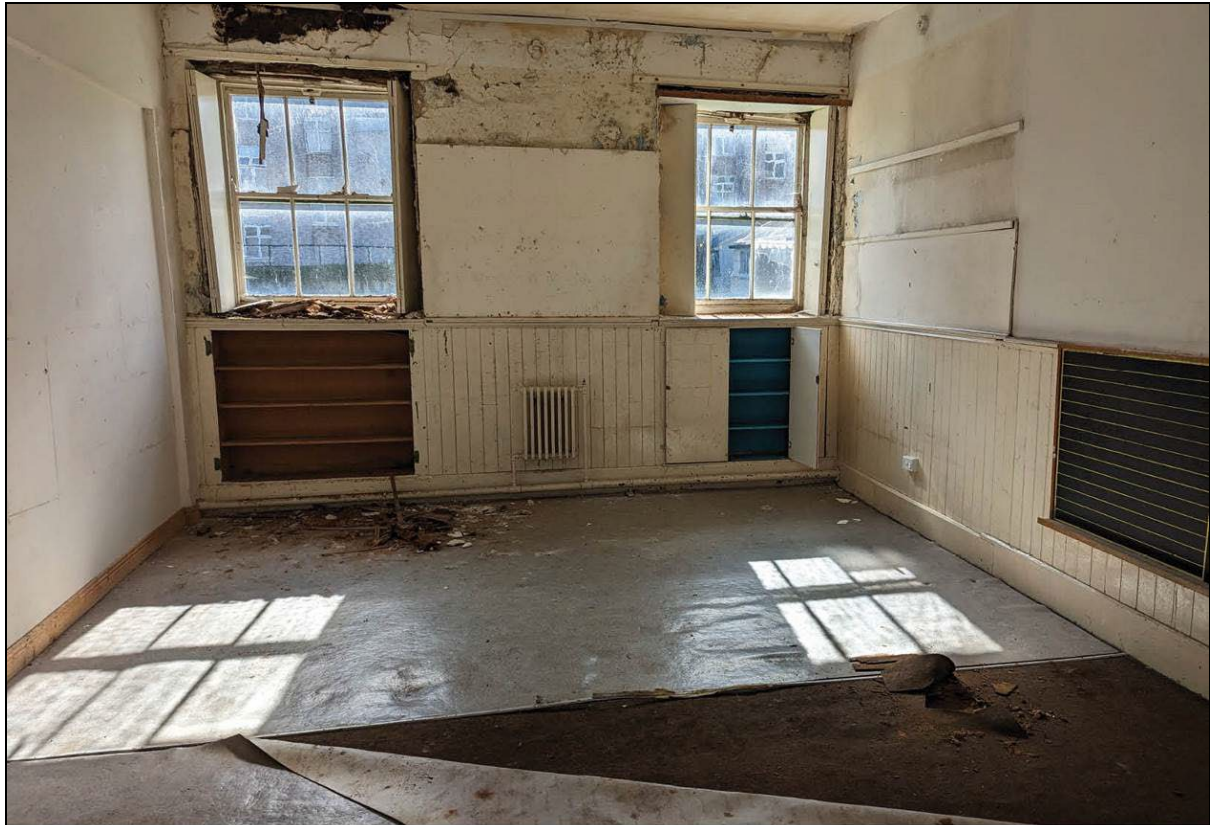
Room G05 looking south.

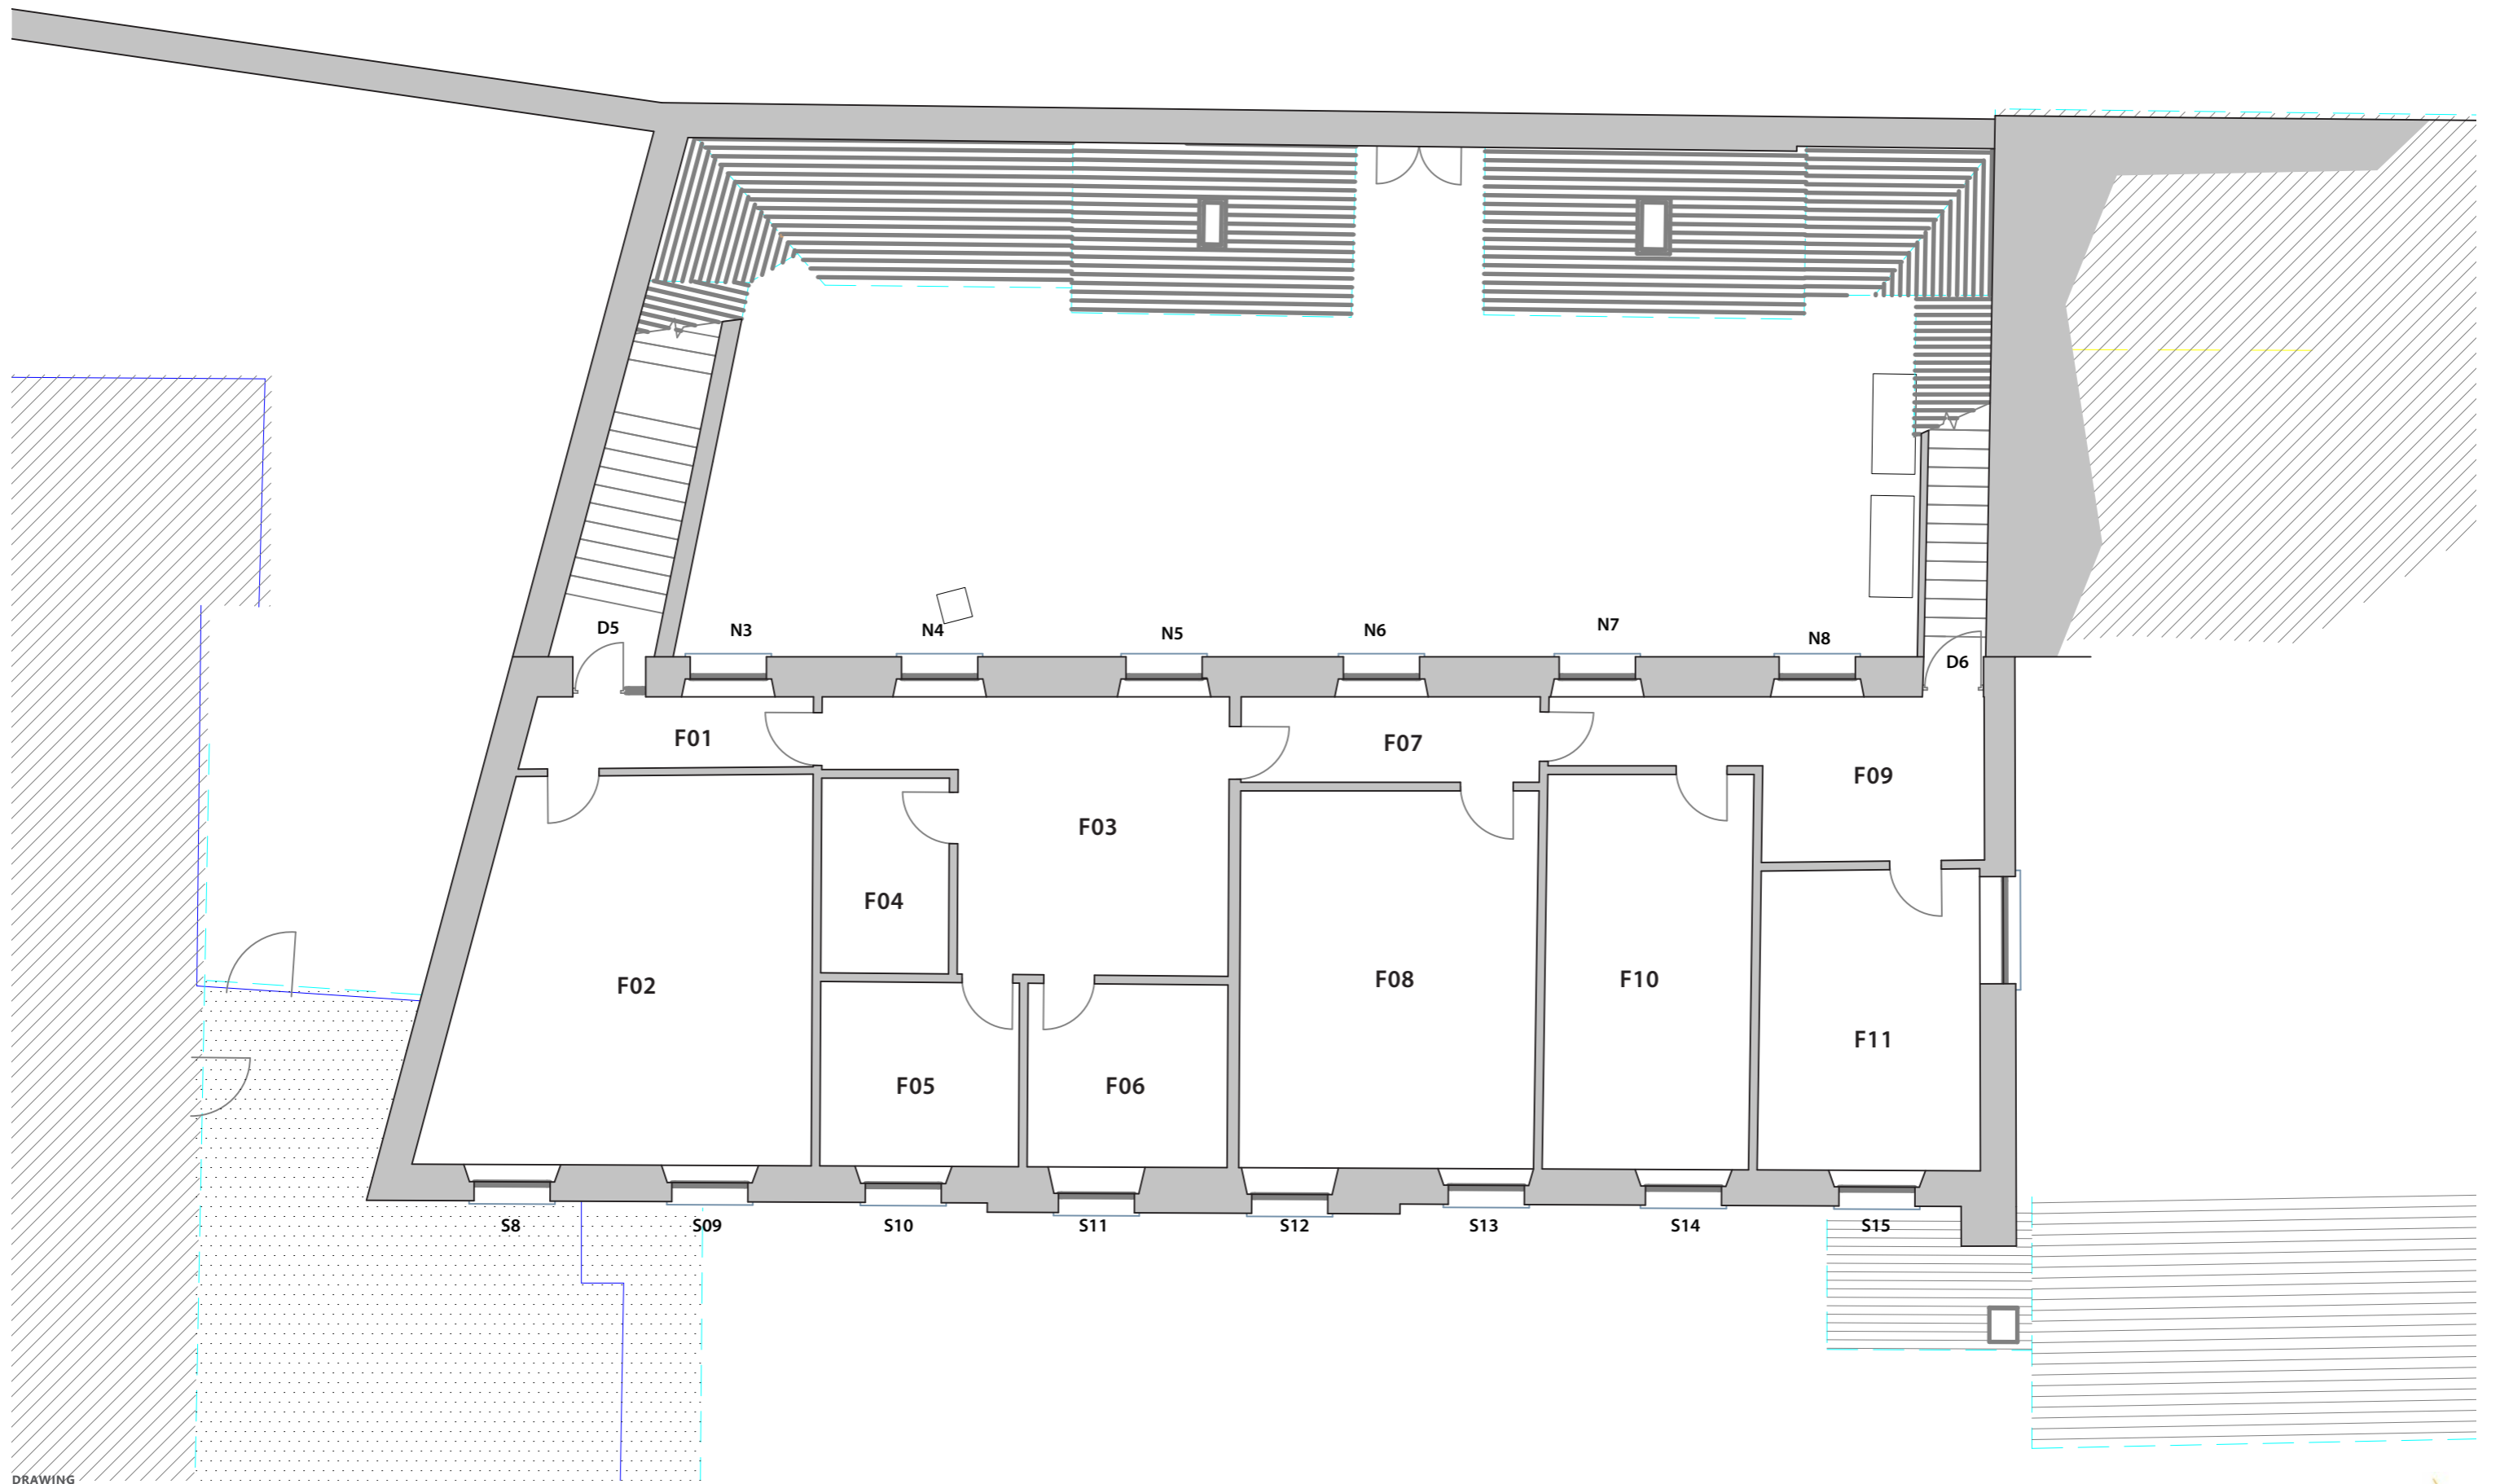
DRAWING  
**05 First Floor Plan**

In order to appraise the condition of the windows and doors the following table can be used as a guide along with **Drawings 4 and 5**.

<b>WINDOW</b>	<b>TYPE</b>	<b>CONDITION</b>	<b>GLASS</b>
<b>N1</b>	3 over 3 sliding sash	Both sashes in reasonable condition	2 panes cylinder glass at top, 3 panes obscure glass at bottom
<b>N2</b>	3 over 3 sliding sash	Both sashes in reasonable condition	3 panes cylinder glass at top, 2 panes obscure and 1 pane modern replacement at bottom
<b>N3</b>	3 over 3 sliding sash	Replacement sashes	6 panes wired modern glass
<b>N4</b>	3 over 3 sliding sash	Original sashes in reasonable condition	5 panes cylinder glass
<b>N5</b>	3 over 3 sliding sash	Original sashes in reasonable condition	5 panes cylinder glass
<b>N6</b>	3 over 3 sliding sash	Both sashes in reasonable condition	3 panes cylinder glass at bottom
<b>N7</b>	3 over 3 sliding sash	Both sashes in poor condition	inaccessible
<b>N8</b>	3 over 3 sliding sash	Both sashes are replacements	6 panes wired modern glass
<b>S1</b>	3 over 3 sliding sash	Both sashes in reasonable condition	3 panes cylinder glass at top, 3 panes obscure at bottom

<b>S2</b>	3 over 3 sliding sash	Both sashes in reasonable condition	3 panes cylinder glass at top, 3 panes fluted at bottom
<b>S3</b>	3 over 3 sliding sash	Both sashes in reasonable condition Rot and buckling in upper part of frame	3 panes cylinder glass at top, 3 panes fluted at bottom

<b>S4</b>	3 over 3 sliding sash	Both sashes in reasonable condition, lintel is failing, rot in upper part of frame	5 panes cylinder glass, 1pane modern replacement
<b>S5</b>	3 over 3 sliding sash	Both sashes in reasonable condition, severe rot in lintel, some rot in frame	all 6 panes cylinder glass
<b>S6</b>	3 over 3 sliding sash	Both sashes in slightly poor condition,	all 6 panes cylinder glass
<b>S7</b>	3 over 3 sliding sash	Both sashes in slightly poor condition,	all 6 panes cylinder glass
<b>S8</b>	3 over 3 sliding sash	Lower sash is a replacement,	3 panes cylinder glass at top
<b>S9</b>	3 over 3 sliding sash	Lower sash is a replacement, some rot in frame	1 pane cylinder glass at top
<b>S10</b>	3 over 3 sliding sash	Lower sash is a replacement and in poor condition	1 pane cylinder glass at top
<b>S11</b>	3 over 3 sliding sash	Lower sash is a replacement	2 panes cylinder glass at top
<b>S12</b>	3 over 3 sliding sash	Lower sash is a replacement and in poor condition, some damage to upper sash	3 panes cylinder glass at top

<b>S13</b>	3 over 3 sliding sash	Lower sash is a replacement, frame in v poor condition	3 panes cylinder glass at top
<b>S14</b>	3 over 3 sliding sash	Lower sash is a replacement in poor condition, top sash in poor condition, some rot to frame	3 panes cylinder glass at top
<b>S15</b>	3 over 3 sliding sash	Lower sash is a replacement in poor condition, some rot to frame	3 panes cylinder glass at top

<b>E1</b>	2 over 2 casement with 4 pane fanlight	Reasonable condition	4 panes of fanlight cylinder glass
<b>D1</b>	Part glazed timber panelled door with glazed side light on panelled riser, and glazed square headed overlight.	Reasonable condition some rot at base of frame	6 panes cylinder glass in fanlight
<b>D2</b>	Part glazed timber panelled door with glazed side light on panelled riser, and glazed square headed overlight.	Reasonable condition some rot at base of frame	3 panes cylinder glass in fanlight
<b>D3</b>	Part glazed timber panelled door with glazed side light on panelled riser, and glazed square headed overlight.	Reasonable condition some rot at base of frame	2 panes of cylinder glass in fanlight
<b>D4</b>	Part glazed timber panelled door with glazed side light on panelled riser, and glazed square headed overlight.	Reasonable condition some rot at base of frame	5 panes cylinder glass in fanlight

<b>D5</b>	Part glazed modern timber batten door with wired glass side light	Good condition	Wired modern glass
<b>D6</b>	Part glazed modern timber batten door	Good condition	Wired modern glass

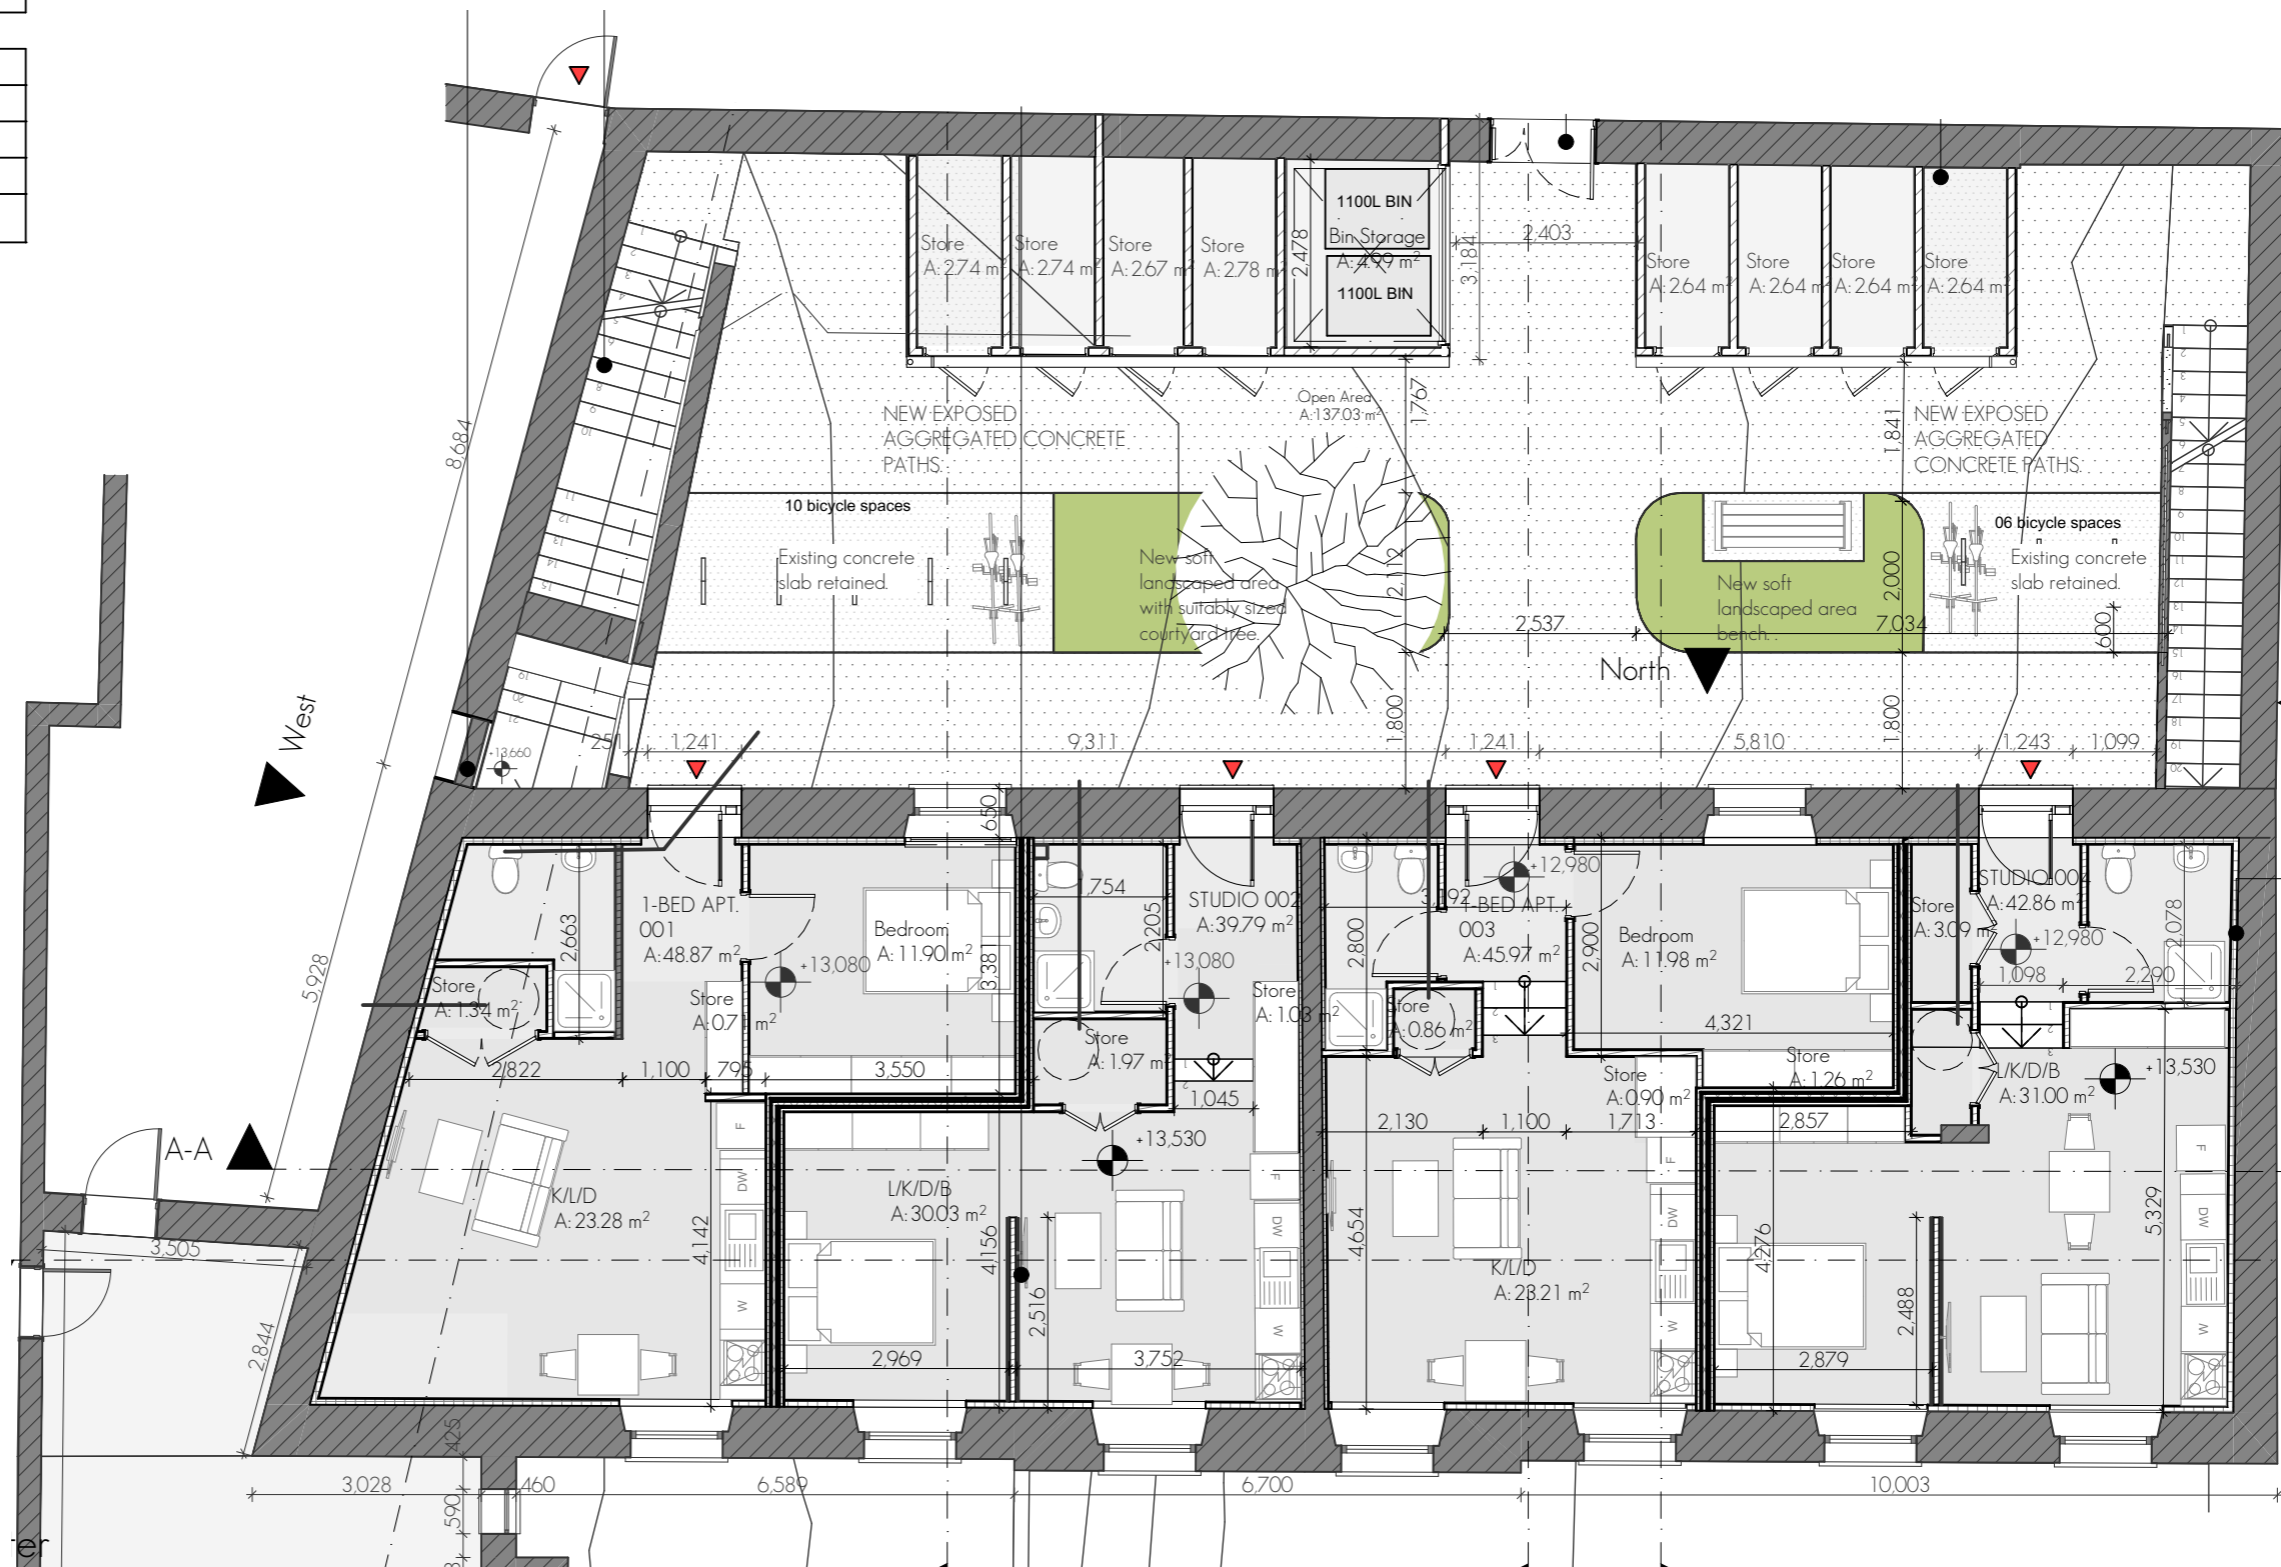
DRAWING  
09 Proposed Ground Floor Plan

This section should be read in conjunction with the accompanying drawing suite, **Drawings 09-11** that present the proposed alterations, interventions and repairs as designed by Meitheal Architects, architectural consultants to the project.

The proposal includes a number of alterations to the internal layout of the protected structure including the insertion of new partitions and internal doors. While modification such as these are not necessarily welcomed on a protected structure it should be noted that the continually evolving use of the building over the years has already resulted in the diminution of many of the original classroom spaces. The conversion of the building to residential use provides for a viable use for this empty protected structure. These alterations are considered necessary in order to bring the building into residential use. Attempts will be made to minimise the impacts of these where necessary and all will be done under the oversight of a buildings archaeologist or conservation architect. On the external envelope the windows and doors are of particular note with the 3 over 3 sliding sash windows retaining much of their original cylinder glass glazing and the ground floor doors showing unusual side lights and mirrored layout. However these are all in varying condition with some in quite poor condition and while the preference would be to repair where possible it has to be acknowledged that some of the sashes will have to be replaced in a like for like manner. In order to improve the thermal performance of the building the developer has proposed repairing all timber sliding sash windows and inserting slim line double glazing. While alternative measures (such as secondary glazing) were considered in order to improve the function of the windows while retaining the original glazing they was deemed impractical by the design team. The proposed approach does have a visual and physical impact in terms of removing historic glass but will have the benefit complying with Part L and of improving the thermal performance of the structure and
