RE: **Section 5 Declaration R883/24 3 Daunt Square, Cork**

**Question/Declaration Details:** Is repair works to the external shop front at 3 Daunt Square exempted development? Works consist of The 'like for like' replacement of decayed/damaged timber shop front.

| <b>PLANNER'S REPORT</b><br><b>Ref. R883/24</b> | | <b>Cork City Council</b><br><b>Development</b><br><b>Management</b><br><b>Strategic Planning and</b><br><b>Economic Development</b> |

**SECTION 5 APPLICATION FOR REPAIR WORKS AT 3 DAUNT SQUARE, CORK TO THE EXISTING TIMBER SHOPFRONT AND WINDOW SURROUNDS AT GROUND FLOOR ONLY**

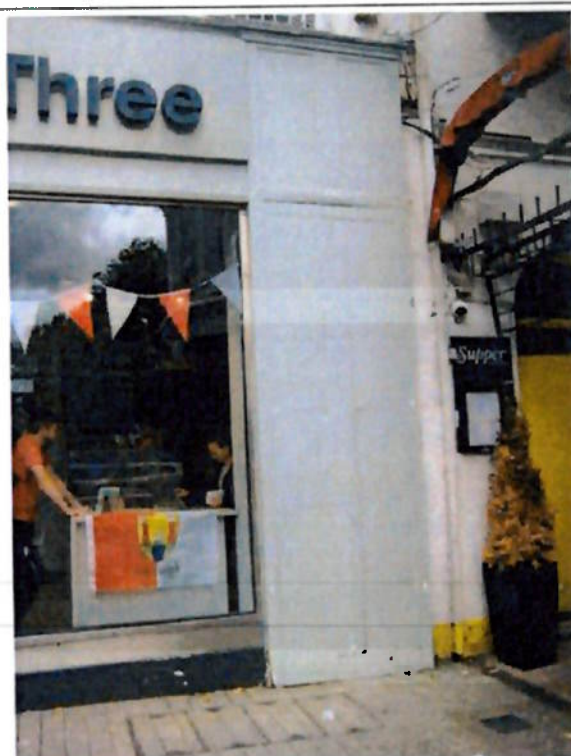
**Photograph 2** General view of Column 4.

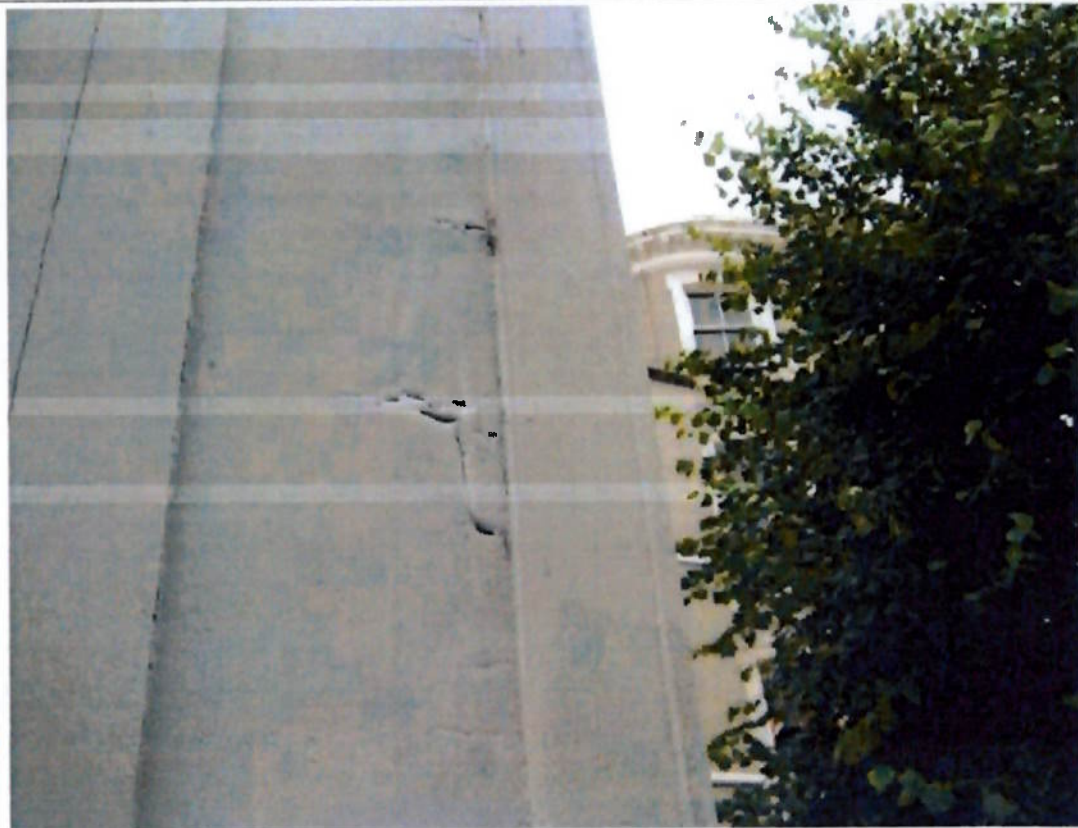
**Photograph 21**      **View of blistering paint to Column 2.**

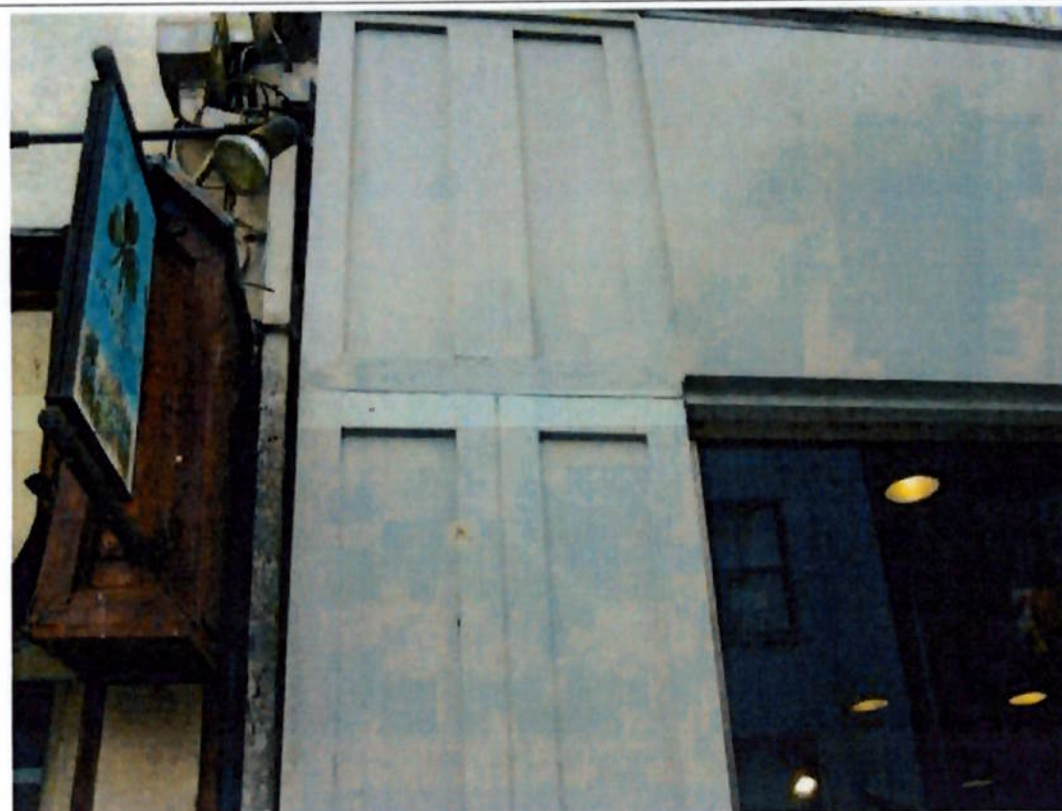
**Photograph 27**      **General view of Column 1.**
