RE: Section 5 Declaration R883/24 3 Daunt Square, Cork

Question/Declaration Details: Is repair works to the external shop front at 3 Daunt Square exempted development? Works consist of The 'like for like' replacement of decayed/damaged timber shop front.

SECTION 5 APPLICATION FOR REPAIR WORKS AT 3 DAUNT SQUARE, CORK TO THE EXISTING TIMBER SHOPFRONT AND WINDOW SURROUNDS AT GROUND FLOOR ONLY

APPENDIX 1: SCHEDULE OF PHOTOGRAPHS

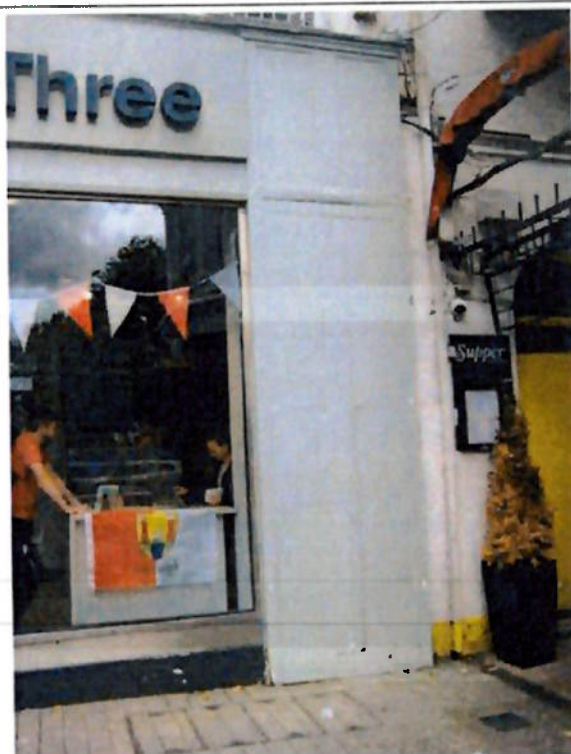
Photograph 2 General view of Column 4.

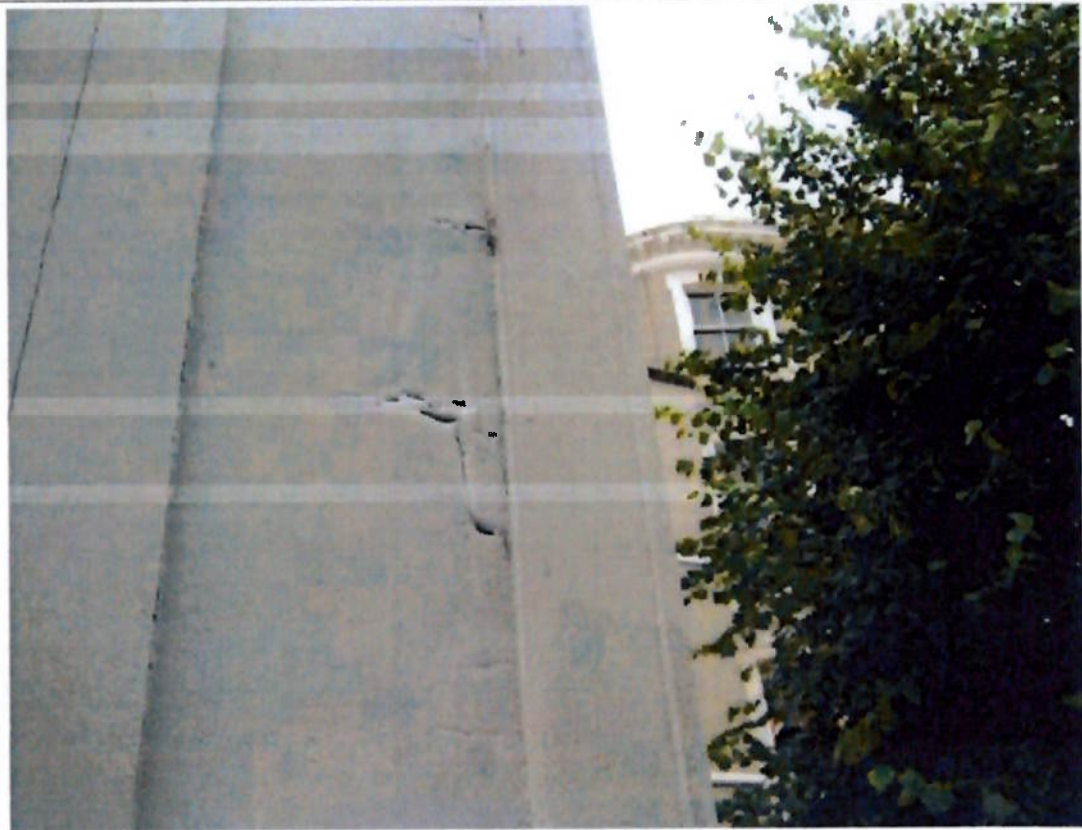
Photograph 21 View of blistering paint to Column 2.

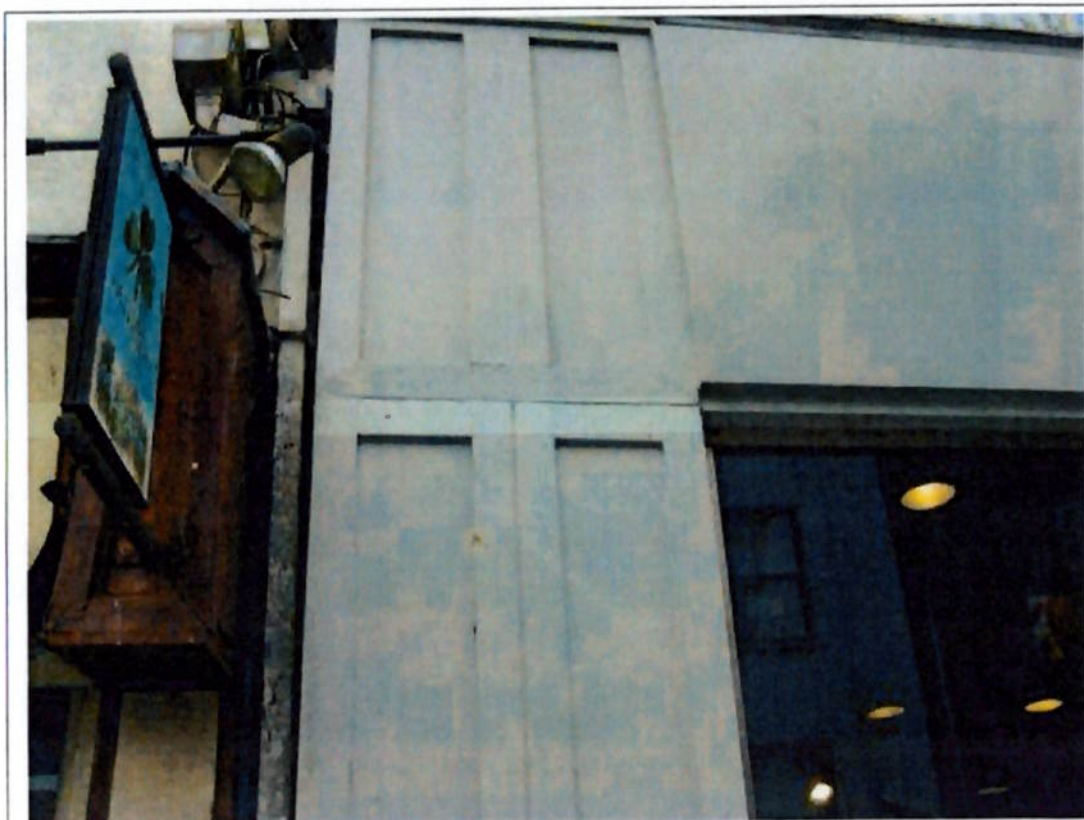
Photograph 27 **General view of Column 1.**

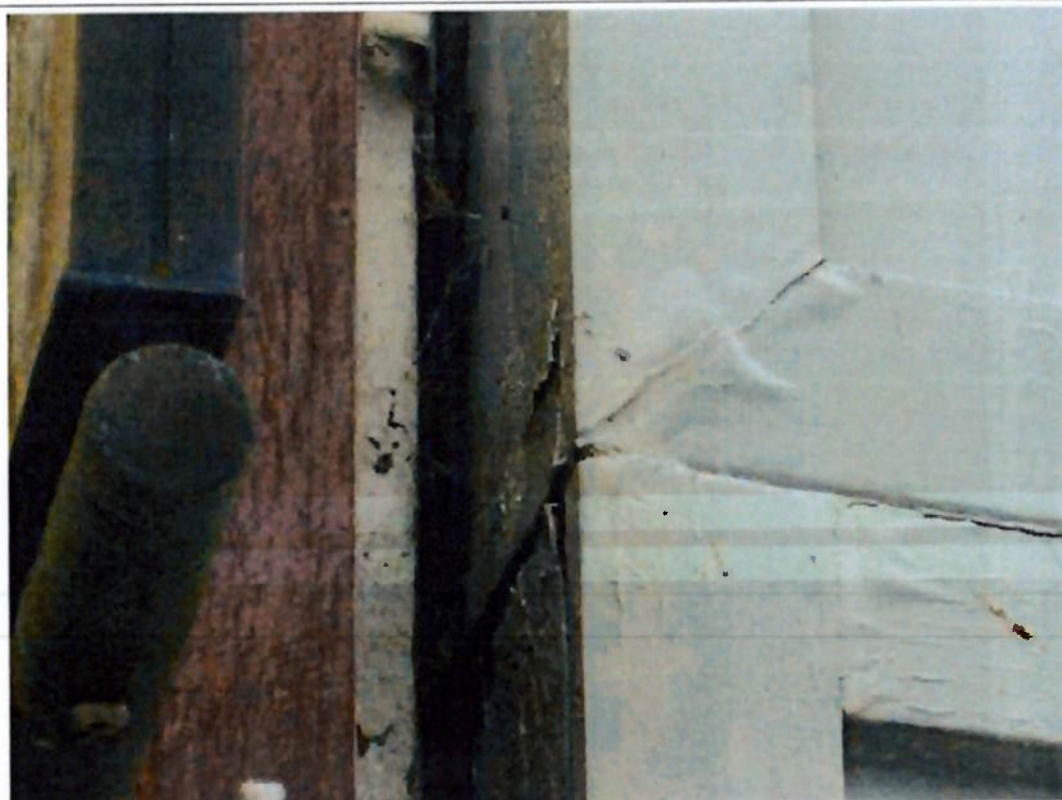
Photograph 28 **View of blistering paint to Column 1.**

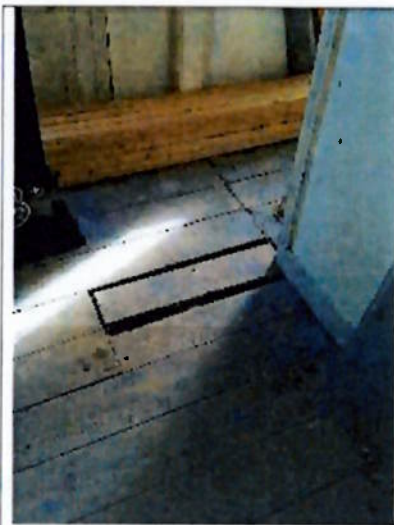
Sash boxes have been damaged in order to remove chords and pulleys on almost all windows

All sliding sash timber windows to be removed assessed by a joiner experienced in the conservation of historic sash windows. Windows to be conserved/ repaired where necessary and removed from site for same if deemed necessary by joiner. Sash chords and pulleys to be reinstated.

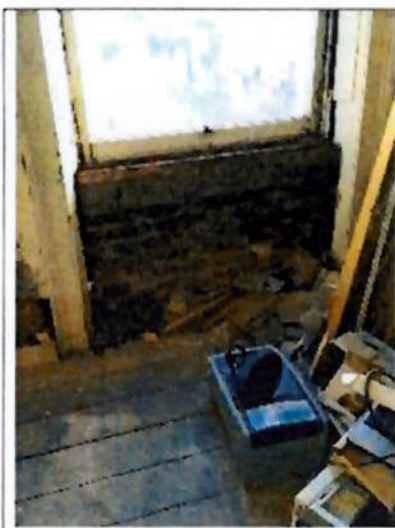
FIGURE 1: REMOVED PANELLING

Panelling has been removed below windows in some instances, revealing yellow slob bricks

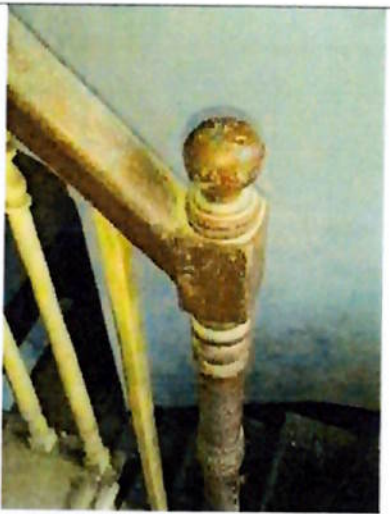
Newel post at half landing, showing a plain replacement baluster to left

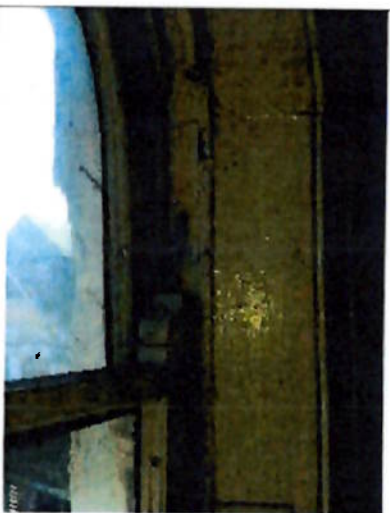
Round-headed one-over-one timber sliding sash window on the third floor.

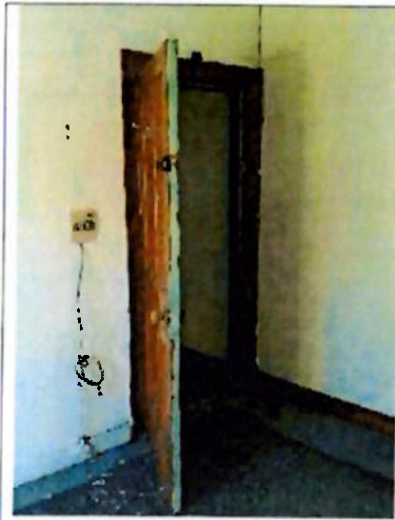
View towards landing on third floor, with four-panelled door in good condition
