RE: **Section 5 Declaration R883/24 3 Daunt Square, Cork**

**Question/Declaration Details:** Is repair works to the external shop front at 3 Daunt Square exempted development? Works consist of The 'like for like' replacement of decayed/damaged timber shop front.

| <b>PLANNER'S REPORT</b><br><b>Ref. R883/24</b> | | <b>Cork City Council</b><br><b>Development</b><br><b>Management</b><br><b>Strategic Planning and</b><br><b>Economic Development</b> |

**SECTION 5 APPLICATION FOR REPAIR WORKS AT 3 DAUNT SQUARE, CORK TO THE EXISTING TIMBER SHOPFRONT AND WINDOW SURROUNDS AT GROUND FLOOR ONLY**

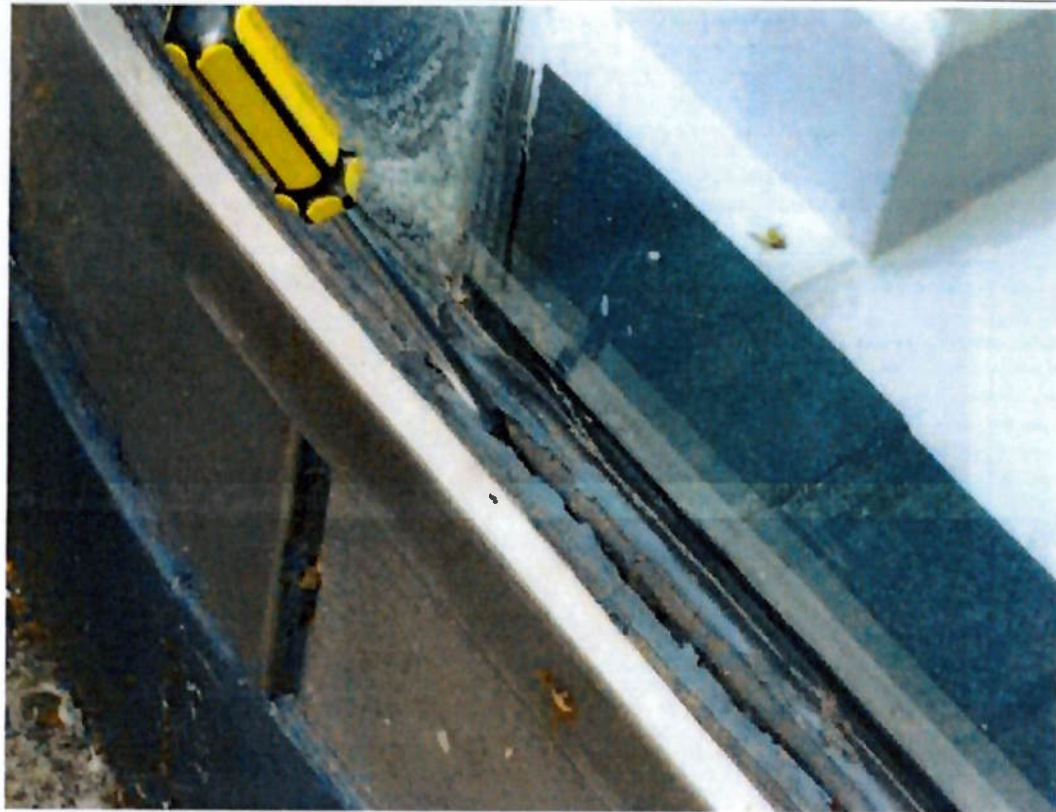
**Photograph 11** View of screwdriver placed within a large gap to the mastic seal.

- The existing timber shopfront at Ground Floor only, have deteriorated and succumbed to rot which is in a state of disrepair. We will replace the damaged timber frame surrounds 'like for like' to match the existing.
- The existing mastic window seals and stainless steel plinth at Ground Floor only, have perished and shown signs of damage/deflection. We will replace the mastic window seals 'like for like' and repair and reinstate the existing stainless steel plinth.

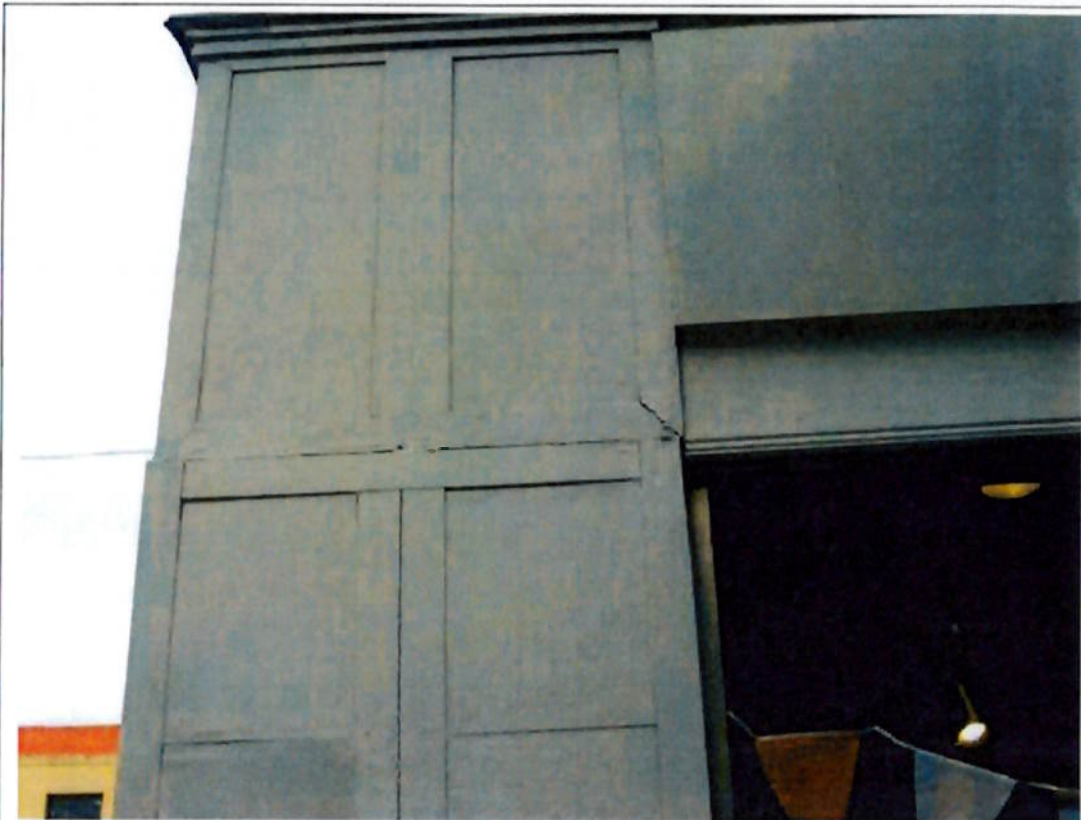
**Photograph 15**      **General view of Column 3.**

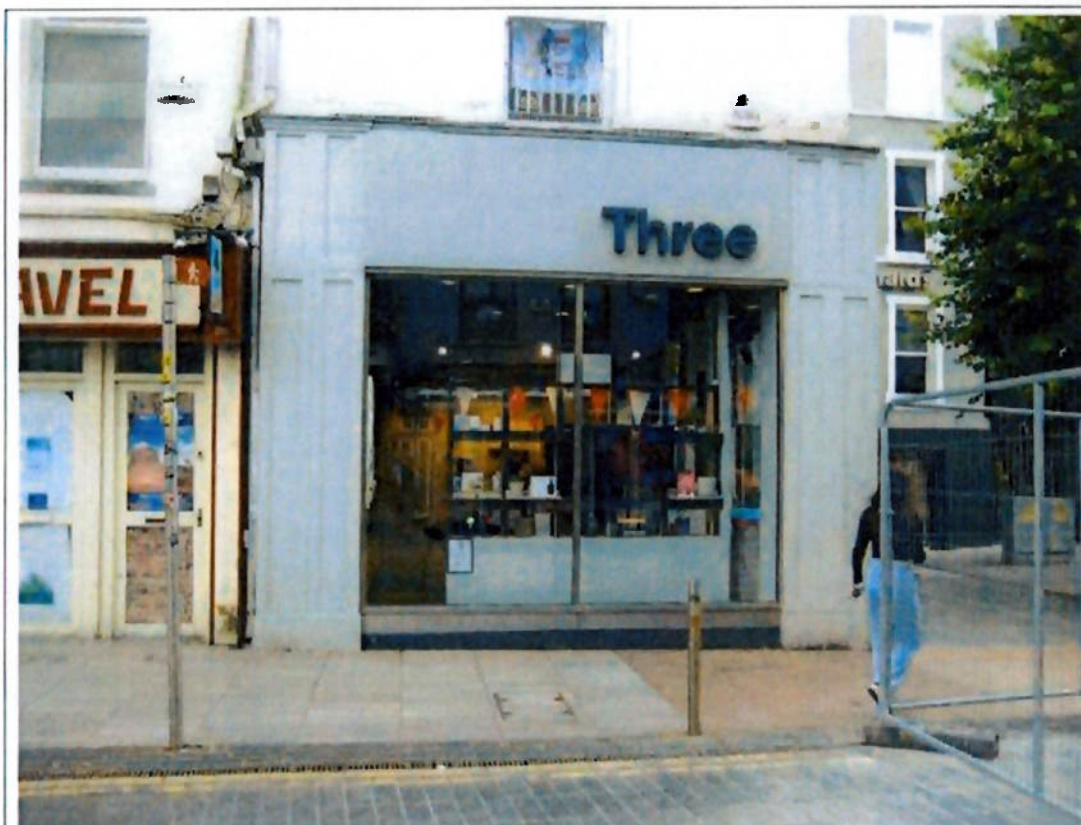
**Photograph 19**      **General view of the Side Elevation.**

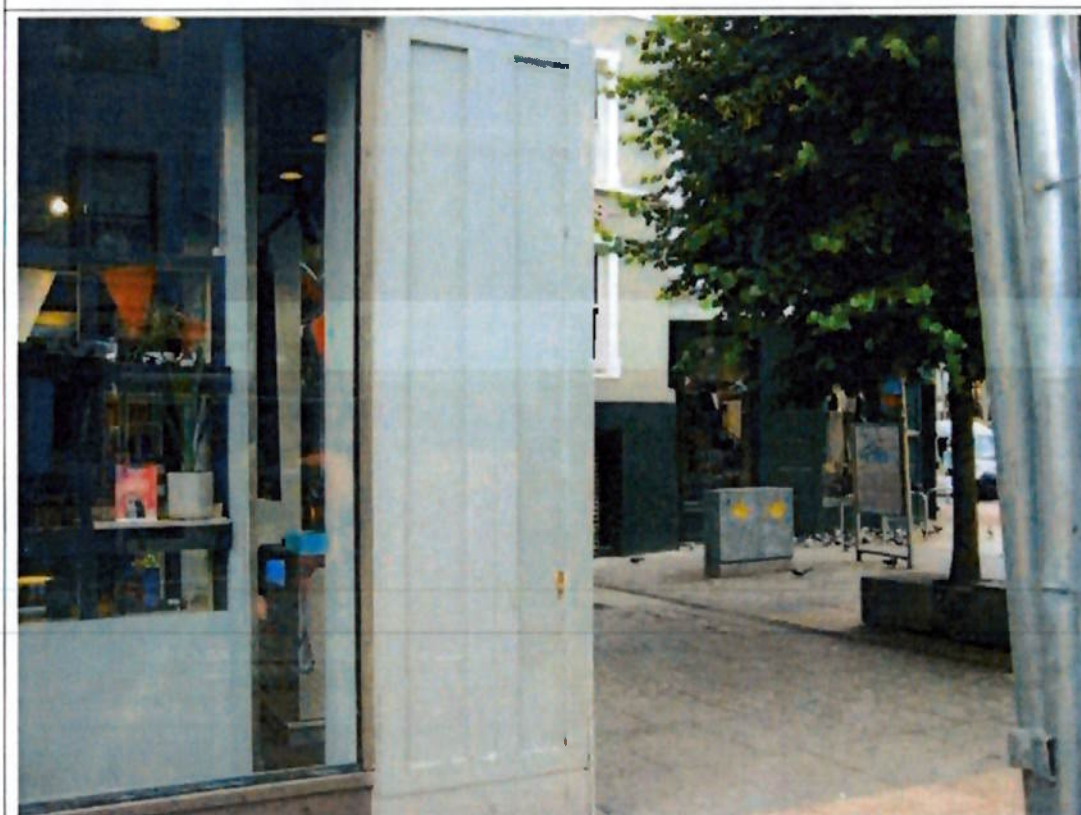
**Photograph 20**      **General view of Column 2.**

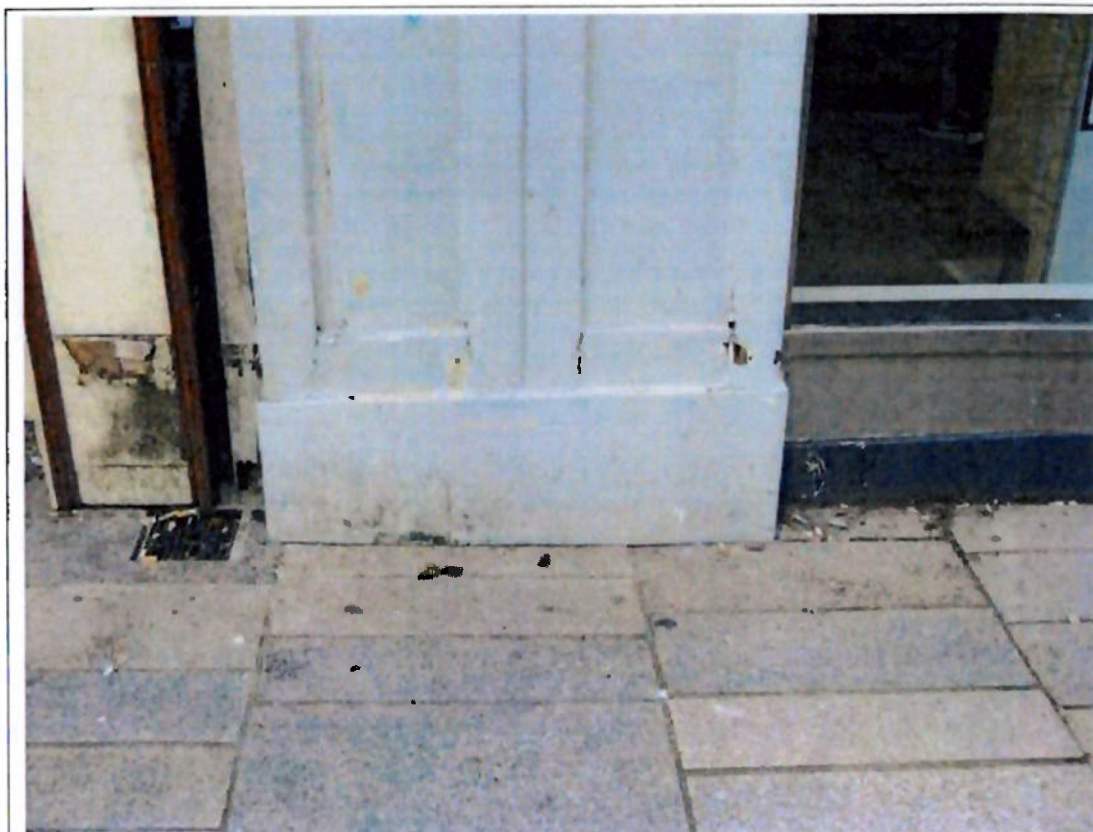
**Photograph 29** View of chipped paint and heavy soiling to the base of Column 1.

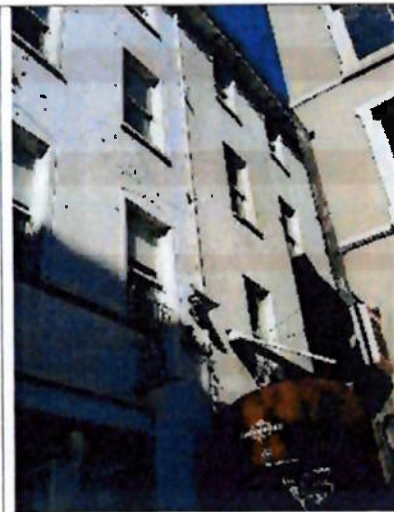
Eastern end of southern elevation, where it adjoins former Woodford and Bourne building

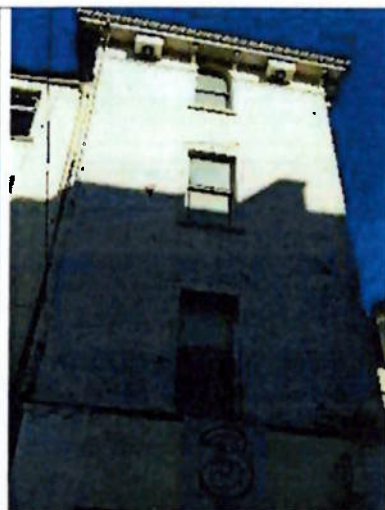
Western elevation

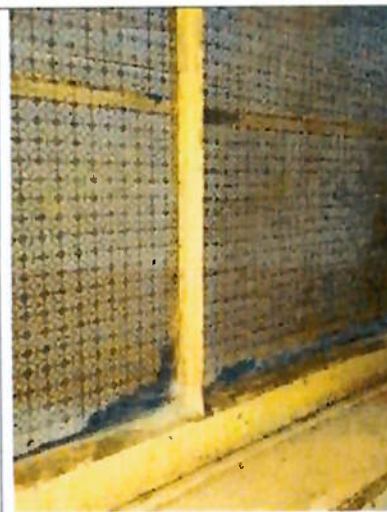
Two-over-two timber sliding sash window located in the northern elevation of the stairwell, which has been covered with opaque decals

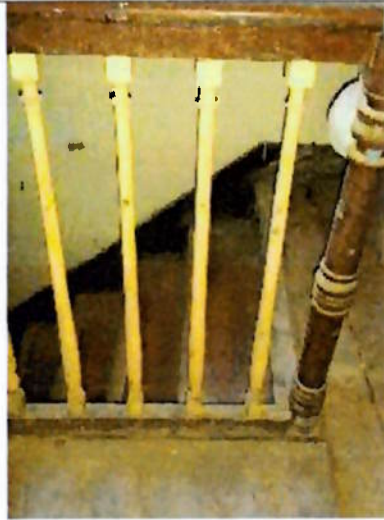
Four surviving Georgian balusters on the second floor landing, representing the earlier phase in the buildings development

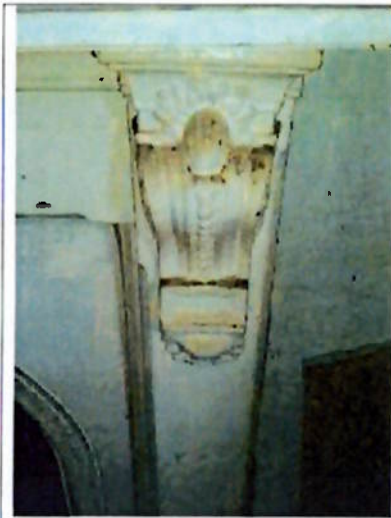
Detail of cast iron console bracket supporting mantel piece

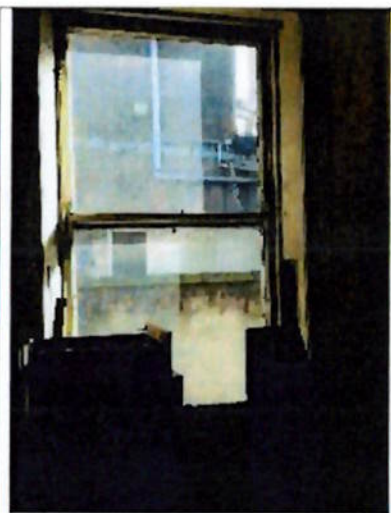
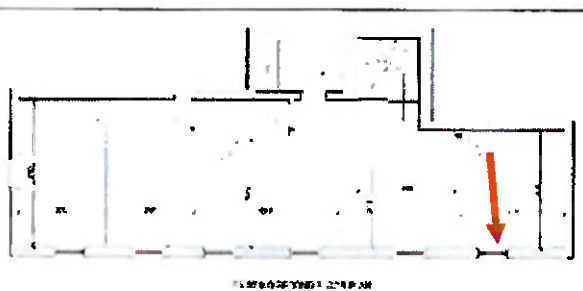
General view of one-over-one sash window

All sliding sash timber windows to be removed assessed by a joiner experienced in the conservation of historic sash windows. Windows to be conserved/ repaired where necessary and removed from site for same if deemed necessary by joiner. Sash chords and pulleys to be reinstated.

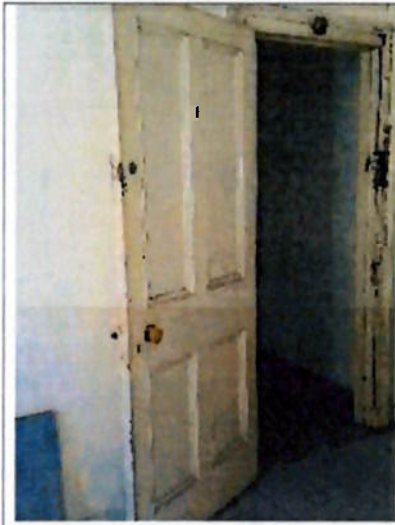
Four-panelled doors with mouse-moulding are found throughout the second and third floors and are in good condition overall

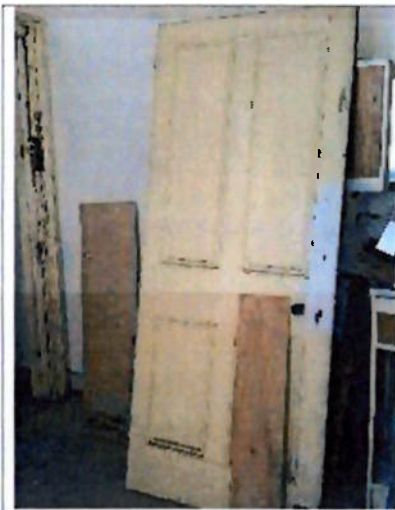
A number of doors are not hanging, but have been carefully stored and are in good condition

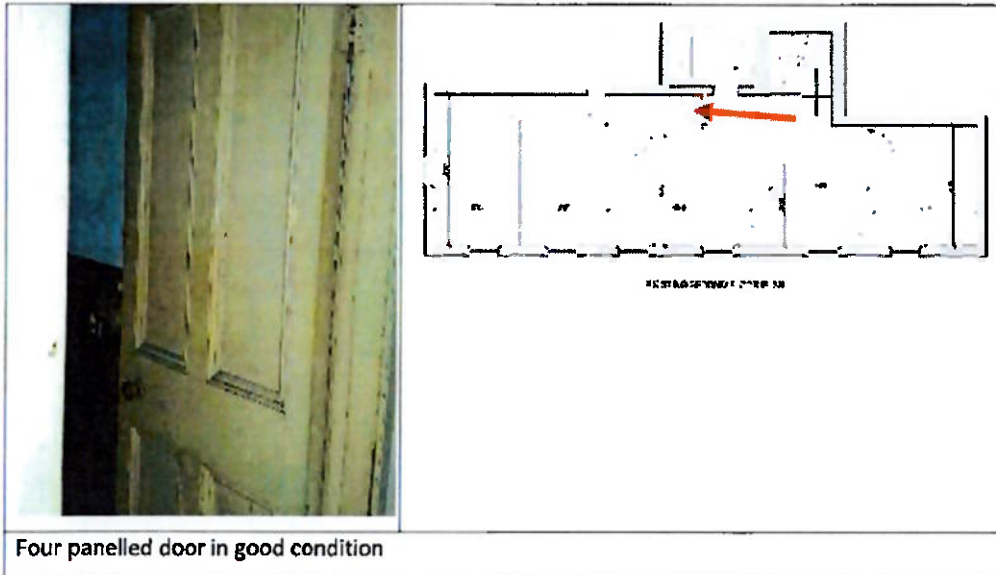
Four panelled door in good condition

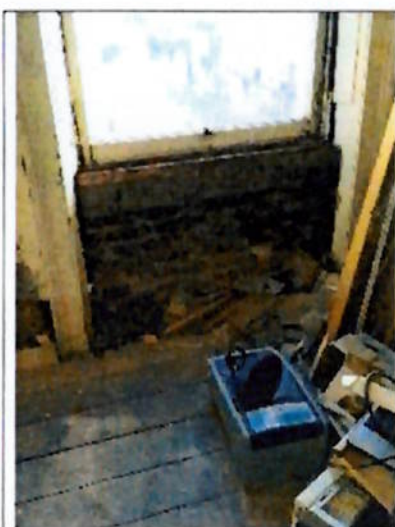
FIGURE 1: REMOVED PANELLING

Panelling has been removed below windows in some instances, revealing yellow slob bricks

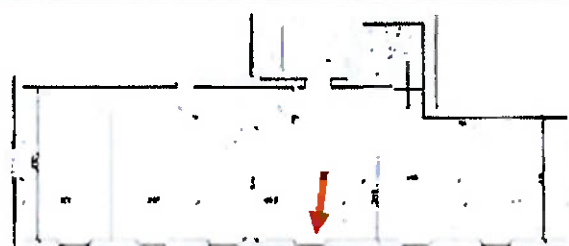
FIGURE 2: FRIABLE BRICKWORK

Yellow slob brick with lime mortar, which has become loose and friable. The fruiting body of wet or dry rot is also visible and should be further investigated

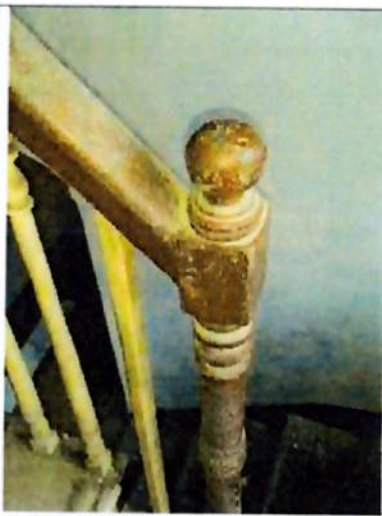
Newel post at half landing, showing a plain replacement baluster to left

The staircase is to be redecorated throughout. Missing balusters/ spindles to be provided to match the existing. Damaged elements to be conserved and repaired where possible or replaced if necessary by a joiner experienced in working with historic buildings. It is proposed to redecorate and service the doors with new ironmongery to be installed as required. Missing or defective elements are to be replaced on a like for like basis by a joiner experienced in working with historic buildings. The skirting boards, architraves, dado rails and picture rails are to be redecorated throughout. Damaged elements are to be repaired if possible or replaced if necessary on a like for like basis. All timber trims, jamb panels, window boards, plinth panels and sash boxes are to be inspected by a joiner experienced in working with historic windows and damaged or missing elements are to be repaired or replaced on a like for like basis if necessary. Internal window elements are also to be redecorated throughout the first, second and third floors.

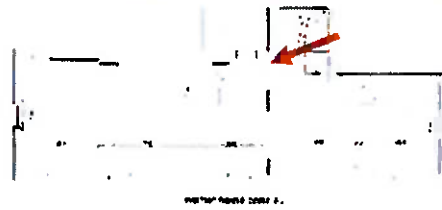
The northern side of the arch on the third floor also needs to be stitched

A number of cracks are visible in the existing structural walls and arches, which were inspected by Chris Southgate, FIEI. Cracks on the front elevation are historic and due to the gradual settlement of the building over time. The crack on the junction between the western and northern elevation is serious and should be tied in accordance with 'Type B' detail (Appendix 1) as a matter of urgency. Cracks in the northern side of the arches on the second and third floor landings should be tied with 6mm Helibars @ 450 centres. The northern sides of the arches on the second and third floors should be stitched in accordance with the specifications in Appendix 1.

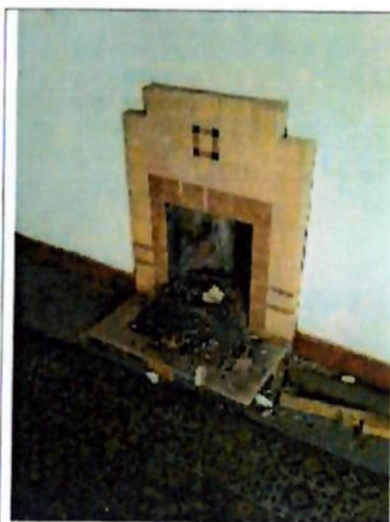
General view towards easternmost room

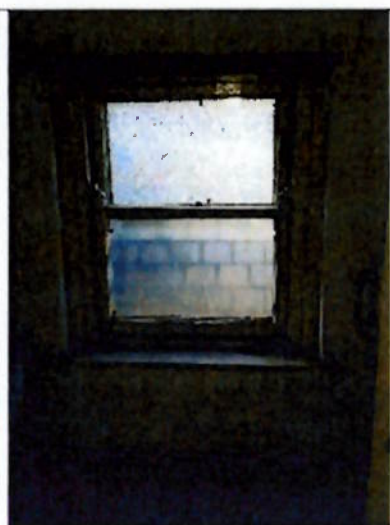
Former dressing room, with access from the easternmost room only.

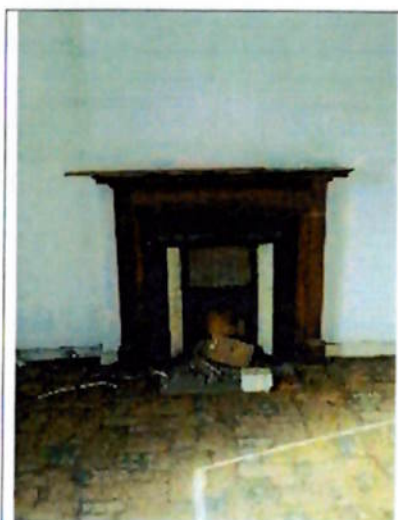
Late nineteenth century fireplace and surround

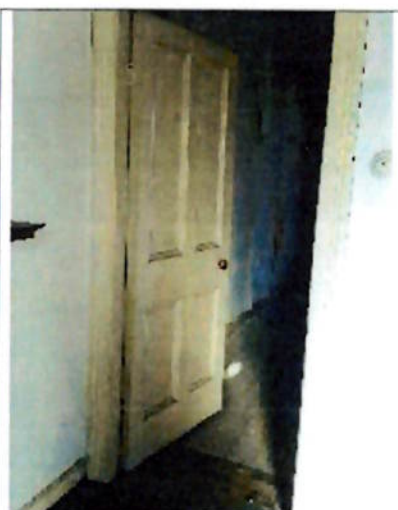
Four-panelled door in good condition, dating to the 1880s
